## **6.3 Architectural Components**

### **6.3.2 Interior Partitions**

#### **6.3.2.1 Interior Partition Walls, Heavy**

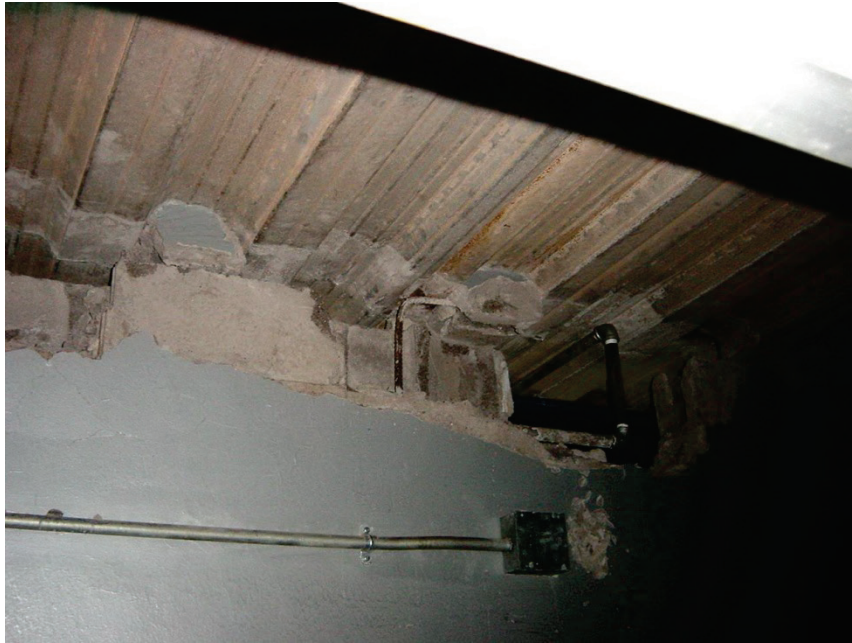
Figure 6.3.2.1-1 Damage along the top of a reinforced concrete masonry unit partition built flush with soffit of metal deck at an industrial facility in the 2001 magnitude-8.4 Peru Earthquake (Photo courtesy of Eduardo Fierro, BFP Engineers).

- Heavy full height partitions need out-of-plane restraint with an in-plane slip joint. This can be provided with steel angles on either side attached to the structural slab above as shown. Steel angles may be continuous or intermittent; check code requirements. Note that special details may be required to meet fireproofing, sound proofing, weatherproofing or insulation requirements.
- Care must be used in detailing slip joints for a series of interconnected perpendicular walls since the out-of-plane restraints for one wall will prevent in-plane slip along the perpendicular wall; vertical isolation joints may be required. Similarly, special details are required where the soffit of the structure above has an irregular profile that would prevent slip such as the metal deck in Figure 6.3.2.1-1, or a sloping profile such as a ramp.

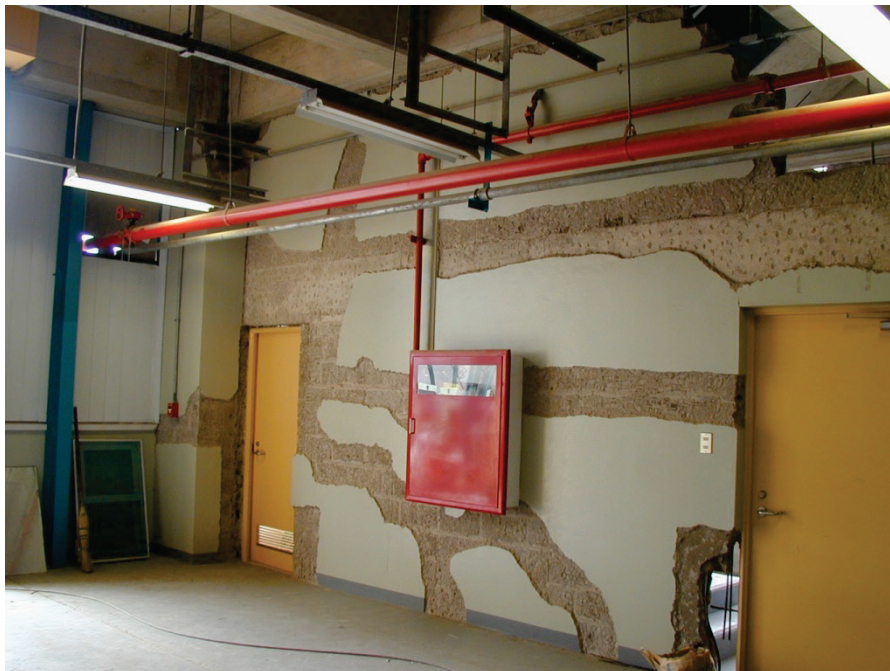
Figure 6.3.2.1-2 Damage to reinforced concrete masonry partition used to support fire protection cabinet and piping in the 2001 Peru Earthquake; loose stucco and masonry were removed prior to photo (Photo courtesy of Eduardo Fierro, BFP Engineers).

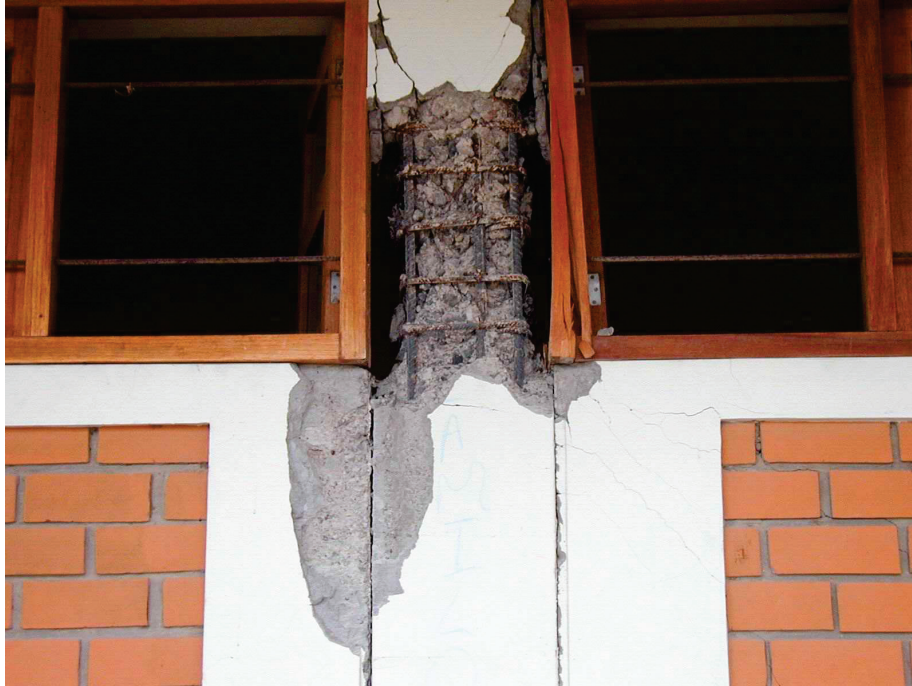
Where partitions are built tight against structural columns, there is a potential for the masonry wall to unintentionally create a “captive column” thereby changing the intended earthquake response of the building. A structural engineer is needed to evaluate the implications of such conditions.

Figure 6.3.2.1-3      Damage to structural column (“captive column”) due to restraint caused by partial height masonry wall in the 2001 Peru Earthquake (Photo courtesy of Eduardo Fierro, BFP Engineers).

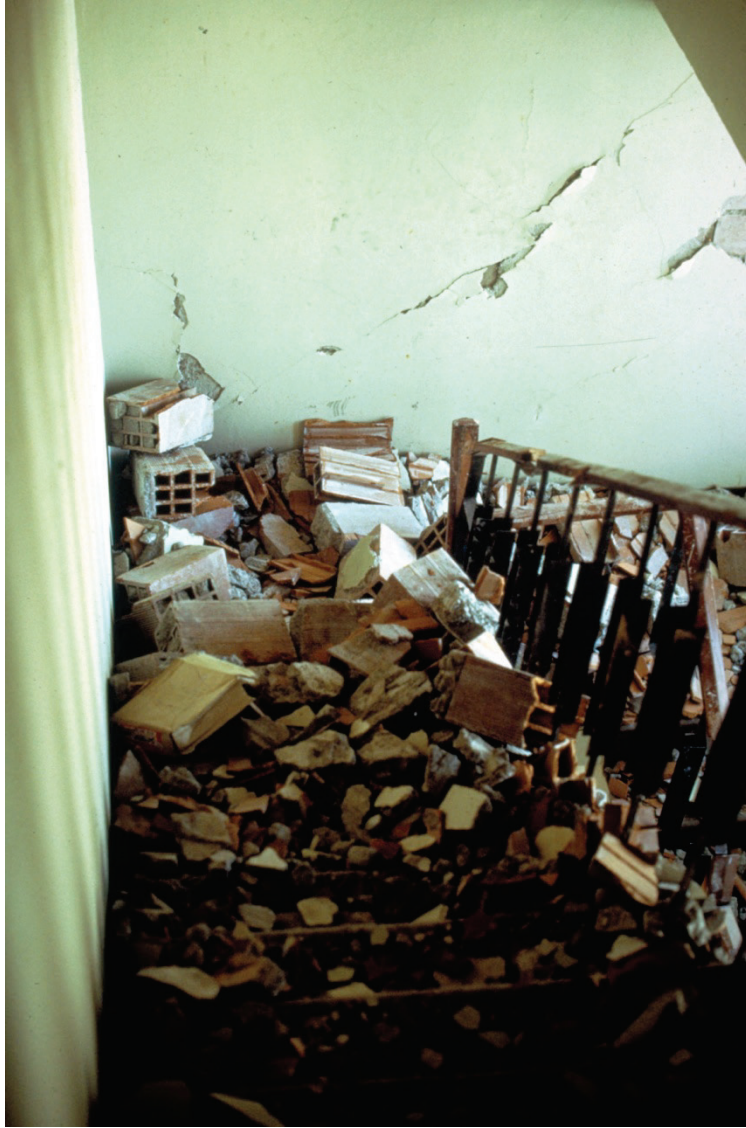
Figure 6.3.2.1-4 View of stairway in the Banco Central Building, Managua, Nicaragua after the 1972 magnitude 6.2 Managua Earthquake. Most of the stairs were covered with debris that resulted from the failure of the hollow tile partitions surrounding the stairs (Photo courtesy of PEER Godden Collection, No. J94).

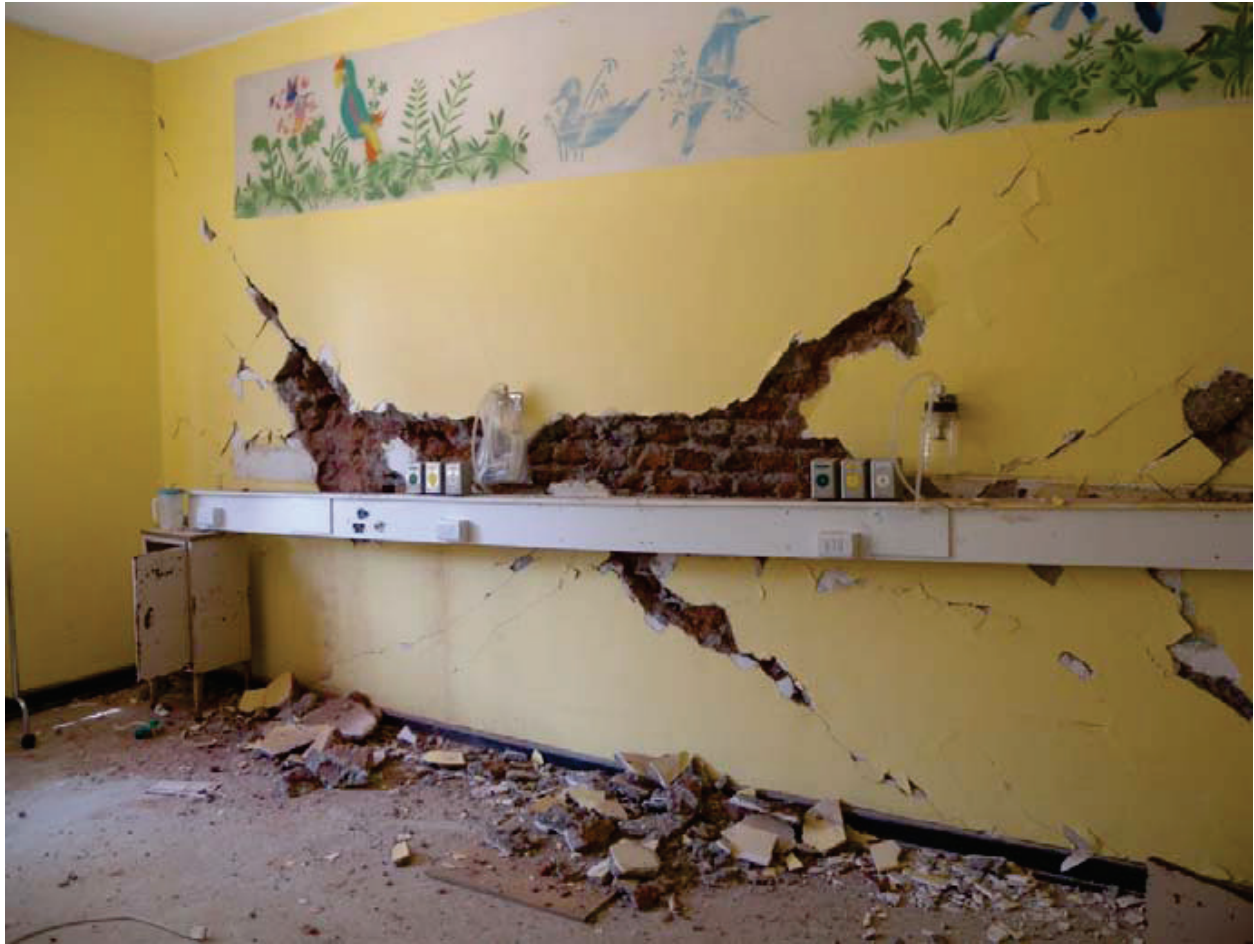
Figure 6.3.2.1-5 Damage to unreinforced brick partitions in patient rooms, and other mostly nonstructural damage, resulted in the evacuation of the Felix Bulnes Hospital in Santiago in the 2010 magnitude-8.8 Chile Earthquake (Photo courtesy of Gilberto Mosqueda, University of Buffalo, SUNY).

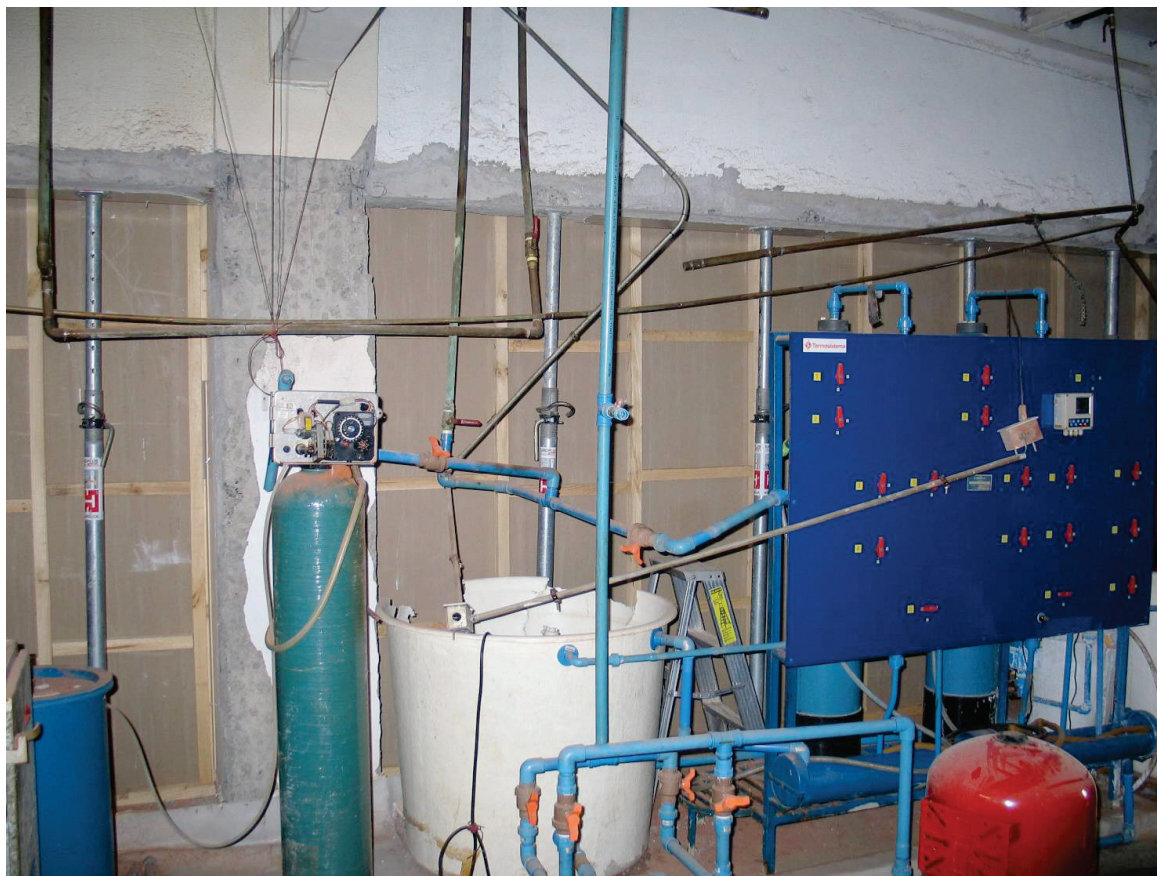
Figure 6.3.2.1-6 An infill masonry wall collapsed onto the distilled water equipment spilling two 150 gallon containers; water leaked past the perimeter edge of the floor slab into the operating room suite below resulting in the closure of 3 of 6 the operating rooms. Replacement gypsum board partition seen in photo. Hospital built in 2005 in Los Angeles, Chile. Damage from the 2010 Chile Earthquake (Photo courtesy of Bill Holmes, Rutherford & Chekene).

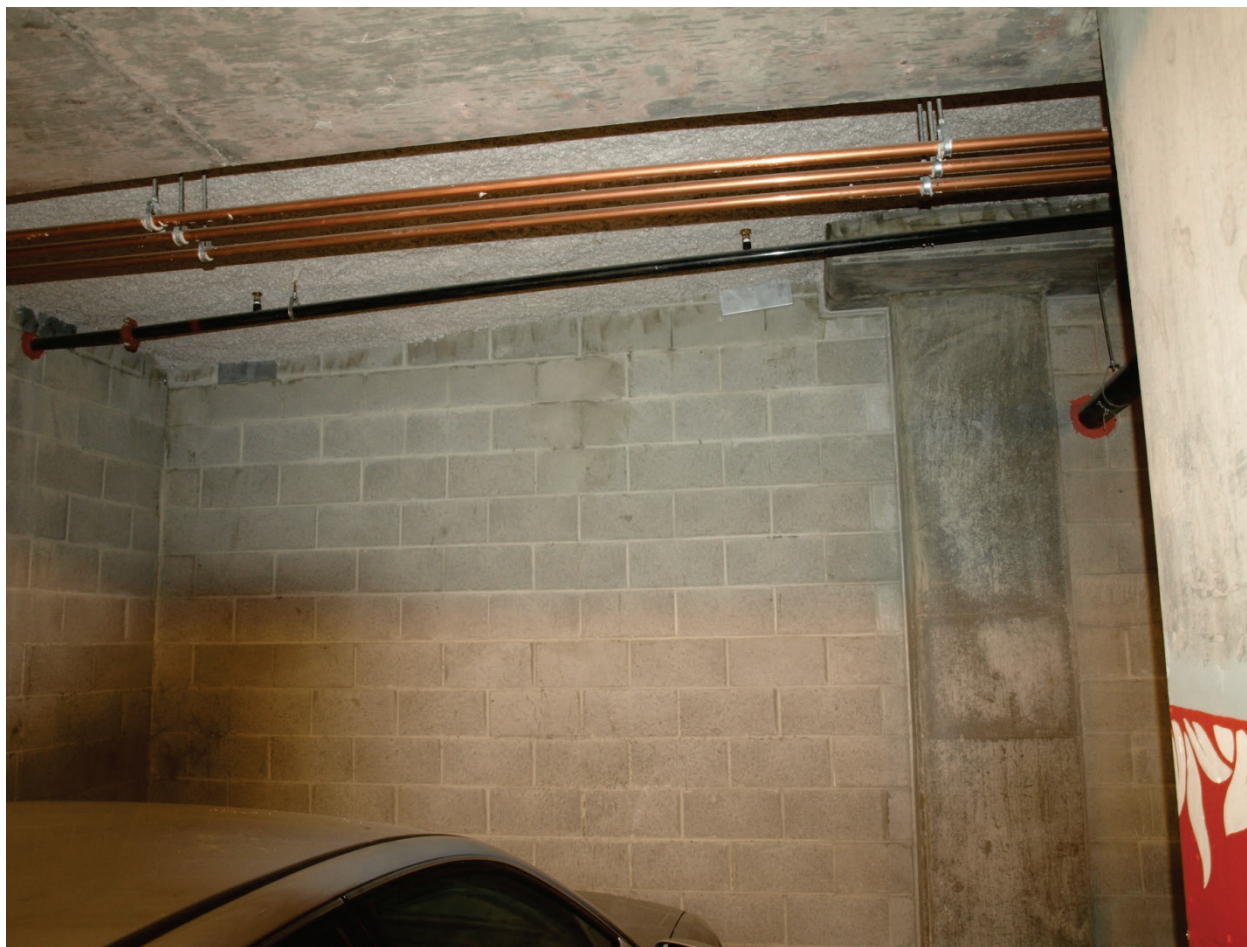
Figure 6.3.2.1-8 Full-height concrete masonry unit walls detailed with steel clip angles (3 angles visible in photo). Configuration shown includes perpendicular walls, sloping ramp above, and column with column capital. Although wall detailed with sealant joints along edges of column and column capital, it is not clear that the concrete frame can move independently of these CMU walls (Photo courtesy of Cynthia Perry, BFP Engineers).
