## 2. Behavior of Nonstructural Components

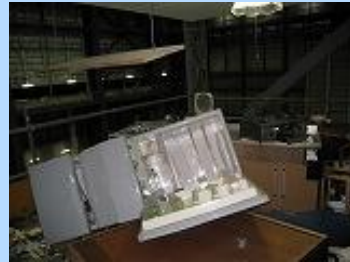
Figure 2-1 Result of shaking table test on room contents (from 01, 2008 test)

The Hyogo Earthquake Engineering Research Center in Japan has posted video footage of shake table testing of nonstructural components during a simulated earthquake. Two of these video clips speak volumes about the hazards of nonstructural components during an earthquake. The video clips focus on the behavior of furniture, contents, and some architectural components.

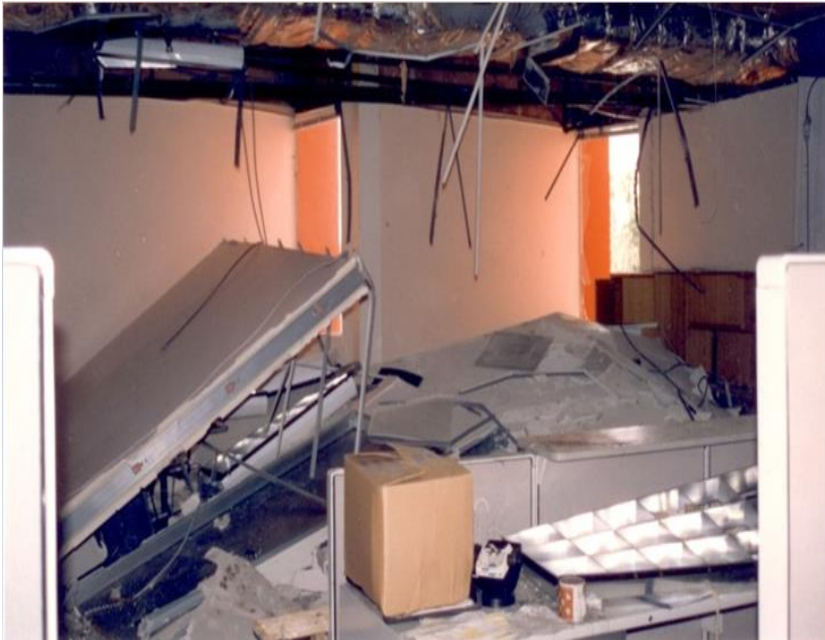
Figure 2.4.1-1 Failure of office partitions, ceilings, and light fixtures in the 1994 Northridge Earthquake (FEMA 74, 1994).

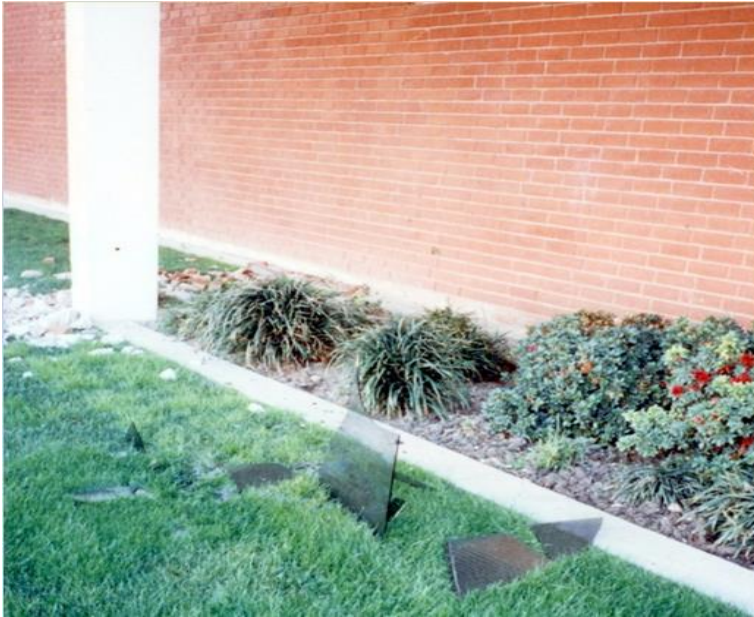
Figure 2.4.1-2 Shards of broken untempered glass that fell several stories from a multistory building in the 1994 Northridge Earthquake. Failures of this type can be very hazardous, especially if glazing is located above exit ways (FEMA 74, 1994).

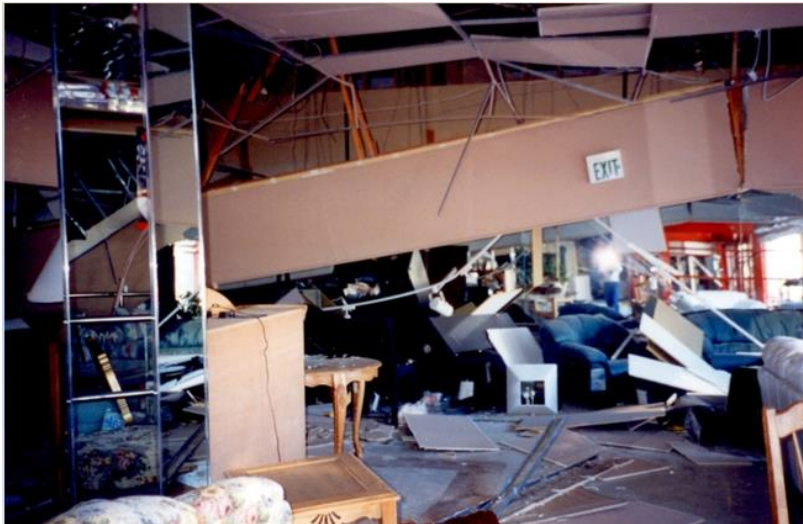
Figure 2.4.1-3 Failure of suspended ceilings and light fixtures in a furniture store (FEMA 74, 1994).

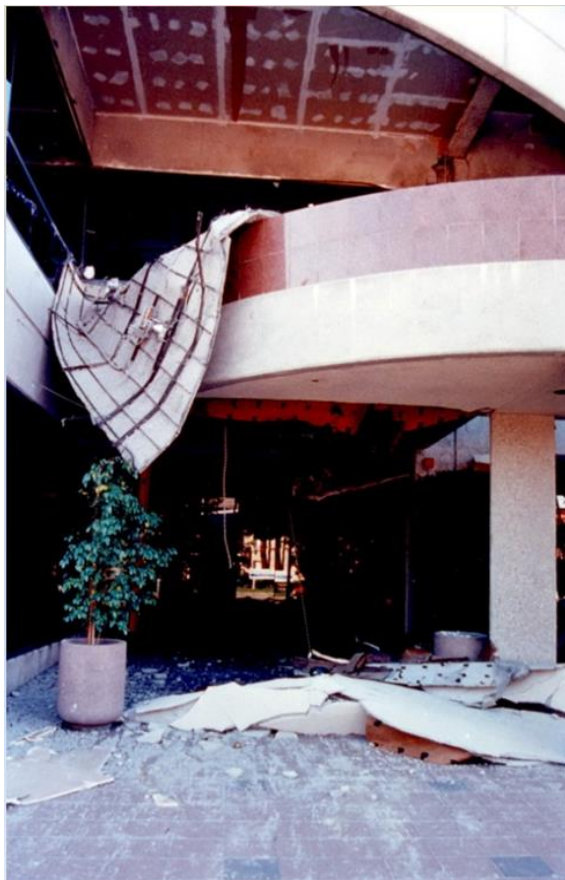
Figure 2.4.1-4 Failure of heavy stucco soffit at building entrance in the 1994 Northridge Earthquake (FEMA 74, 1994).

Heavy suspended ceilings and soffits can be damaged during earthquakes, sometimes causing heavy and dangerous material to fall and injure people below. Figure 2.4.1–2 shows a failed stucco soffit above a building entrance damaged in the 1994 Northridge Earthquake. During the 1989 Loma Prieta Earthquake, the proscenium arch ceiling at the Geary Theatre in San Francisco fell and covered the first six rows of seats in the auditorium; the theater was not in use at the time and no one was injured (Ding, 1990).

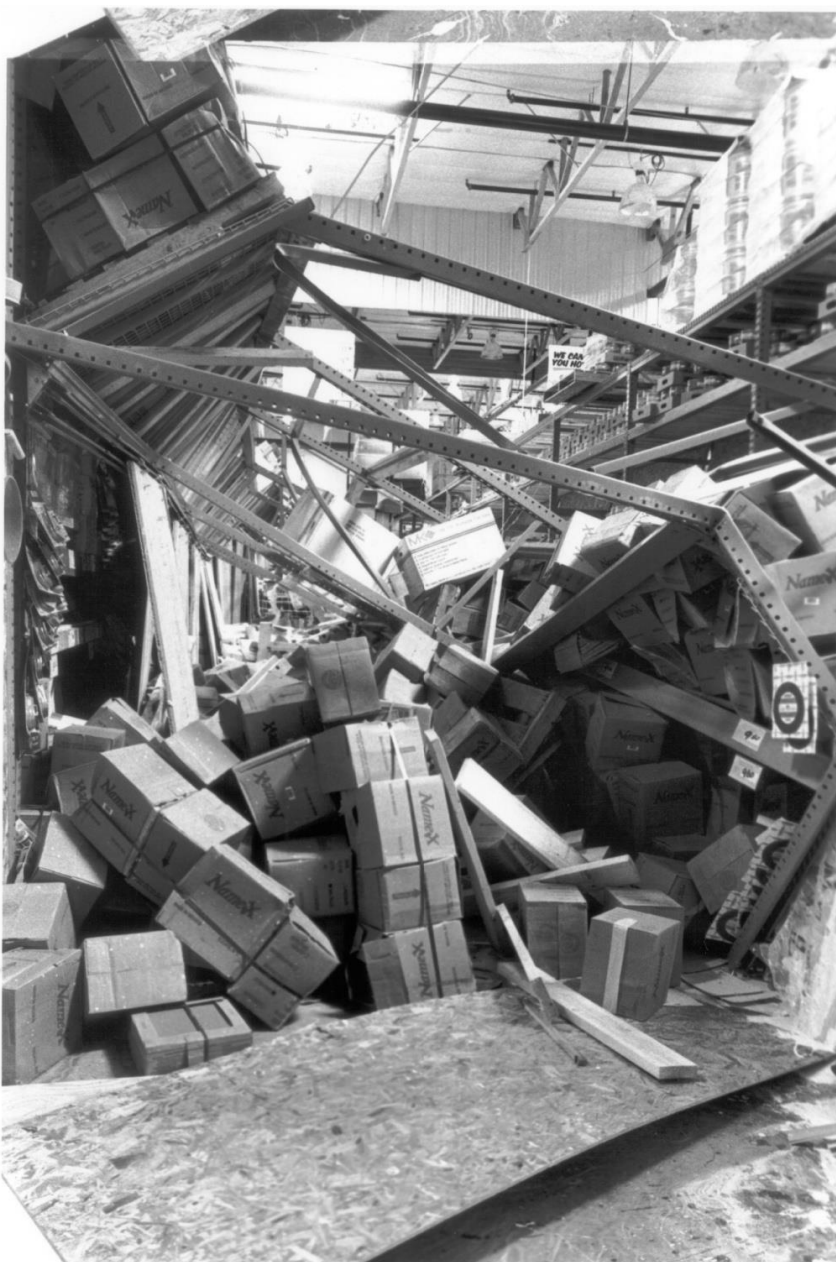
Figure 2.4.1-5 Damage to overloaded racks during the 1994 magnitude-6.7 Northridge Earthquake (FEMA 460, 2005).

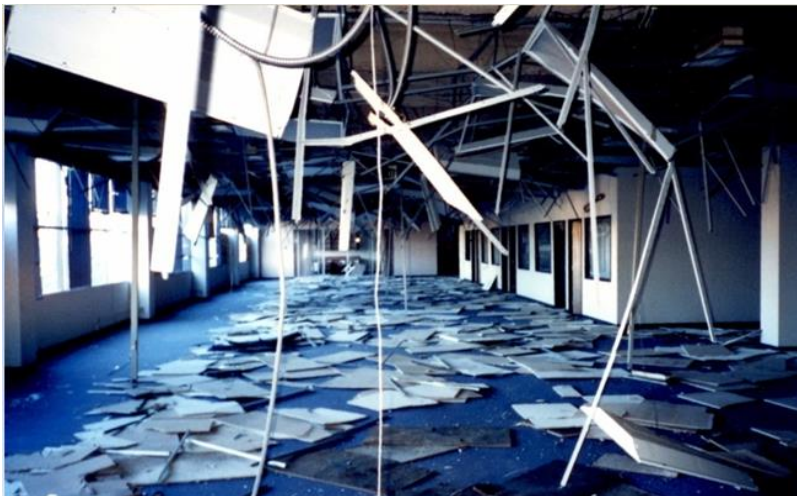
Figure 2.4.2-1 Complete loss of suspended ceilings and light fixtures in the 1994 Northridge Earthquake (FEMA 74, 1994).

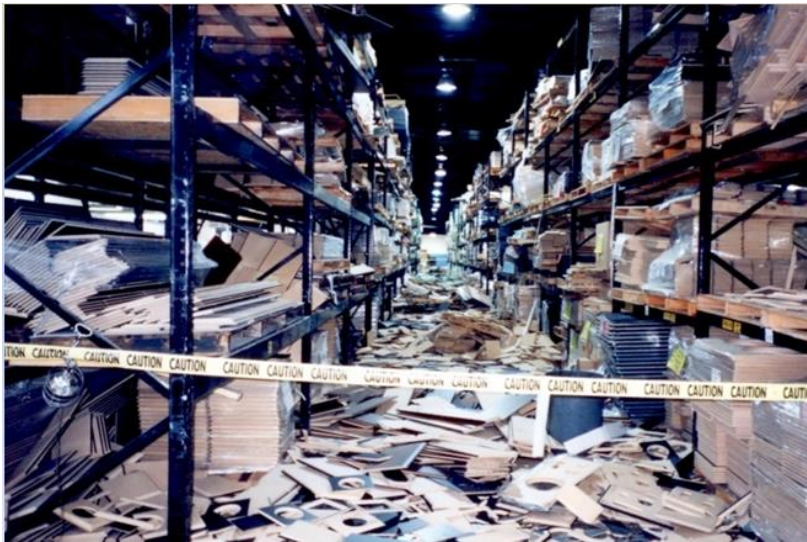
Figure 2.4.2-2 Damage to inventory on industrial storage racks in the 1994 Northridge Earthquake (FEMA 74, 1994).

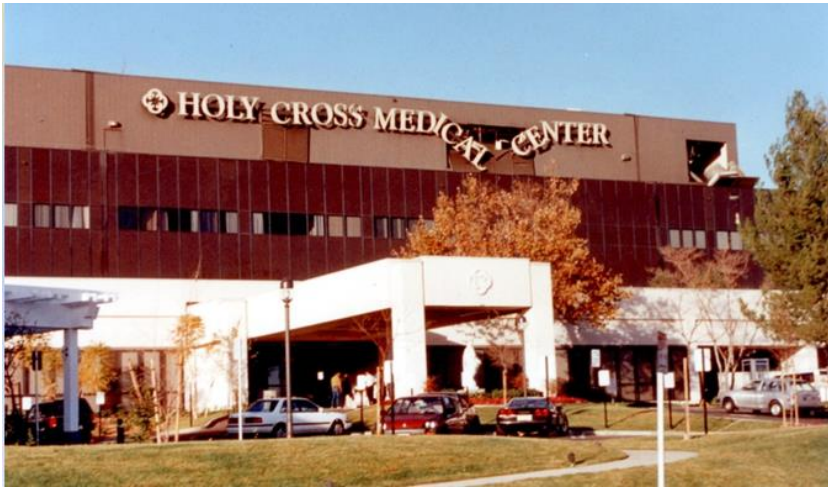
Figure 2.4.3-2 HVAC damage at Holy Cross Medical Center in Sylmar in the 1994 Northridge Earthquake. Damage to signage and louvers was caused when suspended fans in the mechanical penthouse swung and impacted the louver panels. HVAC service outage caused the temporary evacuation of patients (FEMA 74, 1994).
