6.3 Architectural Components

6.3.5 Parapets and Appendages

6.3.5.1 Unreinforced Masonry Parapets

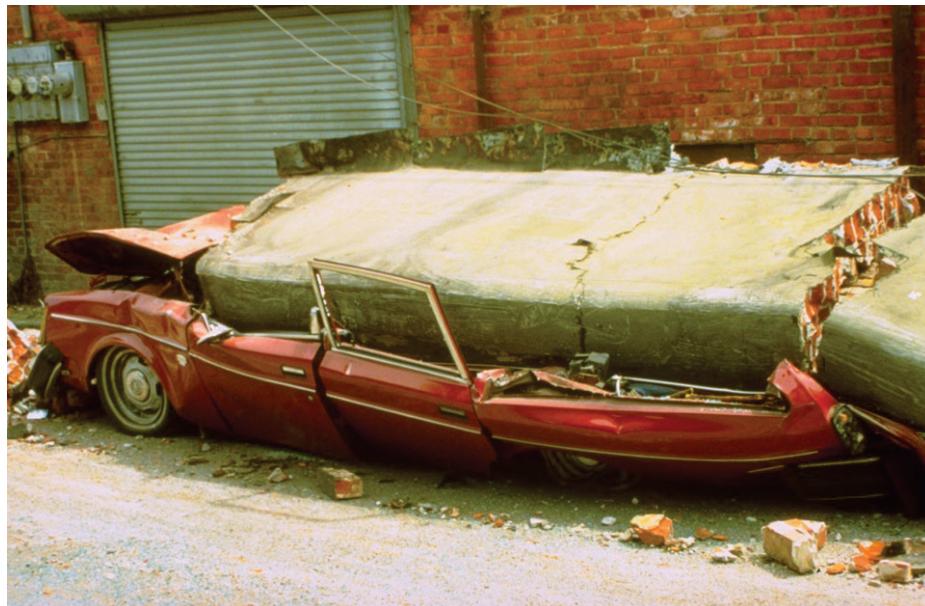
Figure 6.3.5.1-1 URM parapet fell and smashed two cars in the 1992 magnitude-7.2 Petrolia Earthquake. A parapet at same location in Ferndale, California failed in 1906 and killed two cows (NGDC, 2009).

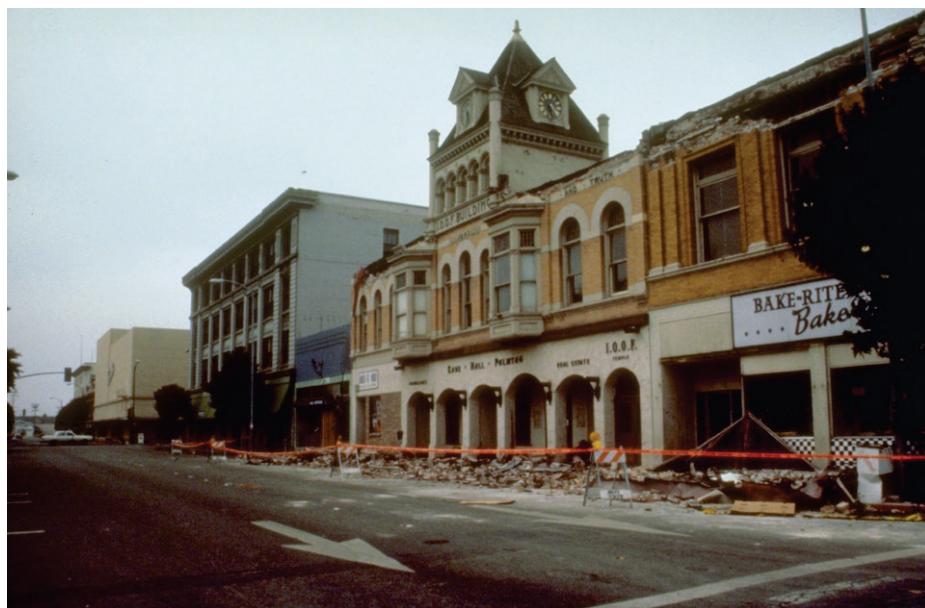
Figure 6.3.5.1-2 Unreinforced masonry parapet failures along Beach Street, Watsonville in the 1989 magnitude-6.9 Loma Prieta Earthquake (NGDC, 2009).

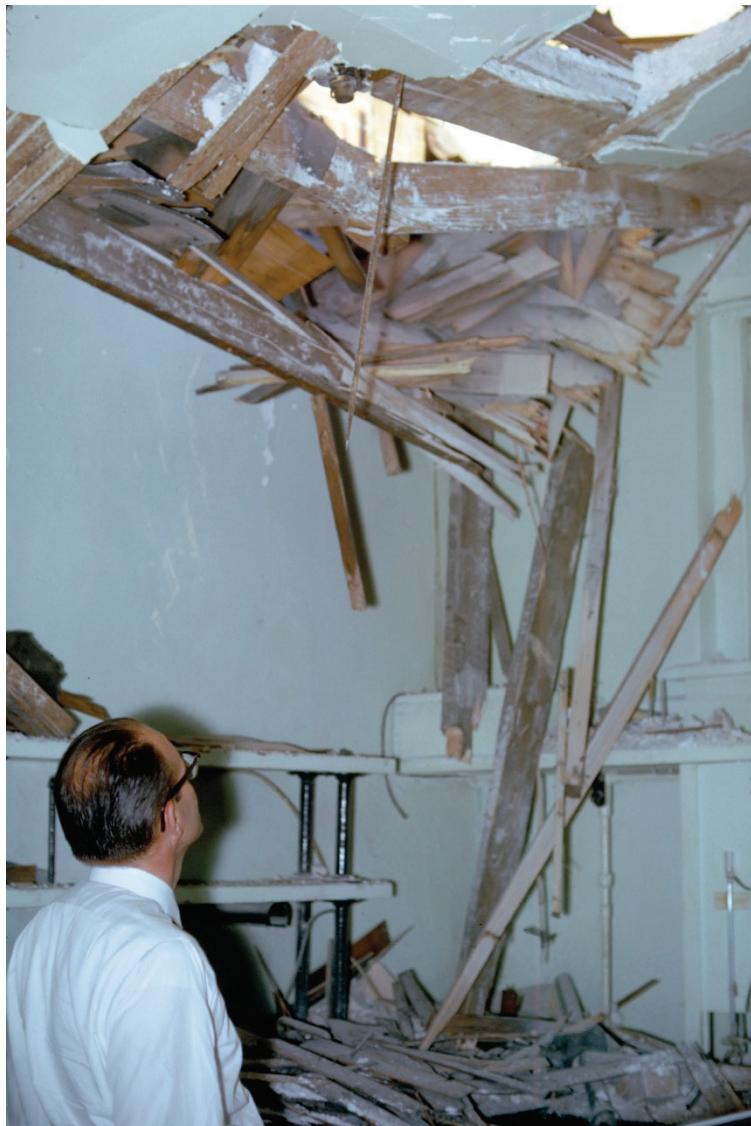
Figure 6.3.5.1-3

Damage to roof framing caused by failure of overhanging brick masonry during the 1962 magnitude-5.8 Cache Valley, Utah earthquake (Photo courtesy of PEER Steinbrugge Collection, No. S828).

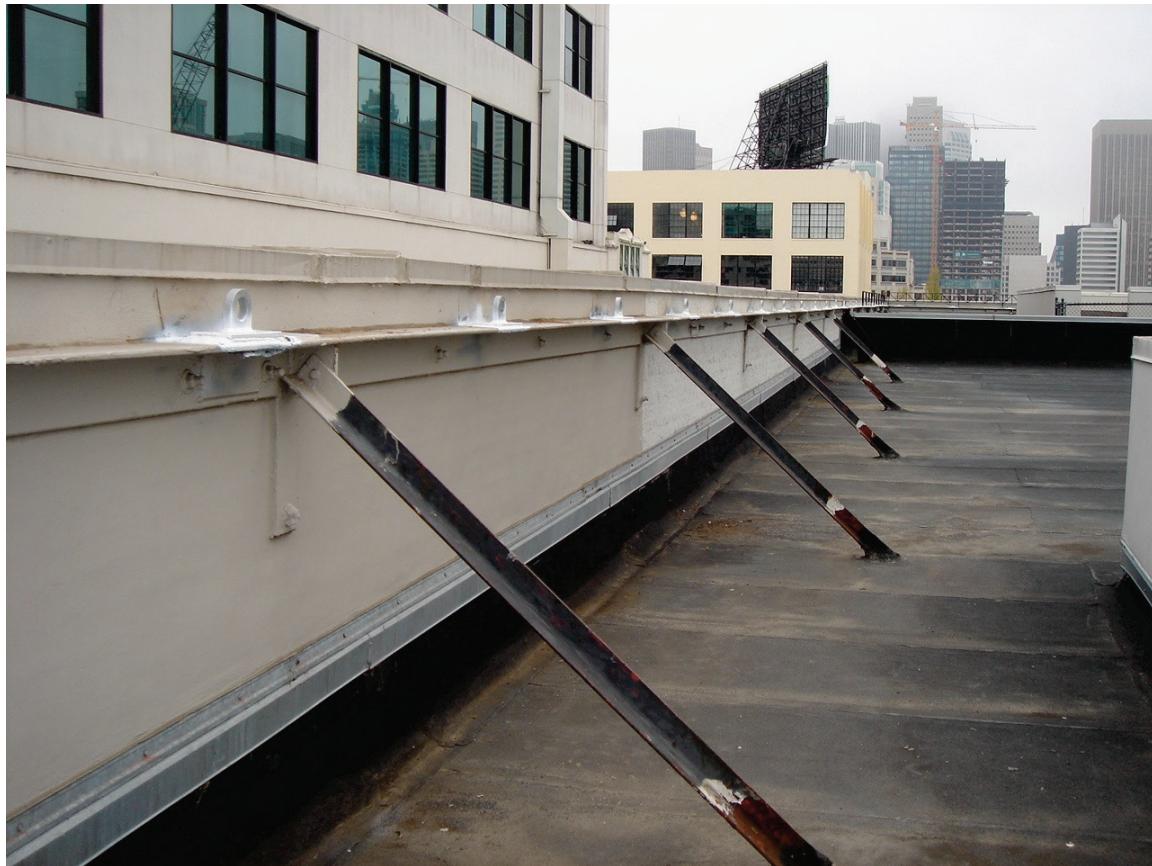
Figure 6.3.5.1-4 Bracing of URM parapet (Photo courtesy of Maryann Phipps, Estructure).

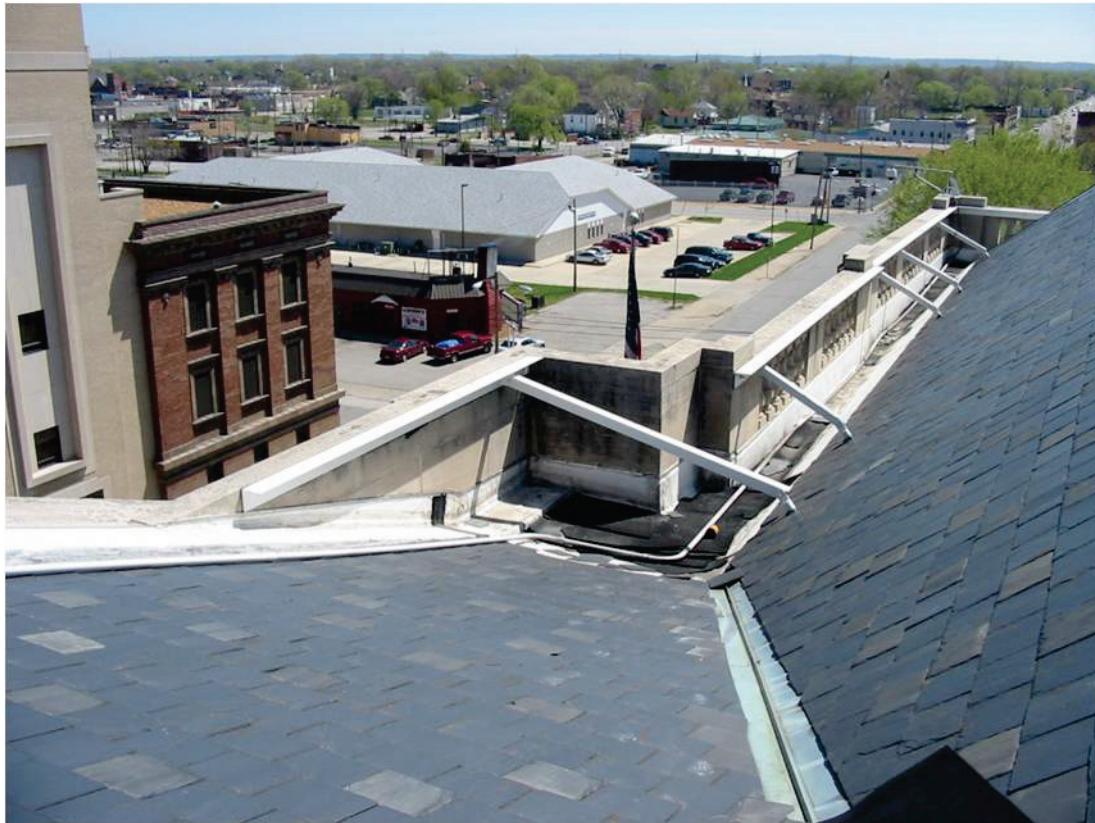
Figure 6.3.5.1-5 Bracing of unreinforced masonry parapet (Photo courtesy of Degenkolb Engineers).

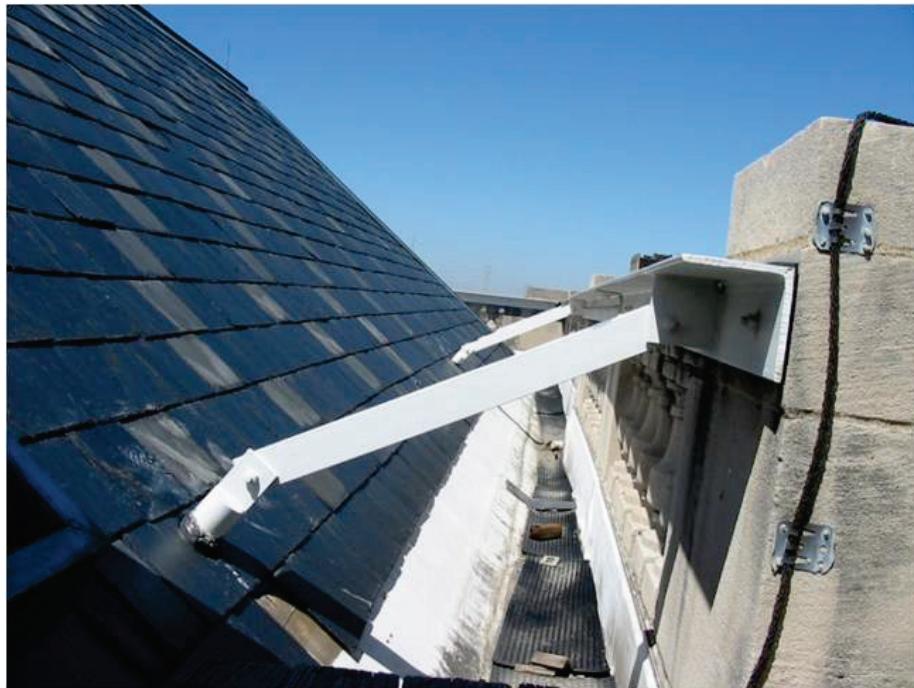
Figure 6.3.5.1-6 Close-up of parapet bracing (Photo courtesy of Degenkolb Engineers).

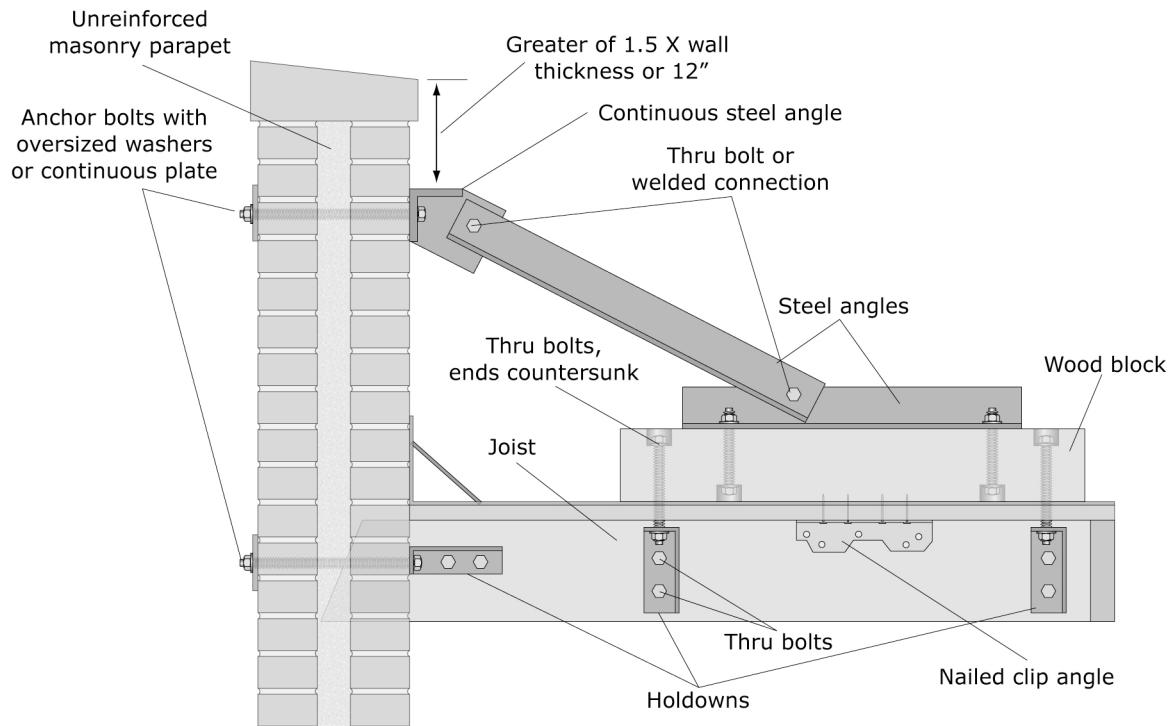
Note: Typical brace configuration shown; parapet and roof conditions may vary widely. Provide appropriate weatherproofing and flashing details.

Figure 6.3.5.1-7 Unreinforced masonry parapet (ER).

- Parapet and roof conditions may vary widely. An engineered design accounting for specific as-built construction details is needed to provide reliable earthquake performance. Flashing and weatherproofing must be provided for any roof-mounted connections.

- The reliability of bolts in unreinforced masonry is heavily dependent on the quality of masonry and the amount of overburden (weight above the anchor). With poor quality masonry or little overburden, oversized plate washers or a continuous plate may be needed on the outside face of the wall to enhance the effectiveness of the anchorage.
