## 6.5 Furniture, Fixtures, Equipment and Contents

### 6.5.2 Bookcases, shelving

#### 6.5.2.2 Library and Other Shelving

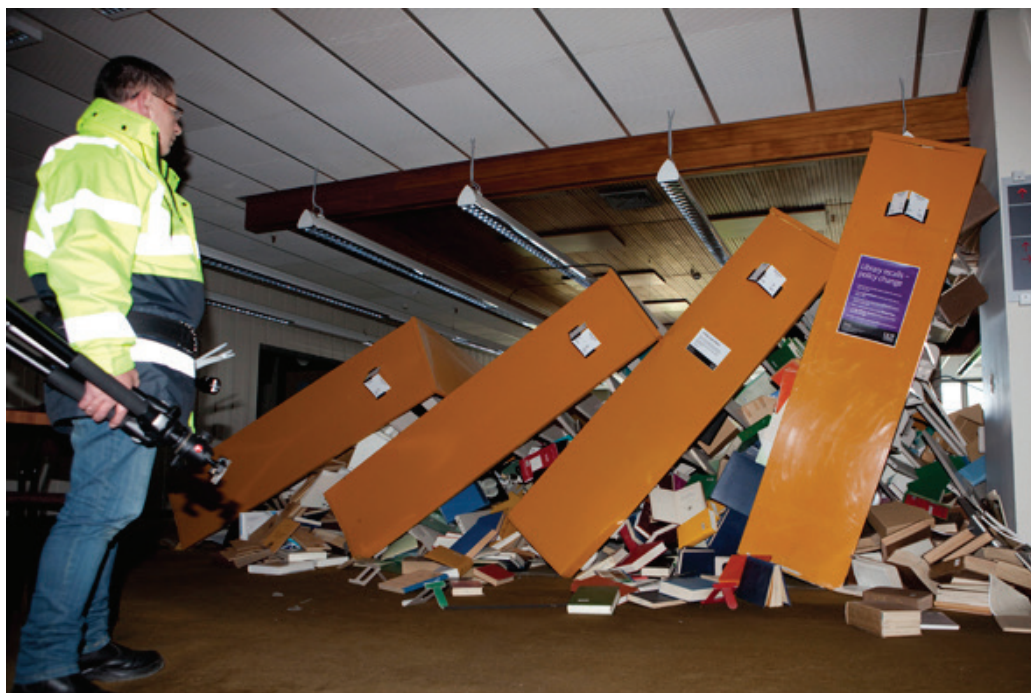
Figure 6.5.2.2-1 Photo showing collapsed library shelving in the 2010 magnitude-7.1 Canterbury New Zealand Earthquake (Photo courtesy of University of Canterbury).

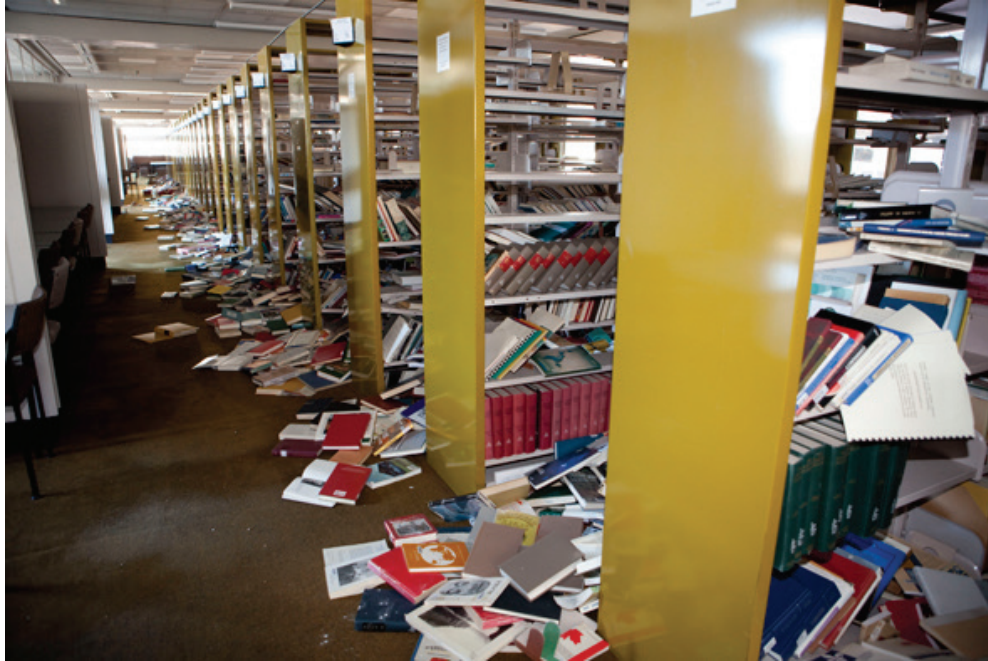
Figure 6.5.2.2-4 Shelving units with longitudinal ties did not fall over but all of the contents spilled to the floor in the 2010 Canterbury Earthquake. The use of lips or wires would have prevented the damage.(Photo courtesy of University of Canterbury).

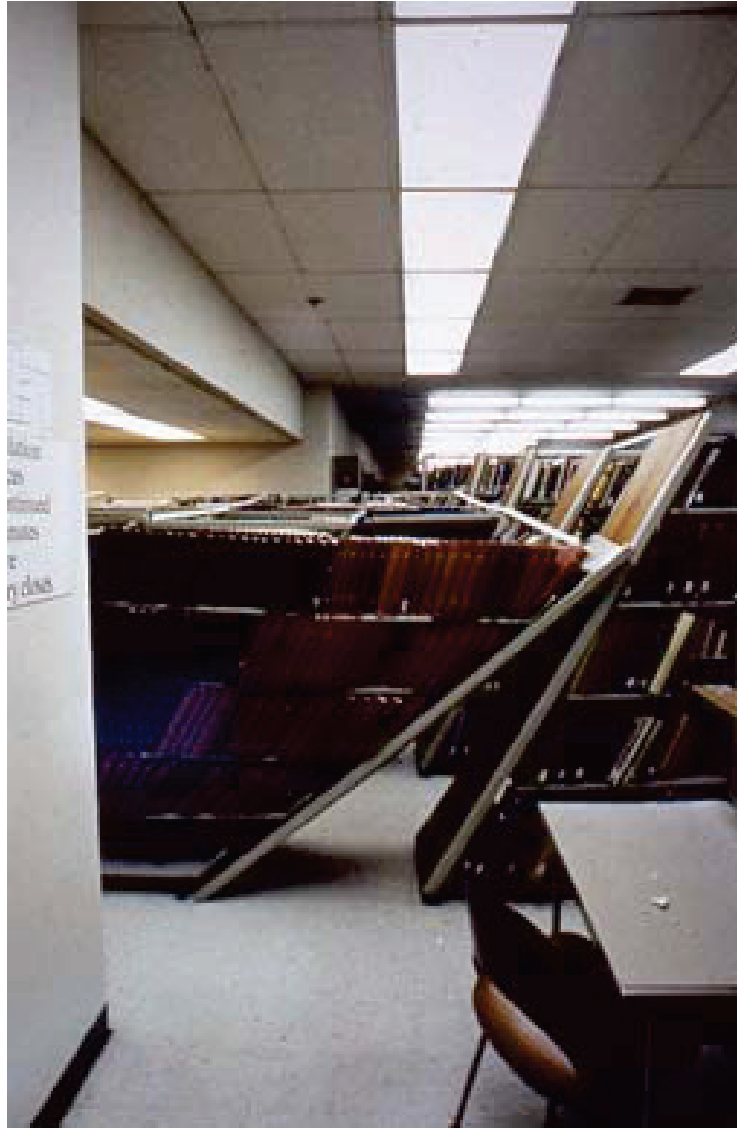
Figure 6.5.2.2-3 Longitudinal failure of library shelving units (Photo courtesy of NISEE-PEER, U.C. Berkeley). Transverse ties used to tie units together but this was not enough to prevent longitudinal failure.

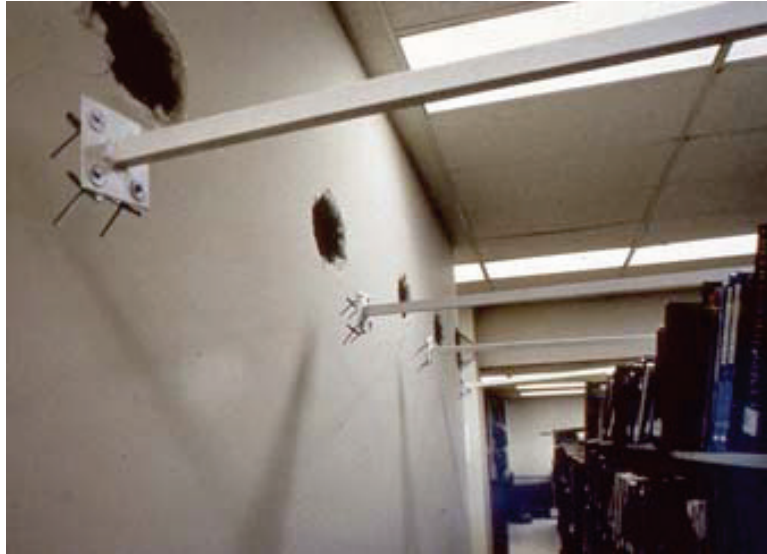
Figure 6.5.2.2-2 Failure of overhead transverse bracing for bookshelves were anchored to gypsum board partition in the 1984 magnitude-6.2 Morgan Hill Earthquake (Photo courtesy of Santa Clara County Office of Emergency Services). The anchors were not attached to wall studs, only to gypsum board.

- Any connections to stud walls must engage the structural studs. Stud walls and partitions typically do not have adequate lateral capacity to support many shelving units unless they have been engineered with heavy gauge studs and braced to resist the imposed lateral loading from the shelving. Anchorage to structural concrete or masonry walls is preferred.

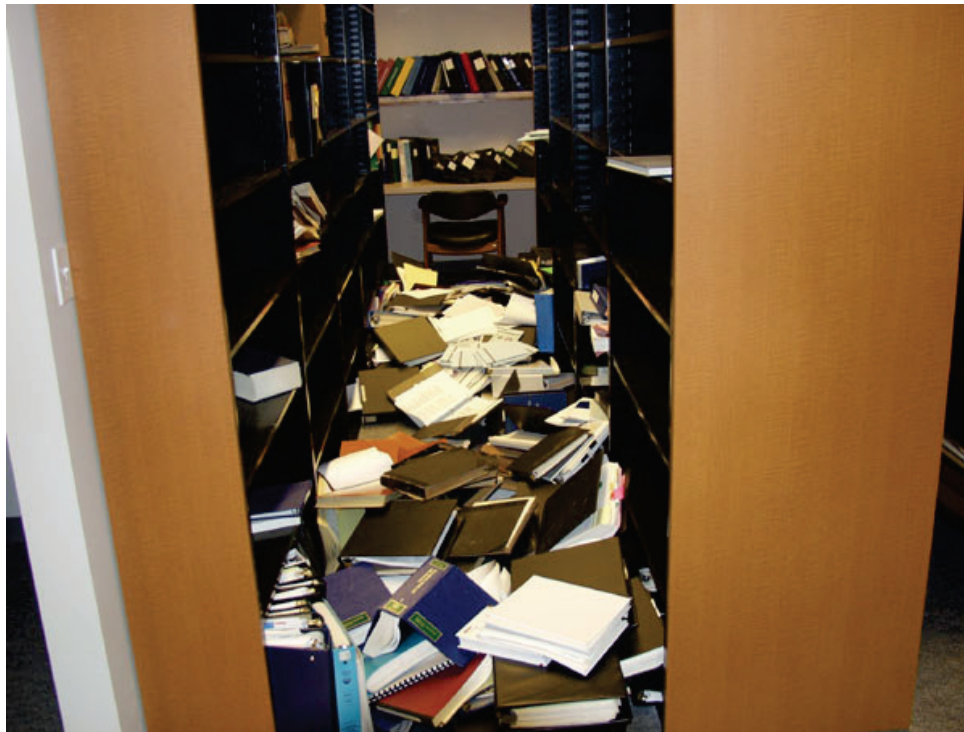
Figure 6.5.2.2-5 These shelving units remained in place but all of the contents spilled in the 2010 magnitude-6.5 Eureka, California Earthquake (Photo courtesy of Steve Mahin, PEER).

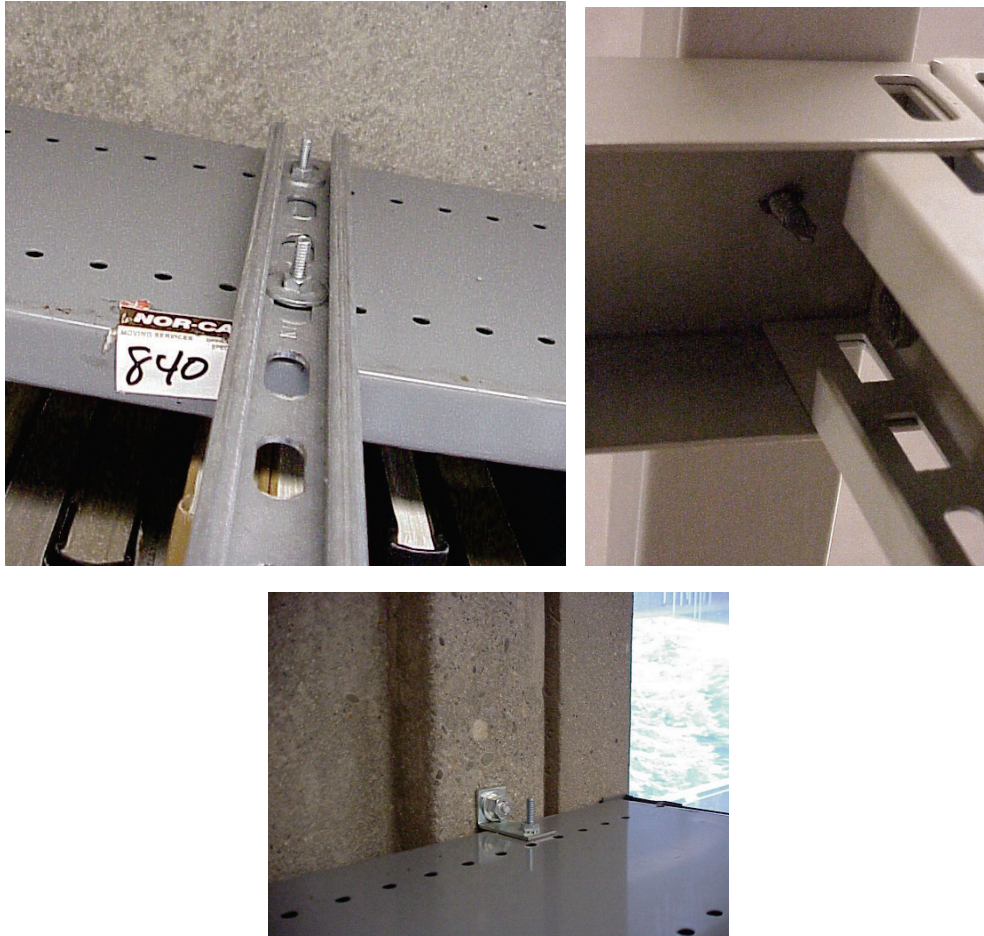
Figure 6.5.2.2-6 Examples of struts and hardware used to retrofit library shelving at the University of California, Berkeley (Photos courtesy of Mary Comerio, Dept. of Environmental Design, University of California Berkeley).

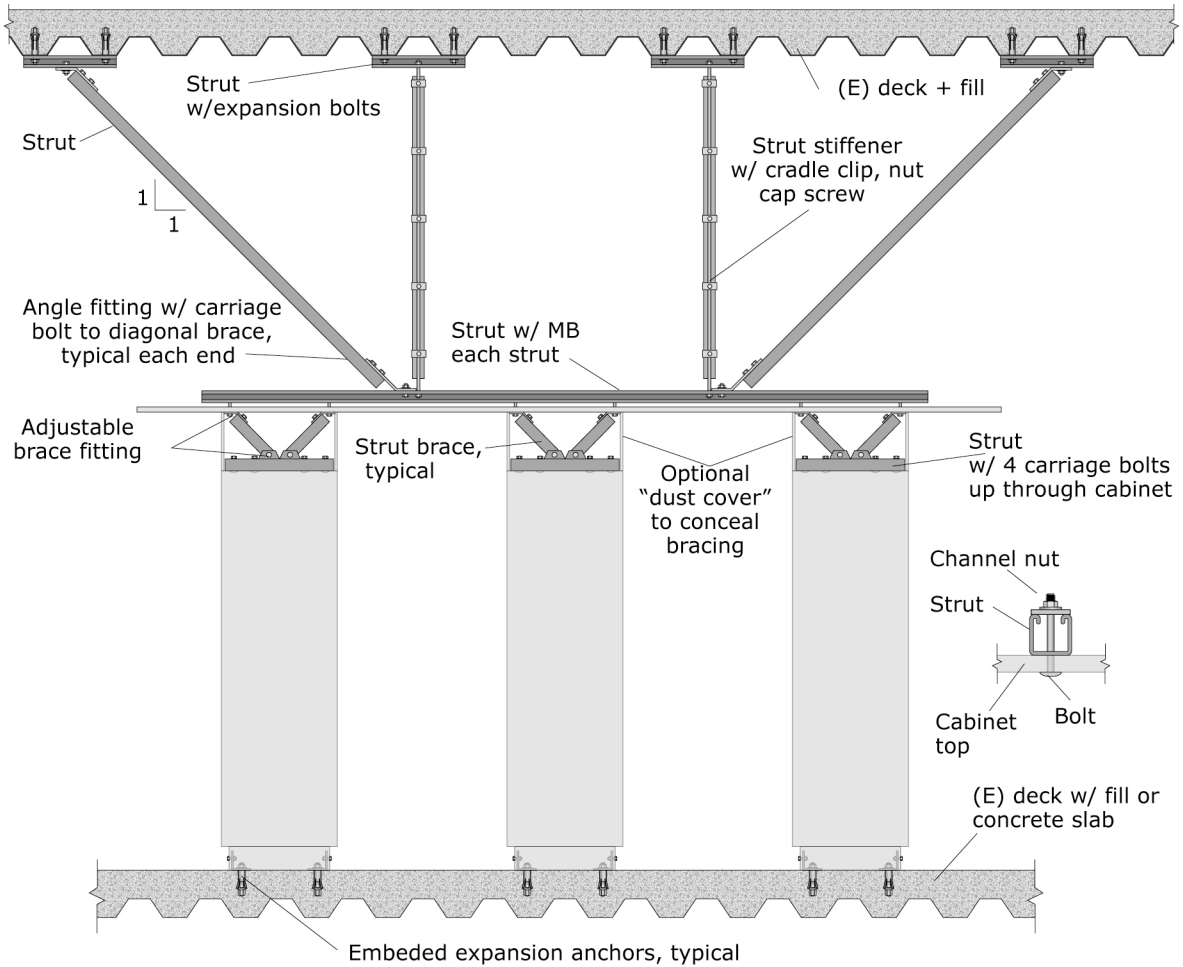
**Note:** since the shelving system is anchored to the floor below and the floor above, use of this detail should be limited to structures with limited interstory drift such as those braced with concrete or masonry shear walls.

Figure 6.5.2.2-7 Concealed overhead restraints for library and other shelving (ER).
