6.5 Furniture, Fixtures, Equipment and Contents

6.5.5 *Miscellaneous Furniture, Fixtures and Equipment*

6.5.5.2 Demountable Partitions

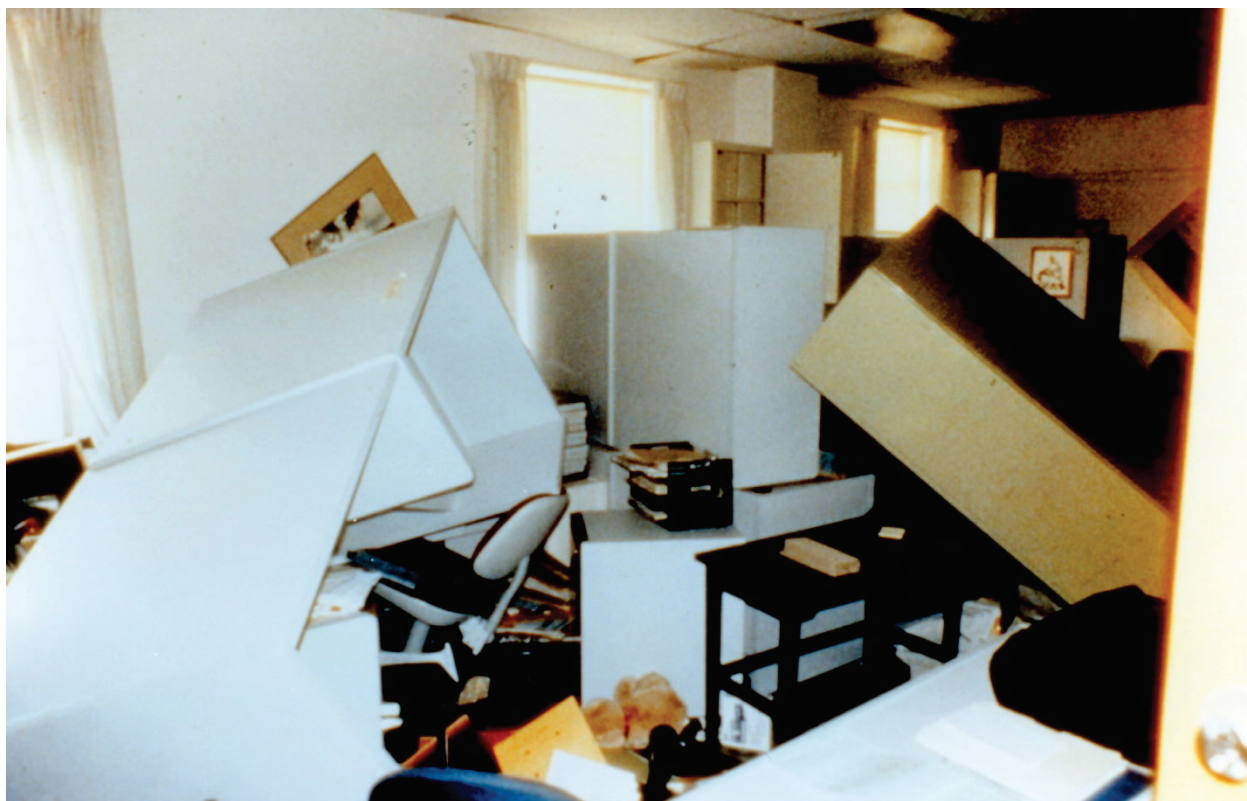
Figure 6.5.5.2-1 Damage to demountable partitions at the Veterans Administration Medical Center in Sepulveda as a result of the 1994 magnitude-6.7 Northridge Earthquake (Photo courtesy of James O. Malley).

- Long runs of unbraced panels are vulnerable to falling over if not specially detailed.
- Partitions that support overloaded shelving units are particularly vulnerable.

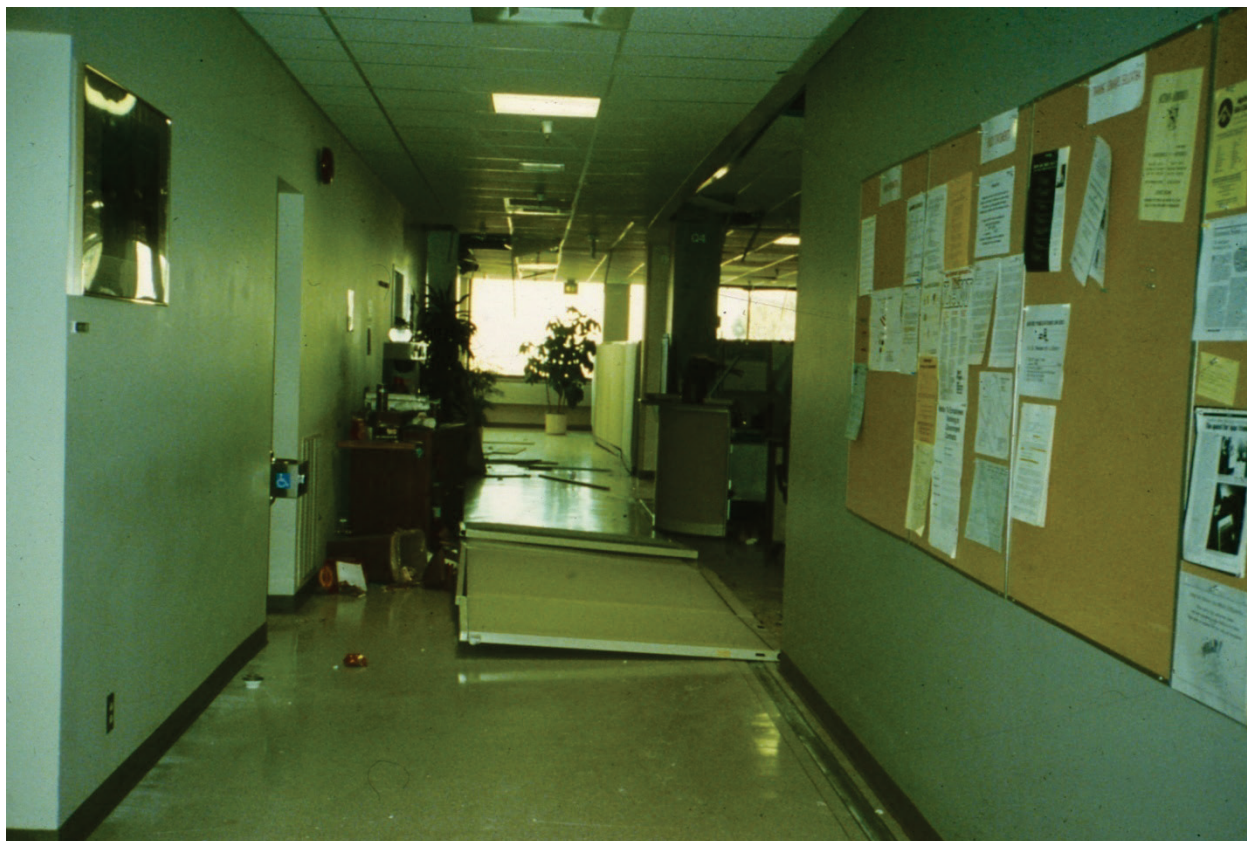
Figure 6.5.5.2-2 Damage to unbraced demountable partition in Silicon Valley office building in the 1989 magnitude-6.9 Loma Prieta Earthquake (Photo courtesy of Maryann Phipps, Estructure).

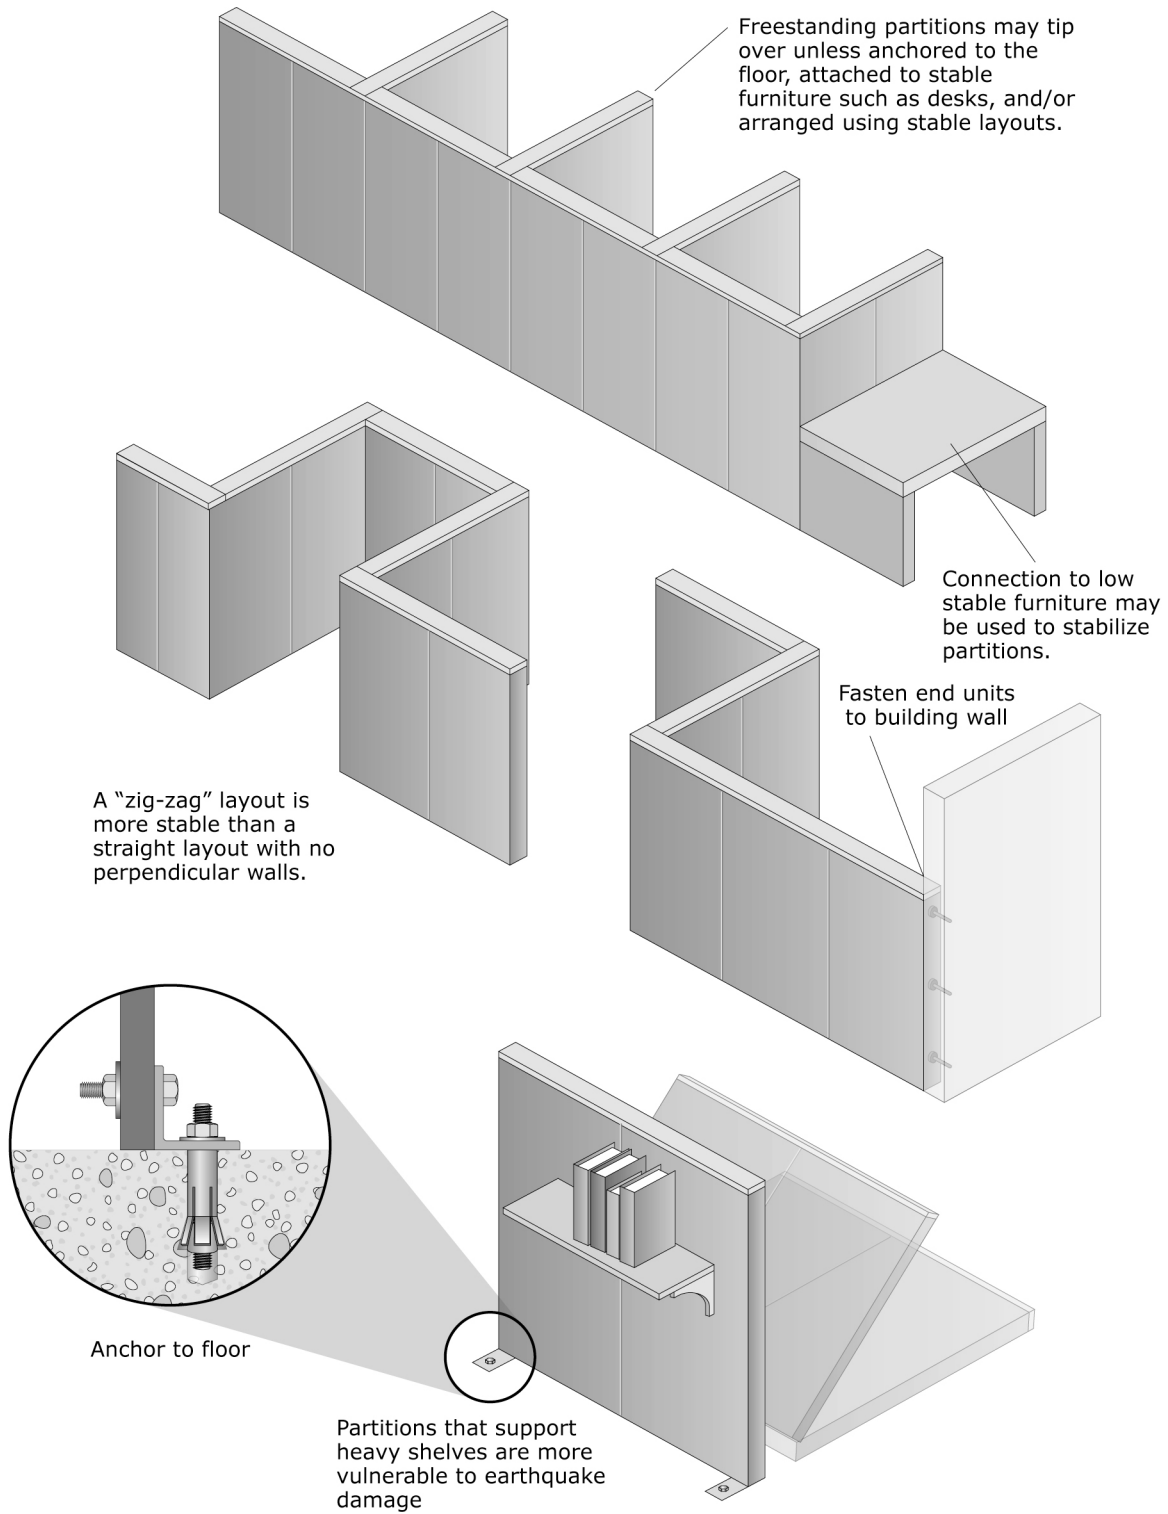
Figure 6.5.5.2-3 Demountable partitions (NE).

- Check the internet for demountable partitions with seismic rated capacity; some of these have been shake table tested and have improved seismic detailing.
- Panel manufacturers typically have guidelines for acceptable panel configurations for use in earthquake prone areas. Shorter runs of panels with panels at 90 degrees to one another provide favorable conditions for earthquake resistance. Panel anchorage at the base and interconnectivity between panels is also needed for reliable performance. Where panels are not stabilized by return panels, or where panels are tall, bracing at the tops of the panels, up to the structural framing, may be required. Anchorage to the floor slab is another alternative as shown in Figure 6.5.5.2-4.

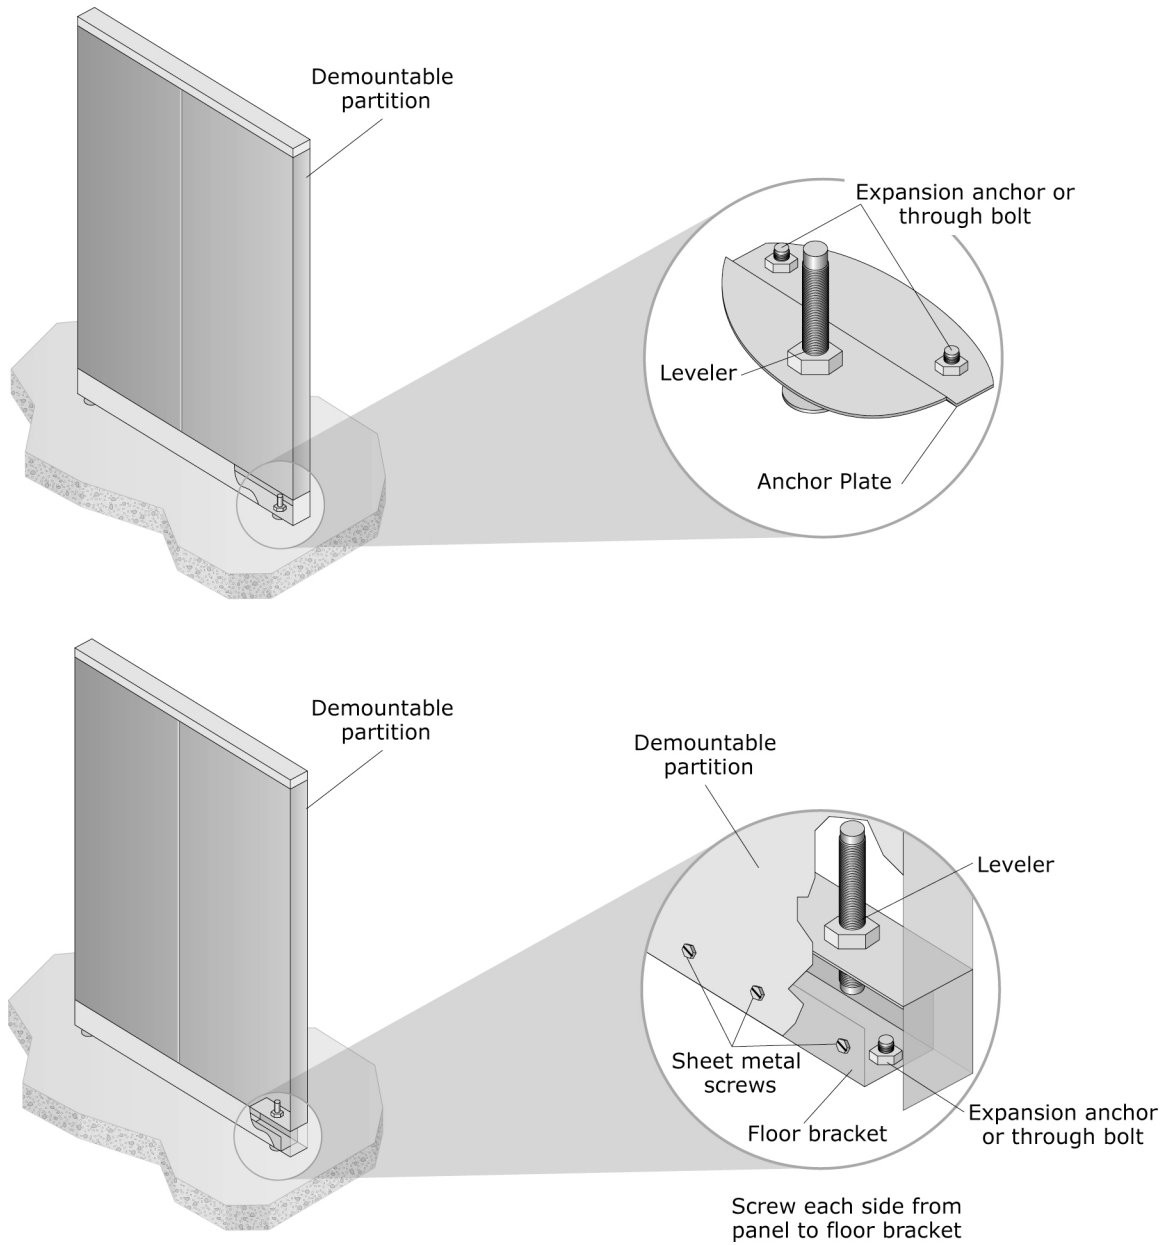
Figure 6.5.5.2-4 Demountable partition details (NE).
