6.3 Architectural Components

6.3.1 Exterior Wall Components

6.3.1.1 Adhered Veneer

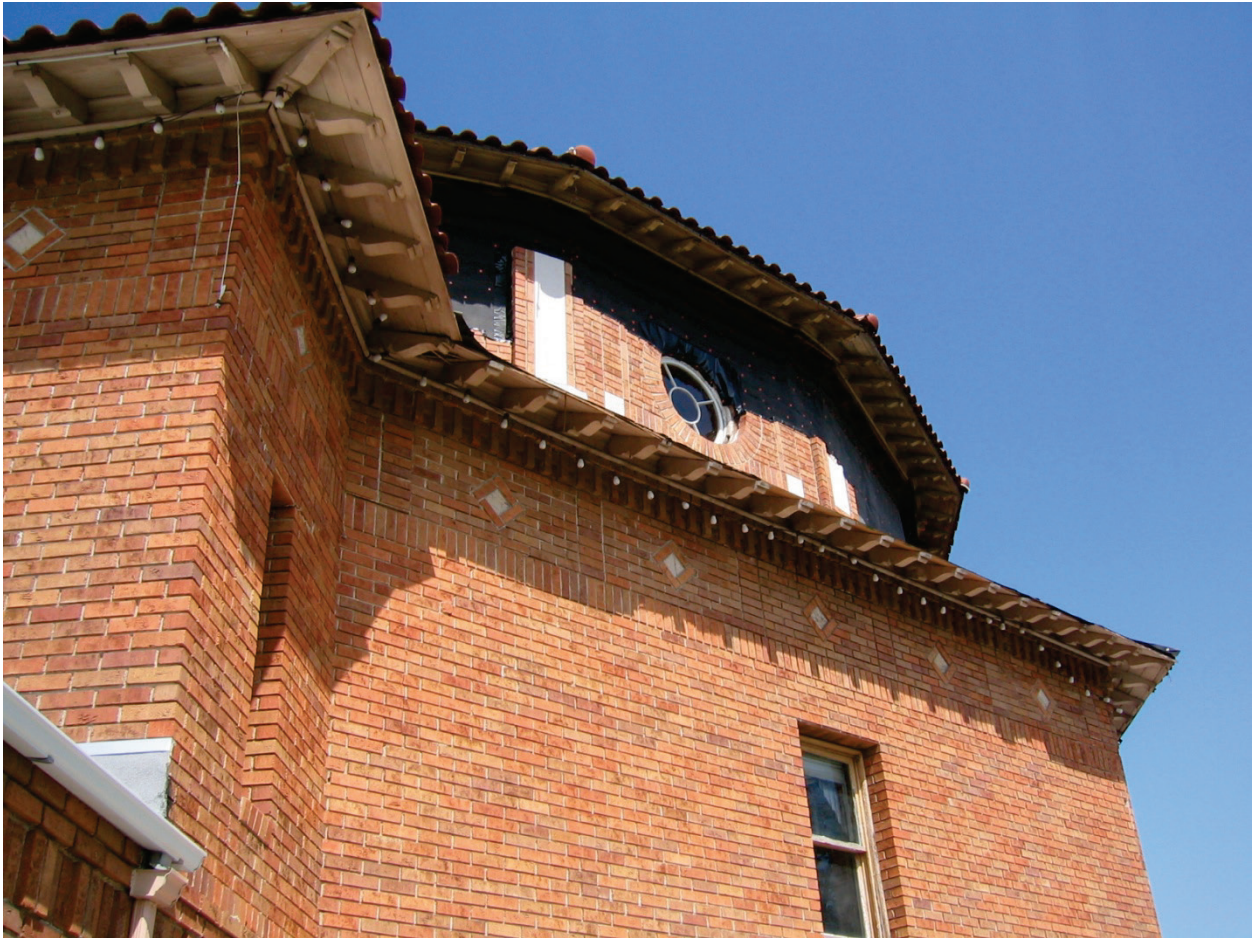
Figure 6.3.1.1-1 Failure of adhered masonry veneer at the Atascadero City Hall in the 2003 magnitude-6.5 San Simeon Earthquake (Photo courtesy of Mike Mahoney, FEMA).

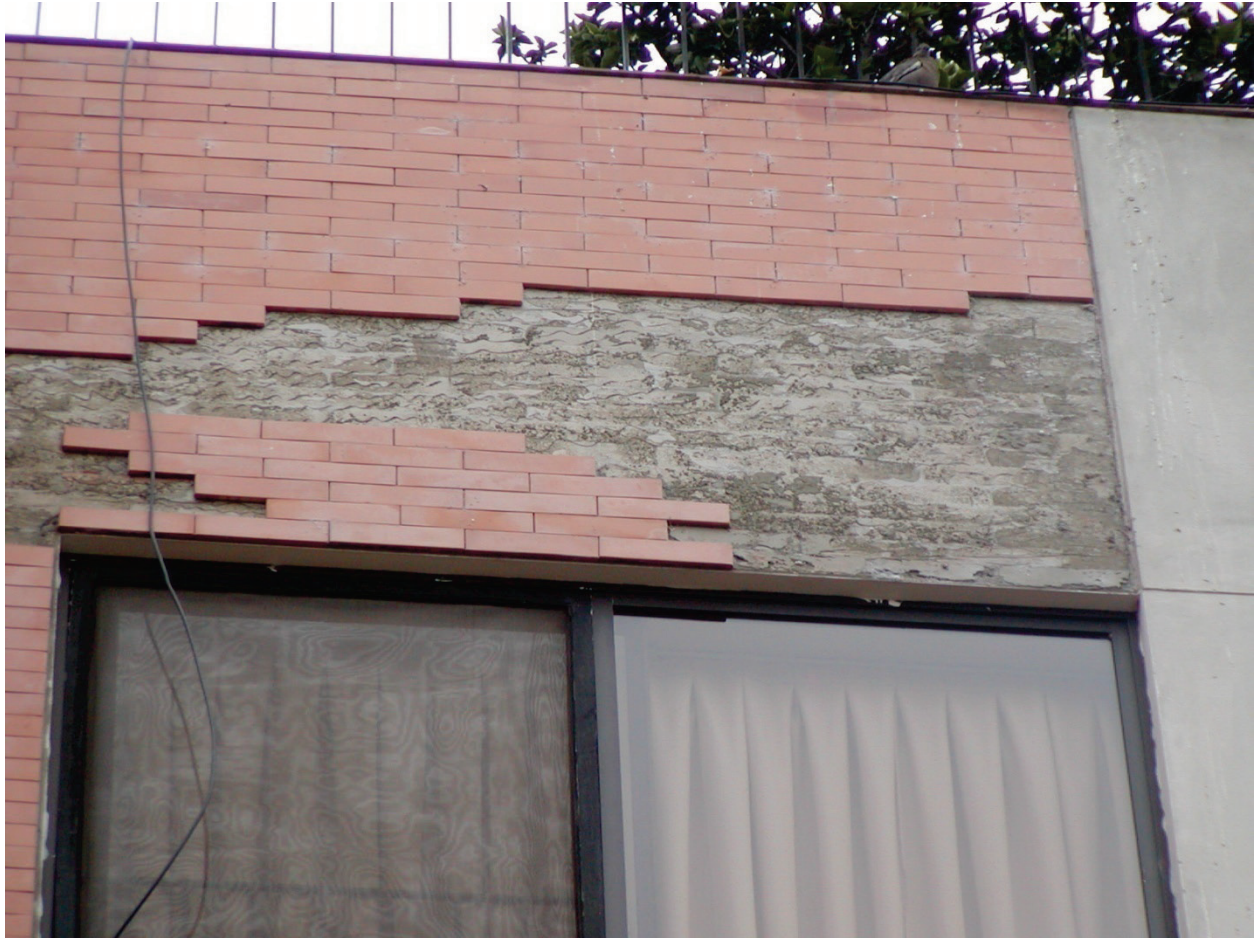
Figure 6.3.1.1-2 Close-up of failed adhered veneer. (Photo courtesy of Eduardo Fierro, BFP Engineers).

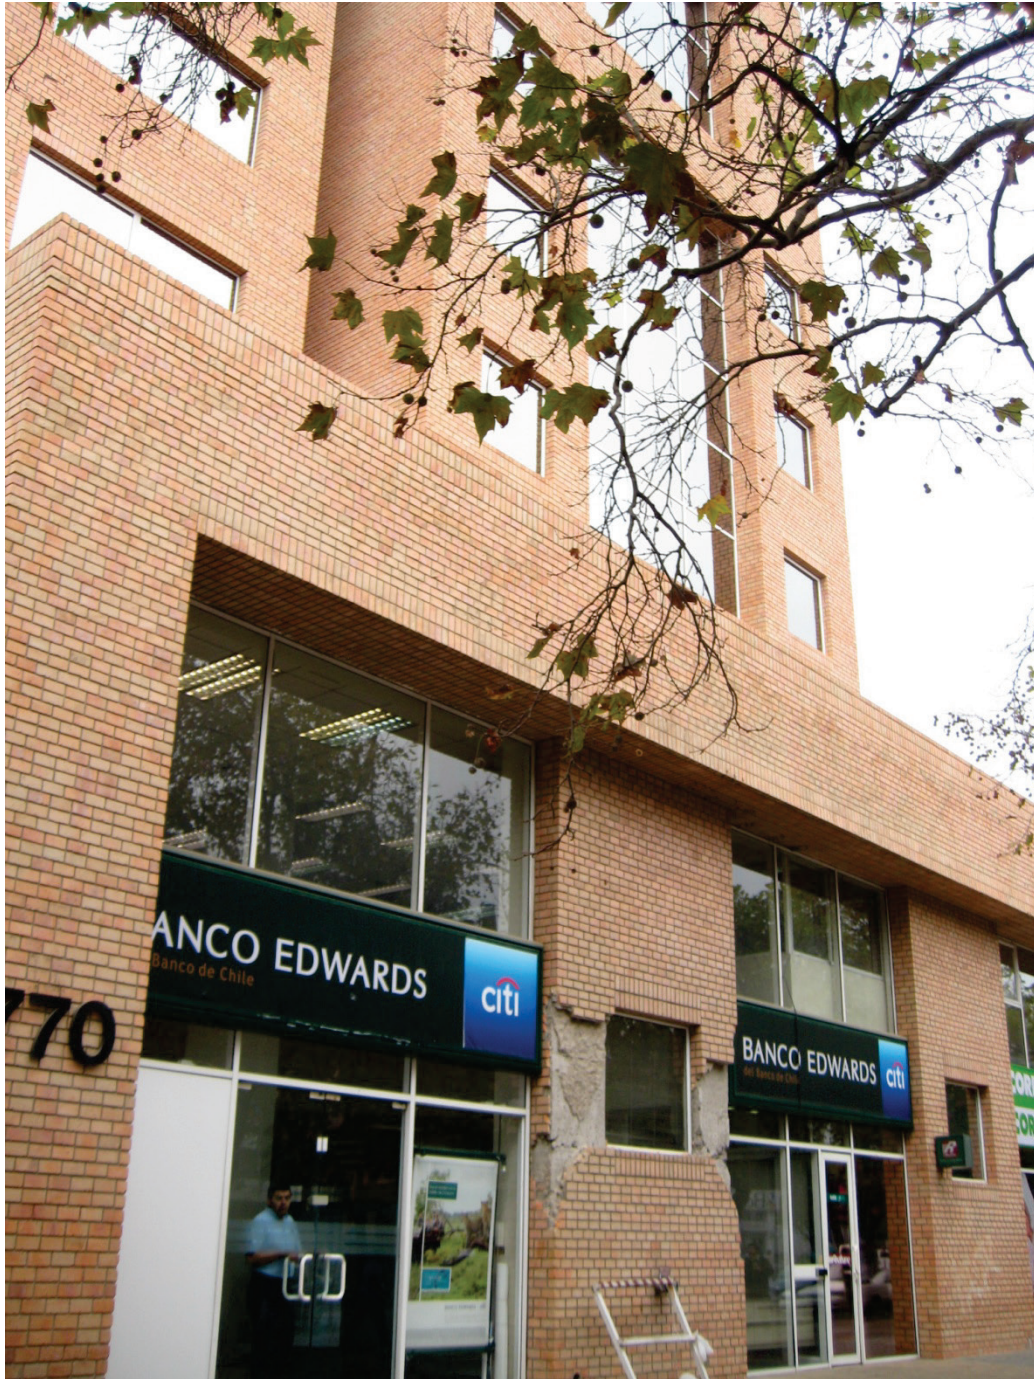
Figure 6.3.1.1-3 Cracked and spalled adhered veneer reveals incipient structural damage to concrete piers in Viña del Mar following the 2010 magnitude-8.8 Chile Earthquake. In this case, the areas of structural and nonstructural damage coincide; the adhered veneer remained intact over portions of the shear wall that did not deform significantly (Photo courtesy of Santiago Pujol, Purdue University).

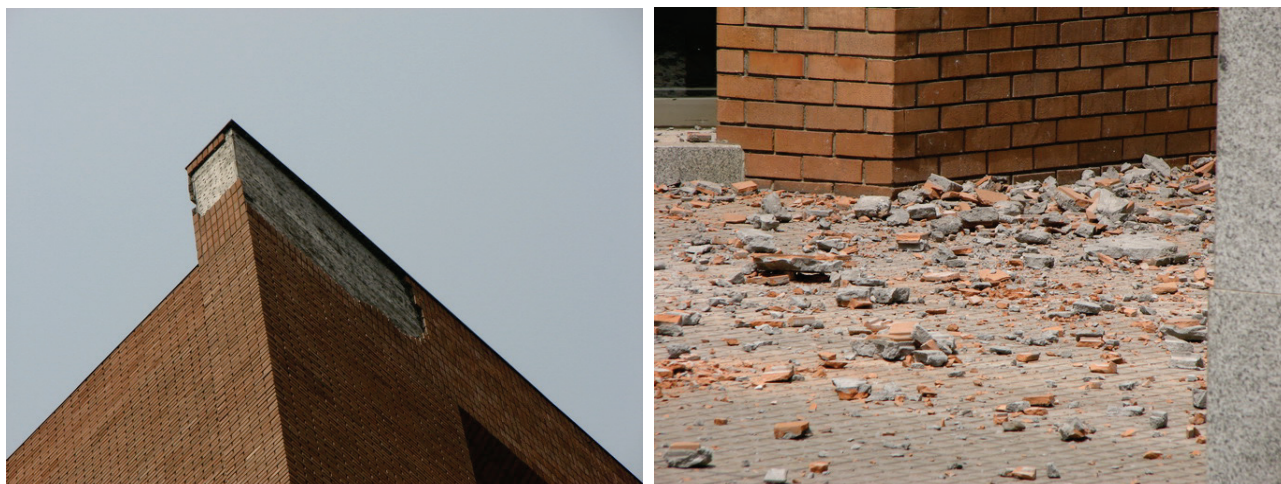
Figure 6.3.1.1-4 Failed adhered veneer fallen from parapet in Santiago following the 2010 magnitude-8.8 Chile Earthquake. (Photos courtesy of Antonio Iruretagoyena, Rubén Boroscheck & Associates)

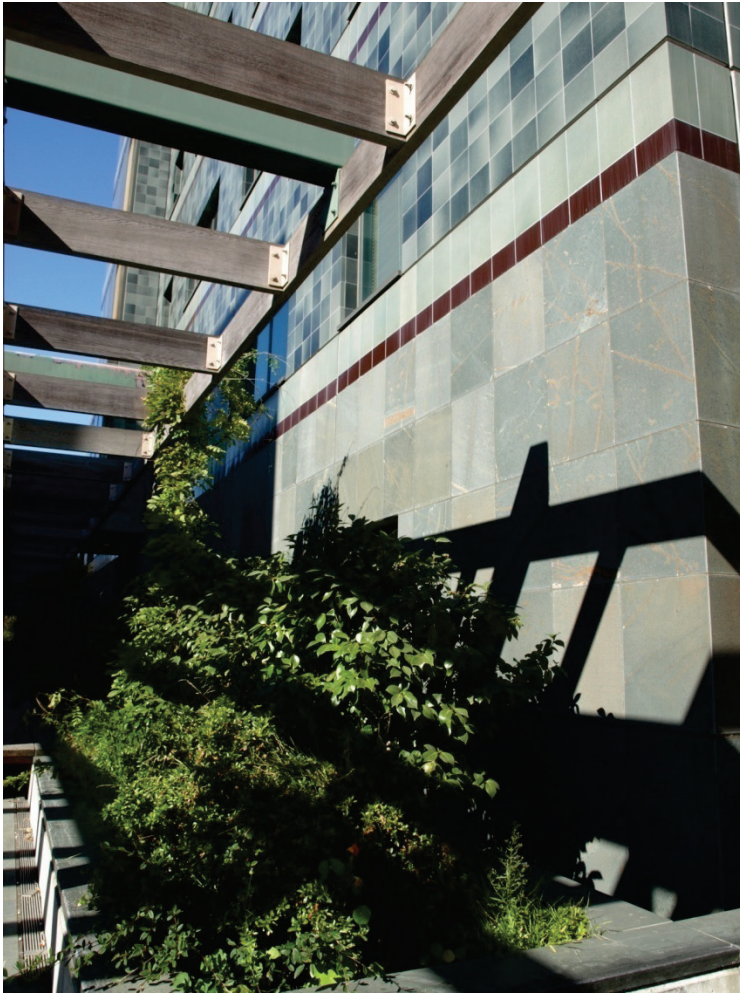
Figure 6.3.1.1-5 Landscaping strip restricts pedestrian access adjacent to adhered veneer façade. Larger units used within lower 6 feet; smaller units used above (Photo courtesy of Cynthia Perry, BFP Engineers).
