6.3 Architectural Components

6.3.1 Exterior Wall Components

6.3.1.2 Anchored Veneer

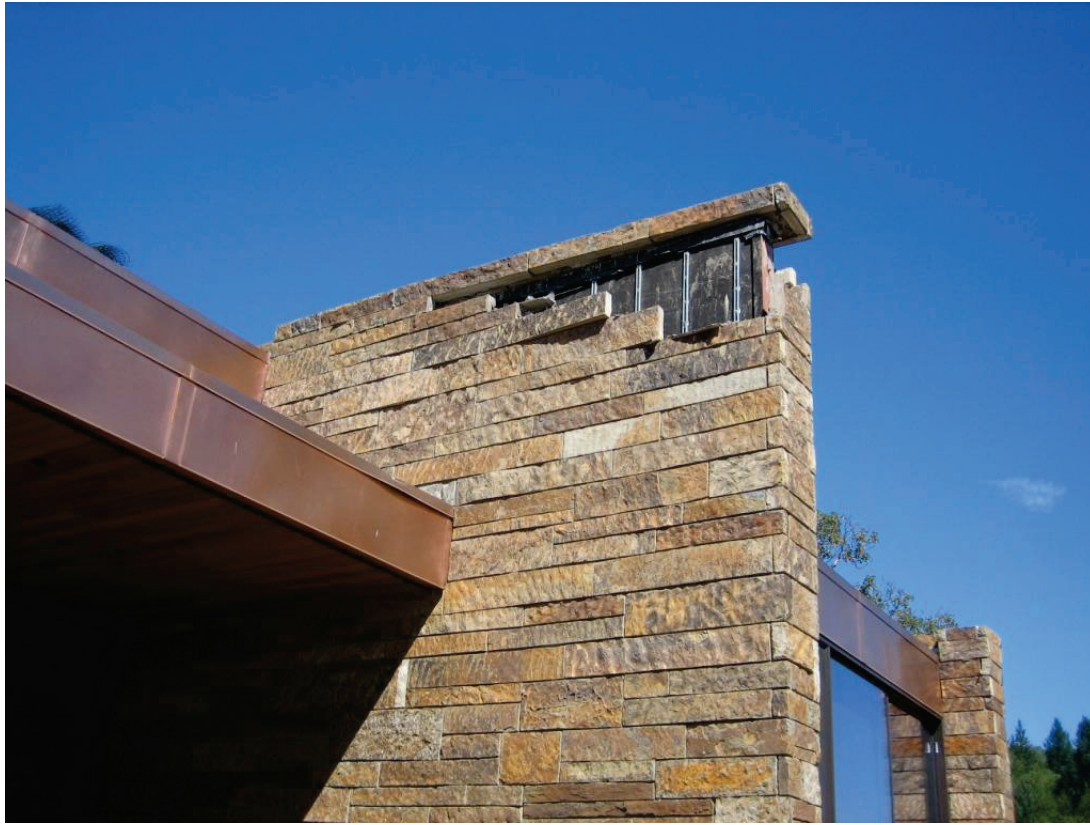
Figure 6.3.1.2-1 Fallen sandstone veneer as a result of a magnitude-4.4 earthquake in northern California. Post-earthquake investigation revealed missing dovetail anchors, missing pencil rods, and weak stone-to-mortar bond (Photo courtesy of Simpson Gumpertz and Heger).

- Anchored veneers and their connections may be damaged by inertial forces and by building distortion; units located at corners and around openings are particularly vulnerable.
- Rigid connections may distort or fracture if they do not have sufficient flexibility to accommodate the seismic drift; veneer units may crack, spall, or become completely dislodged and fall.
- Deterioration or corrosion of the mechanical connections is a significant concern; corroded connections may fail prematurely. Maintaining watertightness at joints is important for the longevity of the anchors.

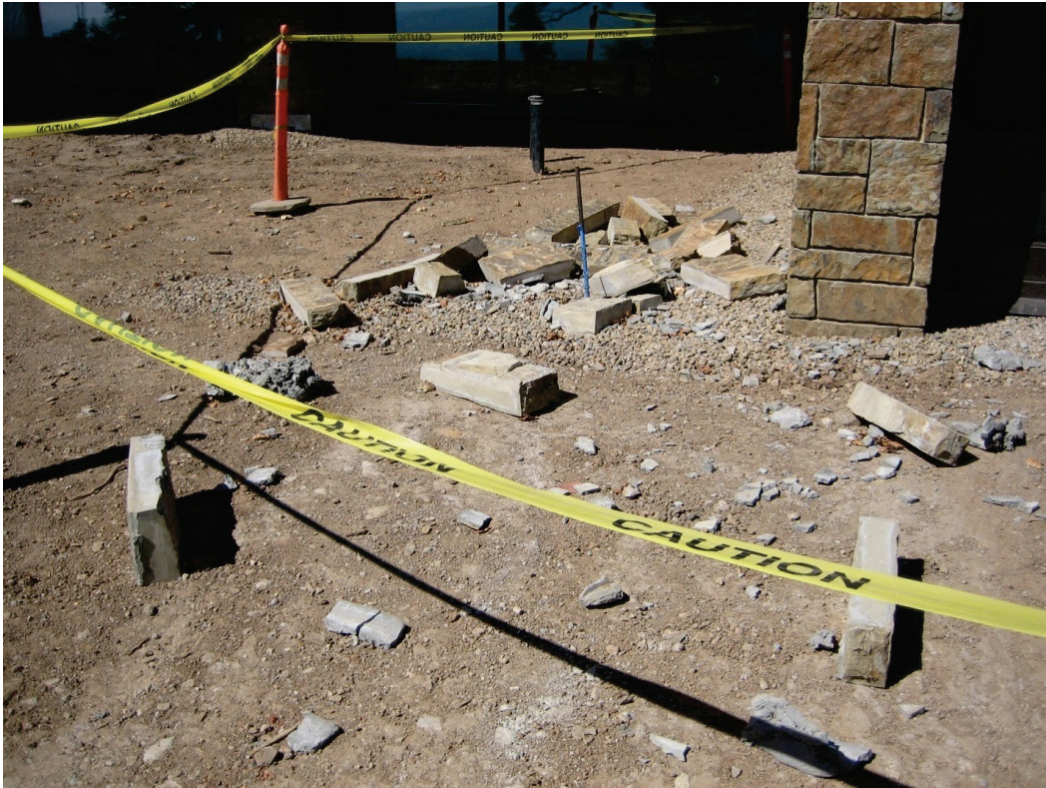
Figure 6.3.1.2-2 Fallen sandstone veneer as a result of a magnitude-4.4 earthquake (Photo courtesy of Simpson Gumpertz and Heger).

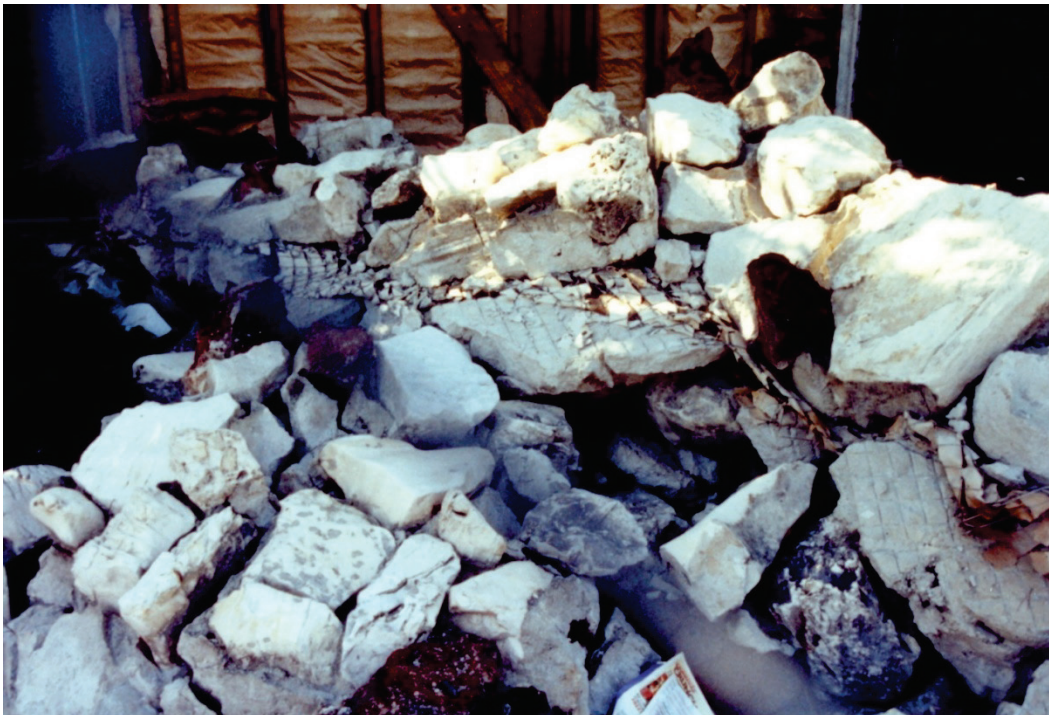
Figure 6.3.1.2-3 Rubble from failed anchored veneer as a result of the 1994 Northridge Earthquake (Photo courtesy of Robert Reitherman).

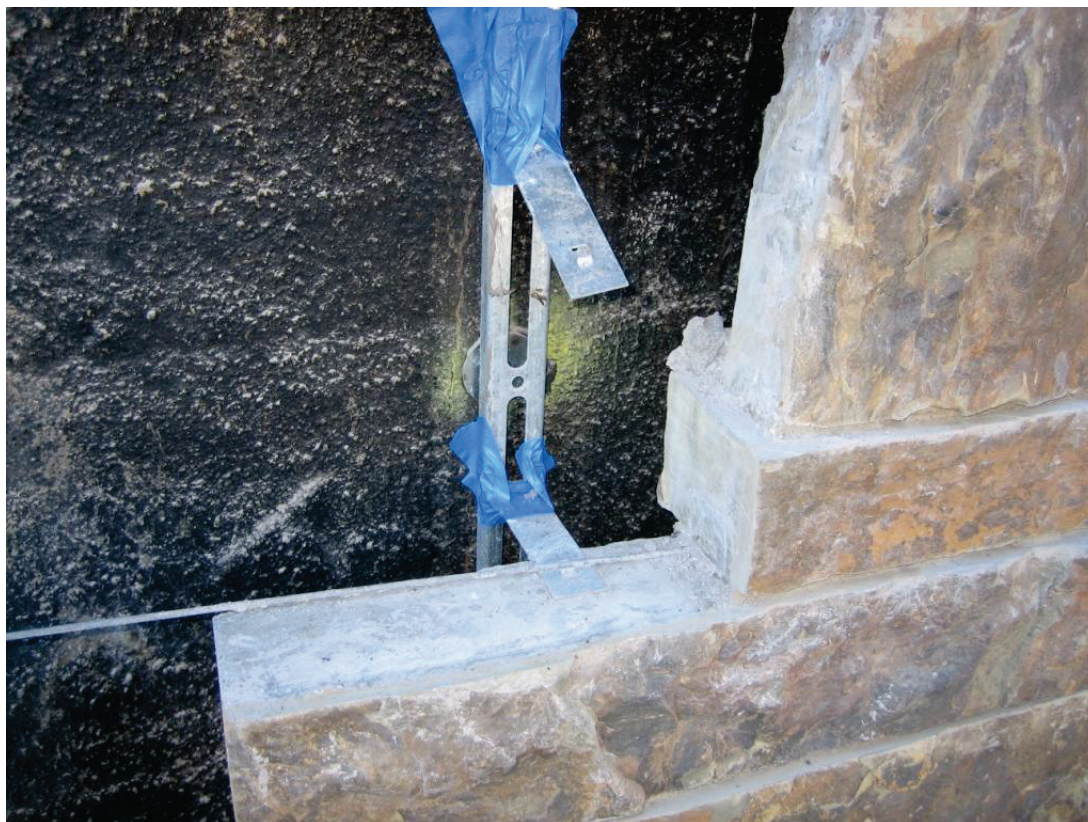
Figure 6.3.1.2-4 Installation of stone veneer showing anchorage to steel dovetail clips which are fastened to steel studs bolted to the grouted reinforced masonry wall behind (Photo courtesy of Simpson Gumpertz and Heger).

- Check the applicable code requirements when considering seismic mitigation options.
- Existing veneer anchors should be checked periodically and corroded anchors should be replaced. Tie spacing should be compared with current code requirements to evaluate whether the anchorage is sufficient. Additional anchors may reduce the falling hazards.
- There are many vendors who supply veneer anchors; these are typically metal wires or clips with a positive attachment to the structural backing that are embedded in the veneer mortar bed. The seismic version of these anchors requires an additional horizontal wire placed in the mortar bed and attached to the anchor. Some examples of these seismic veneer anchors are shown, others can be found online.
