6.3 Architectural Components

6.3.8 Stairways

6.3.8.1 Stairways

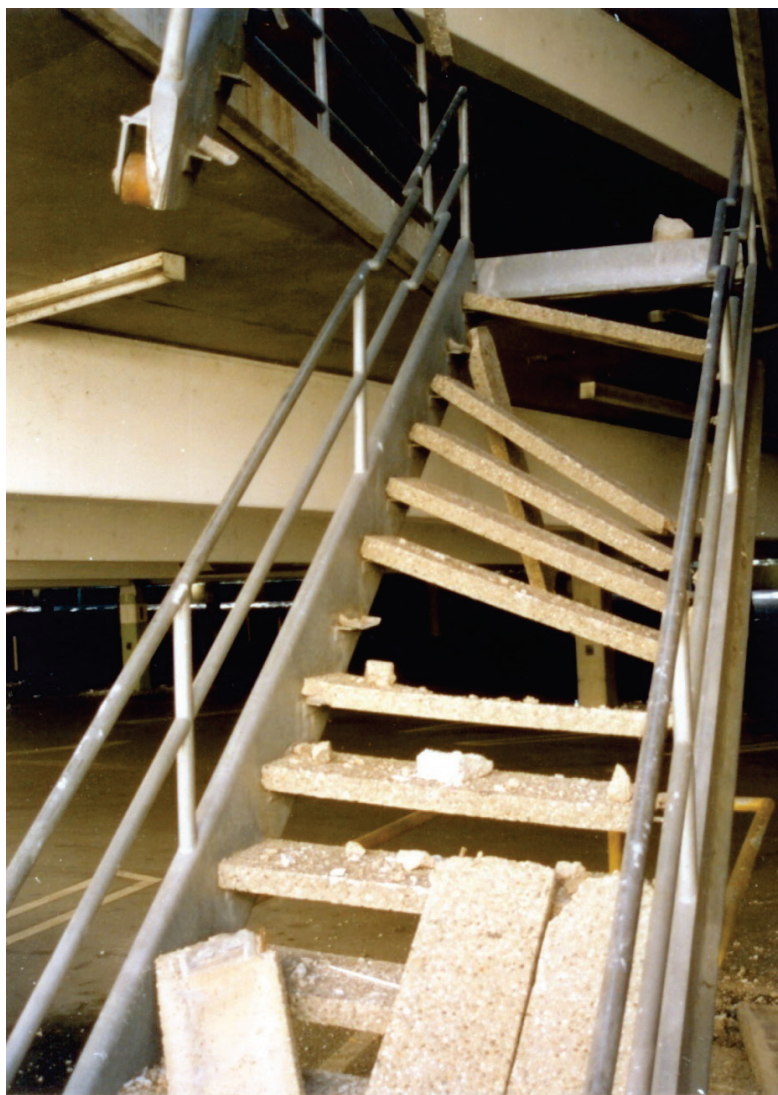
Figure 6.3.8.1-1 Stairway damaged by drift in the 1994 magnitude-6.7 Northridge, California earthquake (Photo courtesy of Wiss, Jenney, Elstner Associates).

- Single run stairs with steel stringers as shown in Figure 6.3.8.1–1, not detailed with slip connections, will provide stiff resistance to drift which could cause buckling of the stringers or failure of the connections.

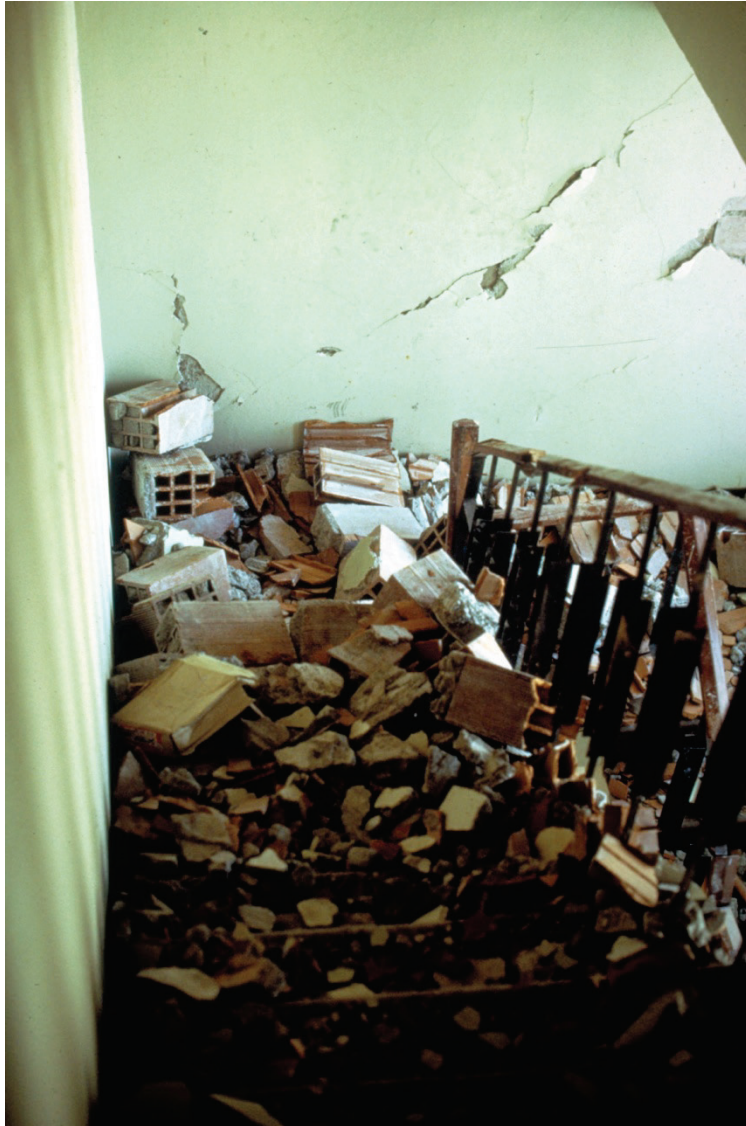
Figure 6.3.8.1-2 View of stairway in the Banco Central Building, Managua, Nicaragua after the 1972 magnitude-6.2 Managua Earthquake. Most of the stairs were covered with debris that resulted from the failure of the hollow tile partitions surrounding the stairs. This photograph highlights the need to not only prevent direct damage to stairway framing and connections, but also to protect against damage to surrounding walls (Photo courtesy of PEER Godden Collection, No. J94).

- Wooden stairs are generally in smaller, stiff buildings and have inherent flexibility in connections. Damage to wooden stairs has not been common, although configurations which provide direct bracing between floors (e.g., a straight run from ground to first floor) should be provided with a slip connection.
- The walls surrounding a stairway may be damaged during an earthquake causing debris to fall into the stairwell and rendering the stairs unusable. Brittle materials such as brick, hollow clay tile, or glass are particularly vulnerable and may create falling and debris hazards in stair enclosures as shown in Figure 6.3.8.1–2.

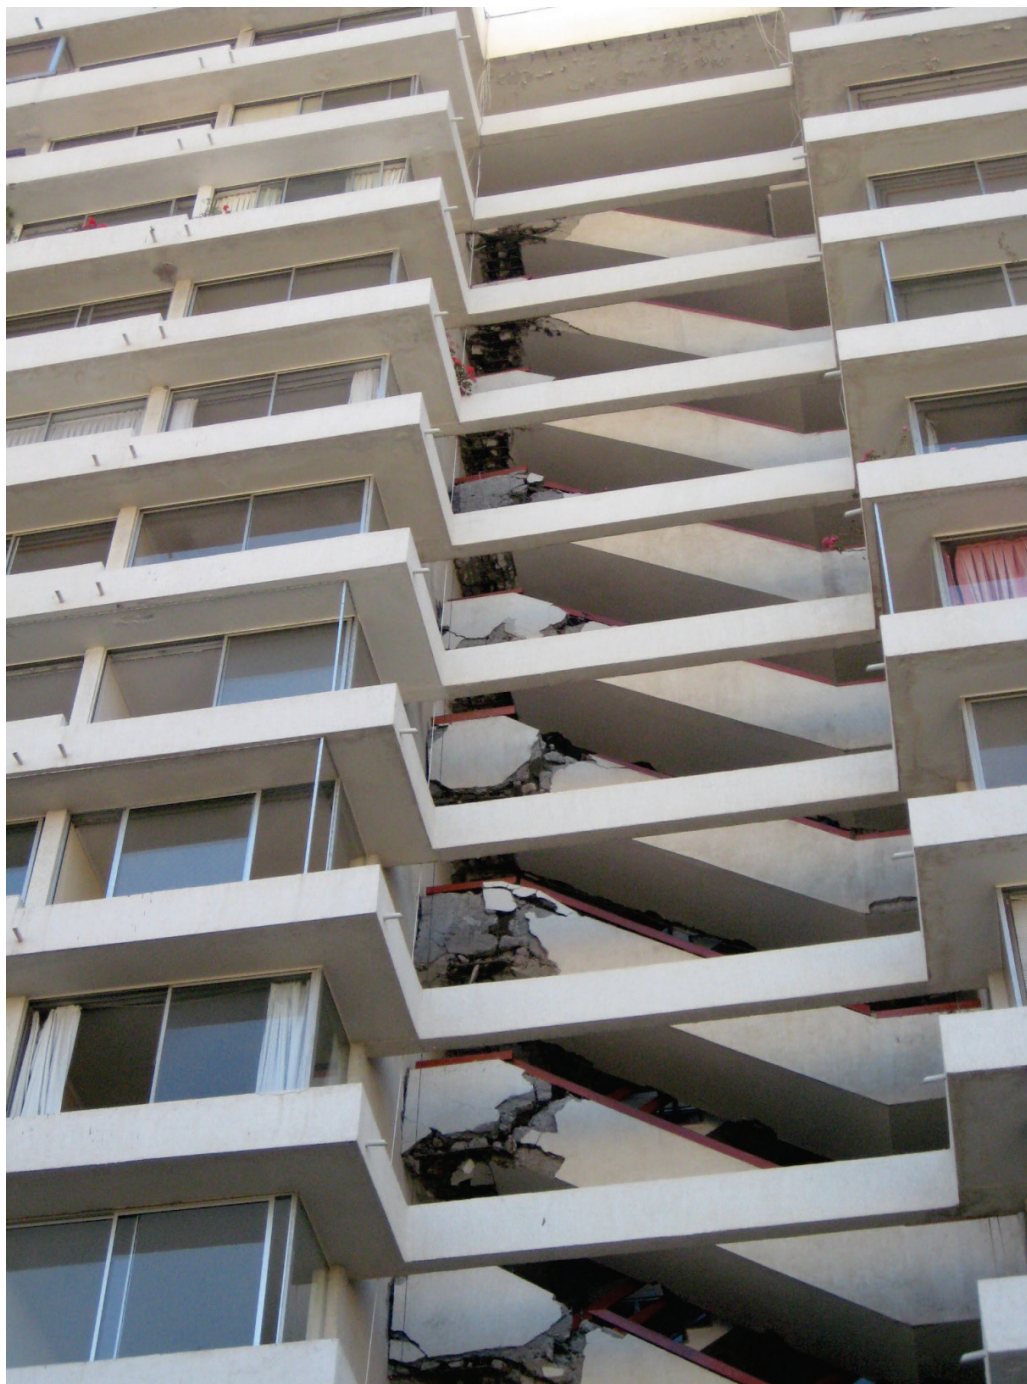
Figure 6.3.8.1-3 Stairs damaged up the full height of this apartment building in Viña del Mar in the 2010 magnitude-8.8 Chile Earthquake (Photo courtesy of Santiago Pujol, Purdue University). The stairs were rigidly attached at adjacent floors and behaved like diagonal braces although they were neither designed nor detailed to function as structural braces.

- When stairs are rigidly attached to both floor levels, the stair structure will try to act like a diagonal brace and could be damaged as shown in Figure 6.3.8.1–3.

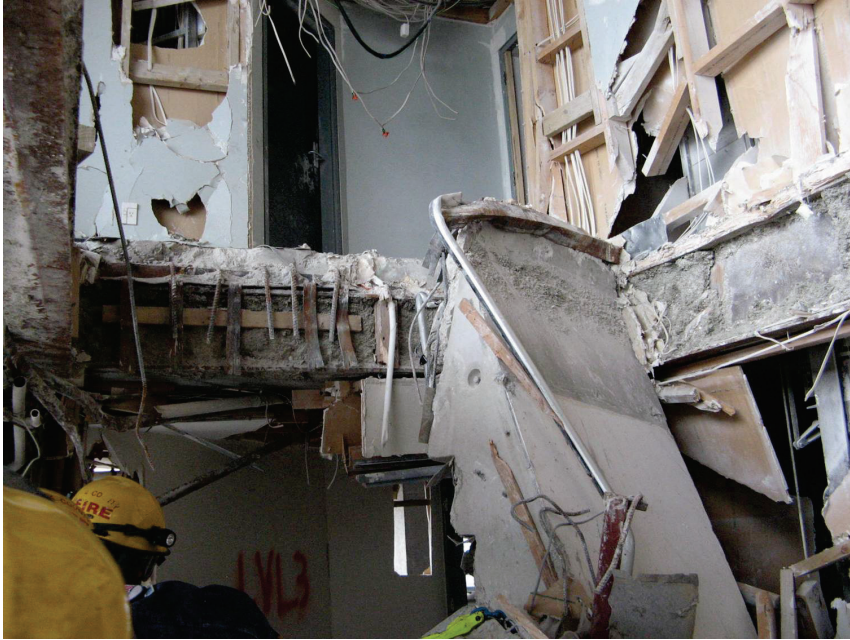
Figure 6.3.8.1-4 Stair support condition at Forsyth-Barr Building in Christchurch, New Zealand. Precast stair runs have completely pulled off supports and collapsed into stairwell (Photo courtesy of Des Bull, Holmes Consulting Group).

- When one end or both ends of the stair have slip or sliding connections, the design differential movement could be exceeded causing failure of the connection and perhaps collapse of the stair as shown in Figures 6.3.8.1–4 and 6.3.8.1–5.

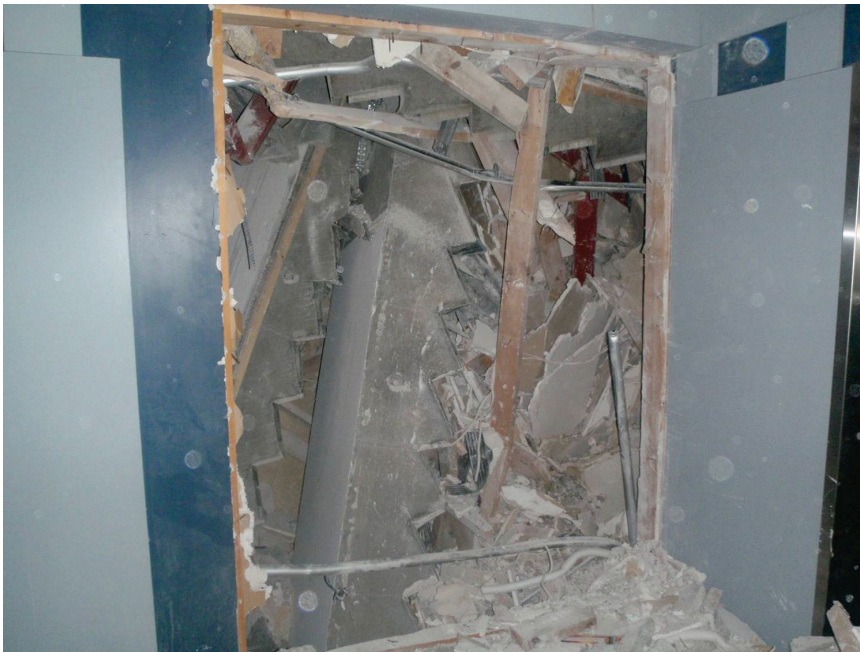
Figure 6.3.8.1-5 One story precast stair units stacked up at base of stairwell after falling off the sliding end supports and collapsing into stairwell (Photo courtesy of Des Bull, Holmes Consulting Group).
