## 6.4 Mechanical, Electrical, and Plumbing Components

### 6.4.3 Pressure Piping

#### 6.4.3.8 Penetrations

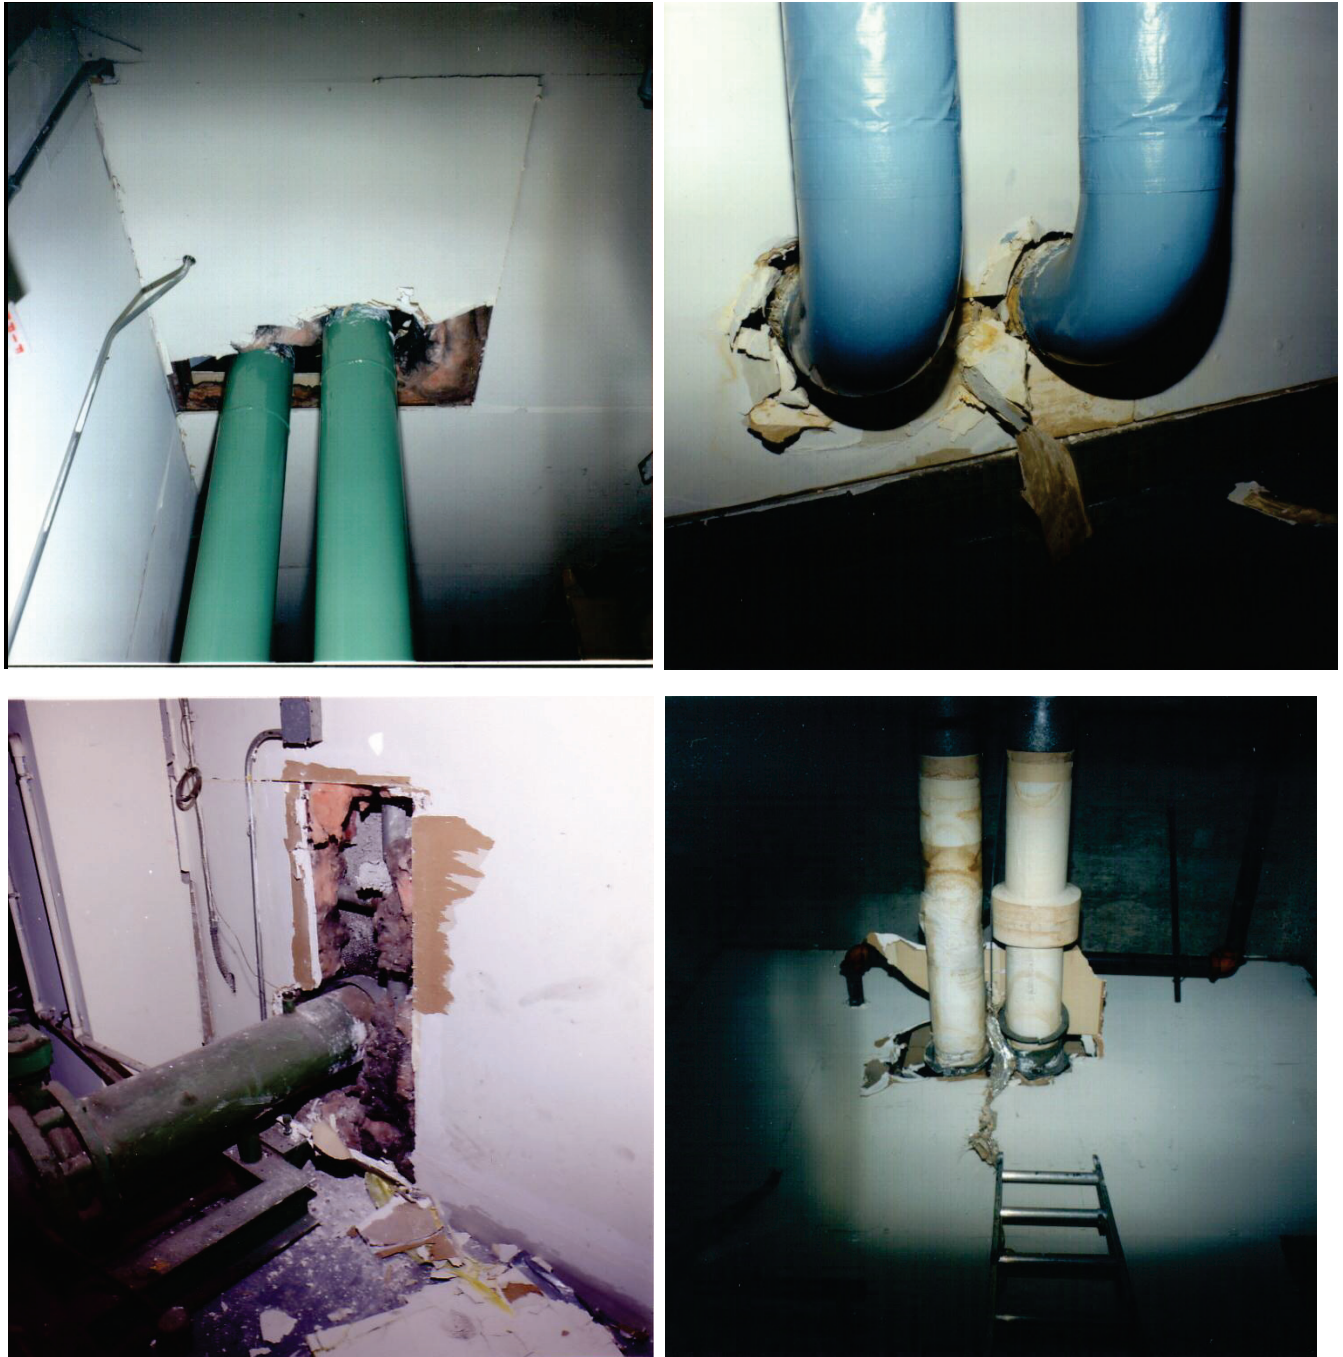
Figure 6.4.3.8-1 Damage to ceilings, gypsum board partitions, fire-proofing, and insulation in the 1994 magnitude-6.7 Northridge Earthquake (Photo courtesy of Mason Industries). Note that the blue piping has joints located in the wall space which leaked, resulting in additional damage.

- Pipes often fail or leak at joints; pipe joints should not be located within penetrations where they will leak into a wall cavity or are inaccessible for inspection and repair.

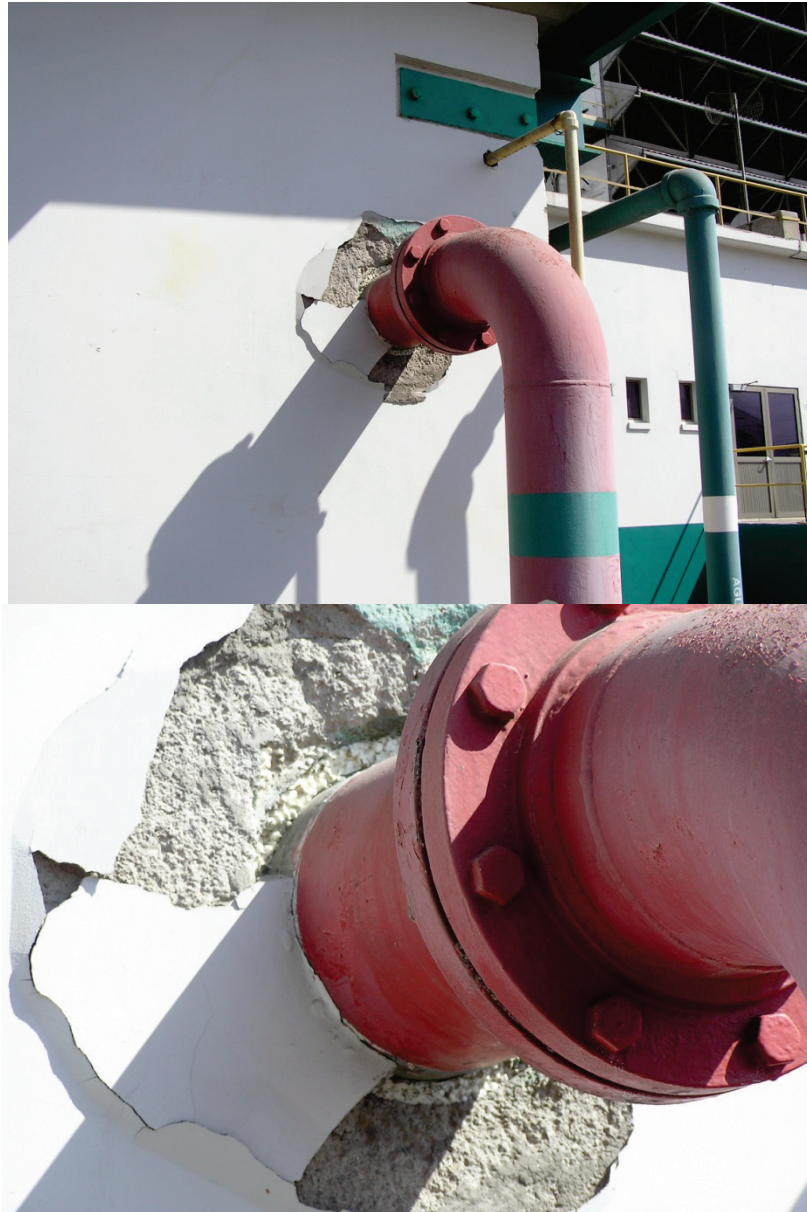
Figure 6.4.3.8-2 Exterior stucco damage at wall penetration for fire protection piping in the 2001 magnitude-8.4 Peru Earthquake (Photos courtesy of Eduardo Fierro, : BFP Engineers).

- Detailing at penetrations often involves several layers of material and finishes each of which require attention; penetrations through structural elements may involve both the engineer and the architect. For instance, a penetration through a masonry wall with interior plaster and exterior stucco will require detailing for all three of these materials. The damage shown in Figure 6.4.3.8-2 occurred because although the masonry penetration was oversized and filled with packing, the exterior stucco was placed flush with the pipe resulting in stucco damage during the earthquake.

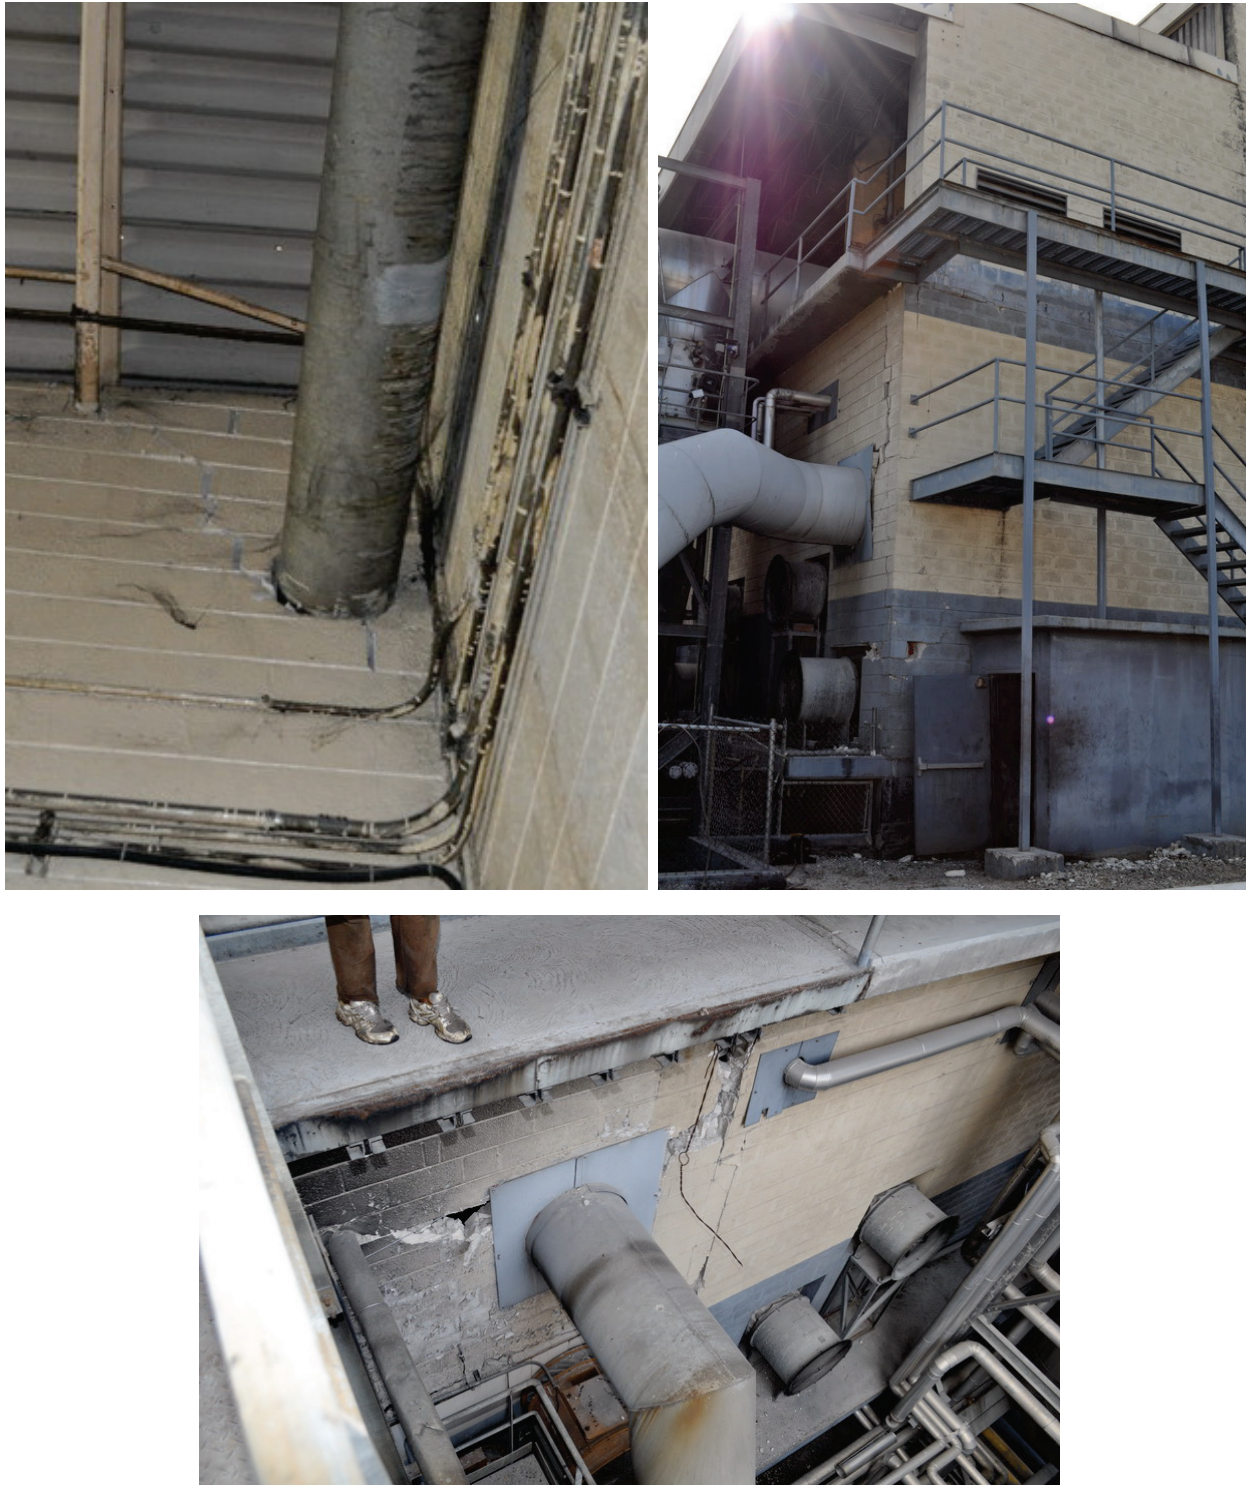
Figure 6.4.3.8-3 Wall penetrations for piping and ducts contributed to damage to unreinforced masonry walls at an industrial facility in the 2010 magnitude-7 Haiti Earthquake (Photos courtesy of Eduardo Fierro, BFP Engineers). The piping and ducts were not damaged but the walls cracked and will need to be repaired.

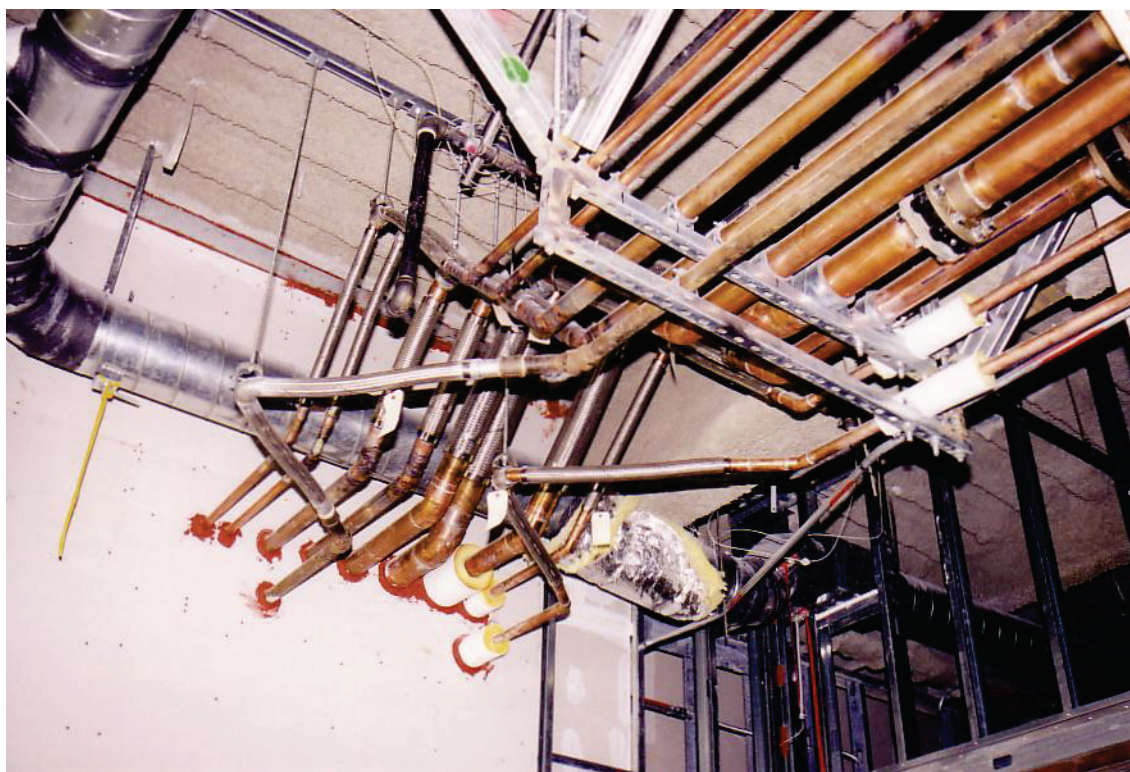
Figure 6.4.3.8-4 Wall penetrations with lateral restraints at trapeze in foreground, flexible couplings with independent vertical supports, and sealant at each wall penetration (Photo courtesy of Mason Industries).

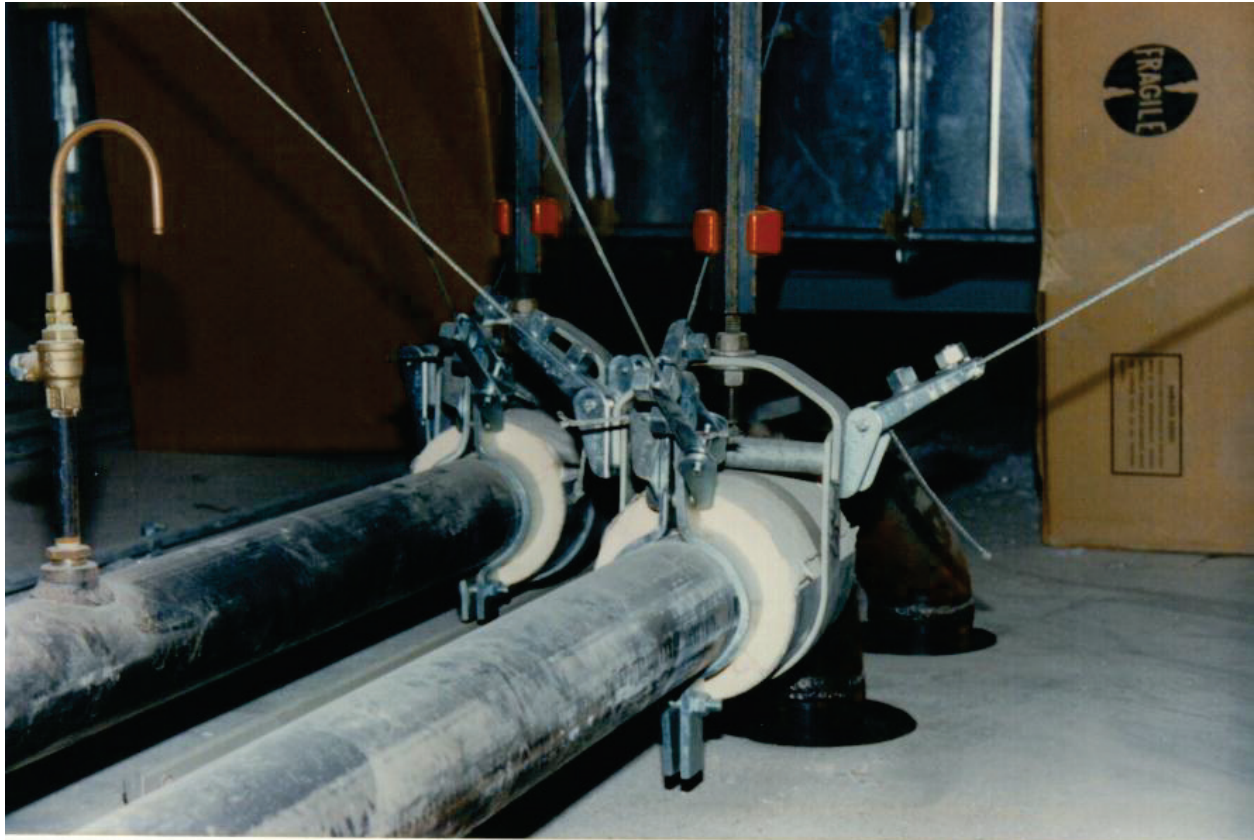
Figure 6.4.3.8-5 Floor penetration with oversized opening and vertical and lateral restraints immediately above floor (Photo courtesy of Mason Industries).

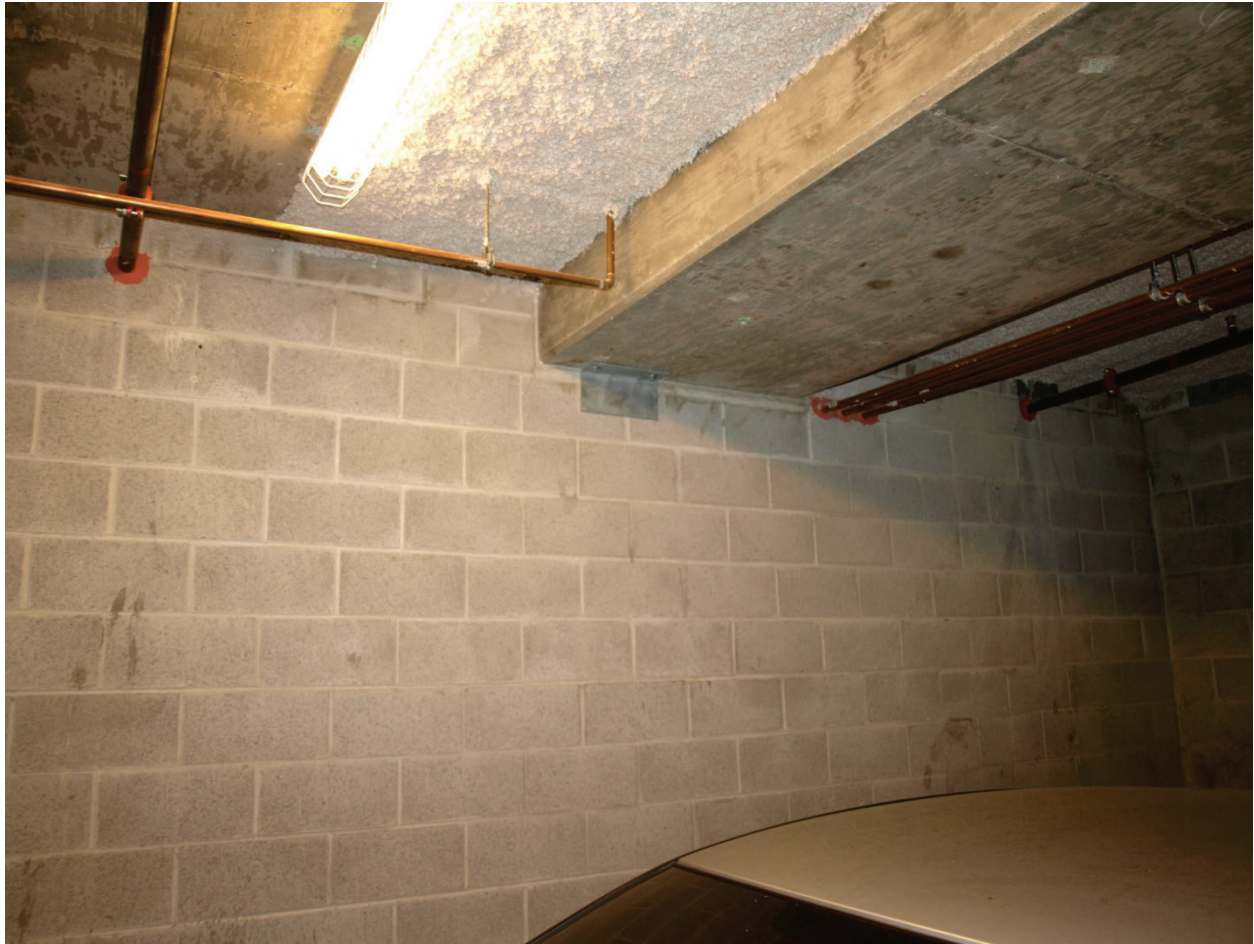
Figure 6.4.3.8-6 Series of pipe penetrations through a full-height CMU partition wall. Note pipe suspended from floor above; partition anchored to floor below and detailed with steel clip angles intended to provide lateral restraint for the wall but allow relative slip between the wall and slab above. The hangers will move with the floor above and the pipe at penetration will move with the wall. Lateral restraints are located immediately above floor (Photo courtesy Cynthia Perry, BFP Engineers).

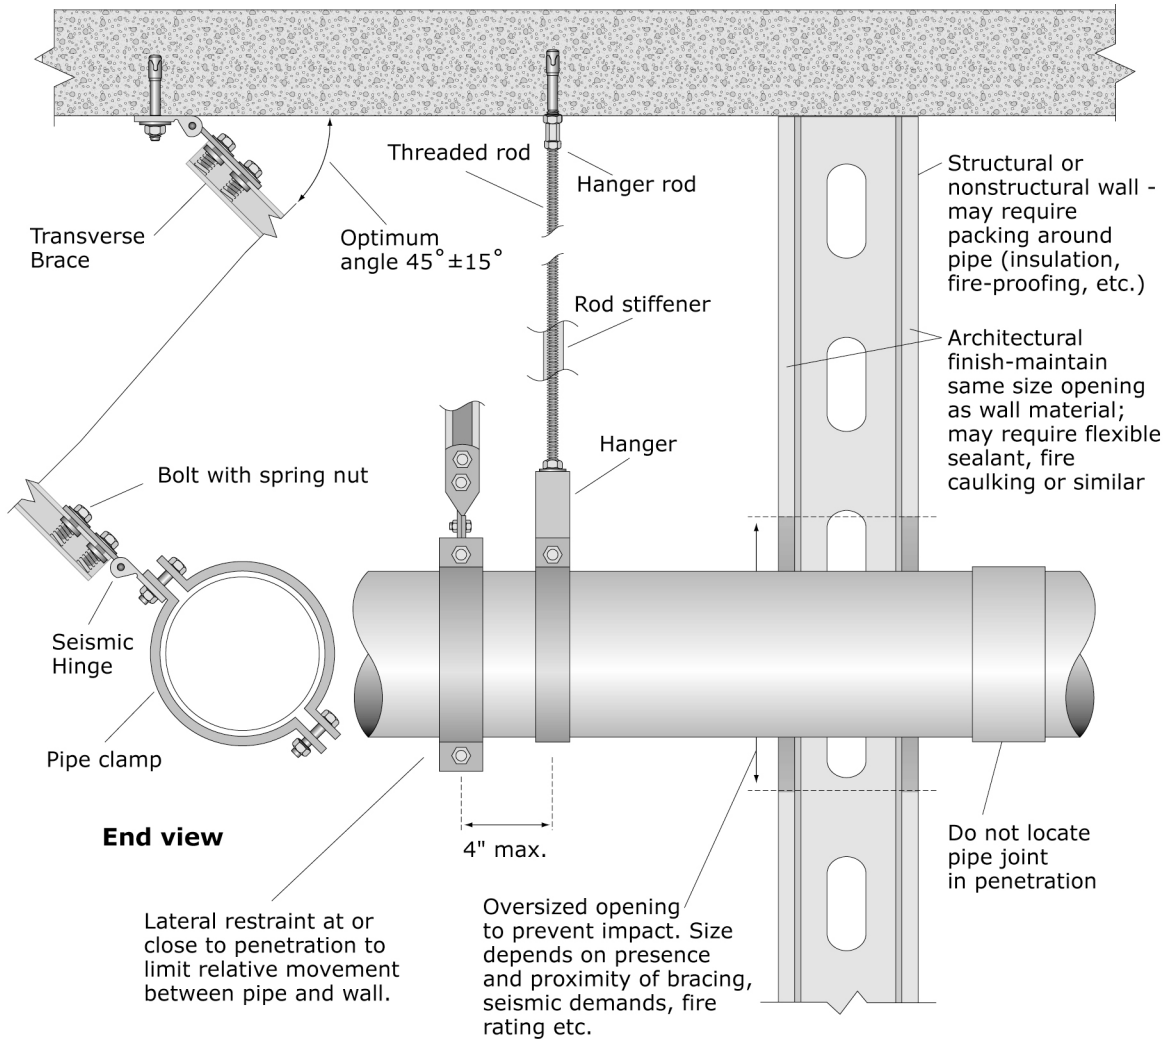
Figure 6.4.3.8-7 Wall penetration (ER).

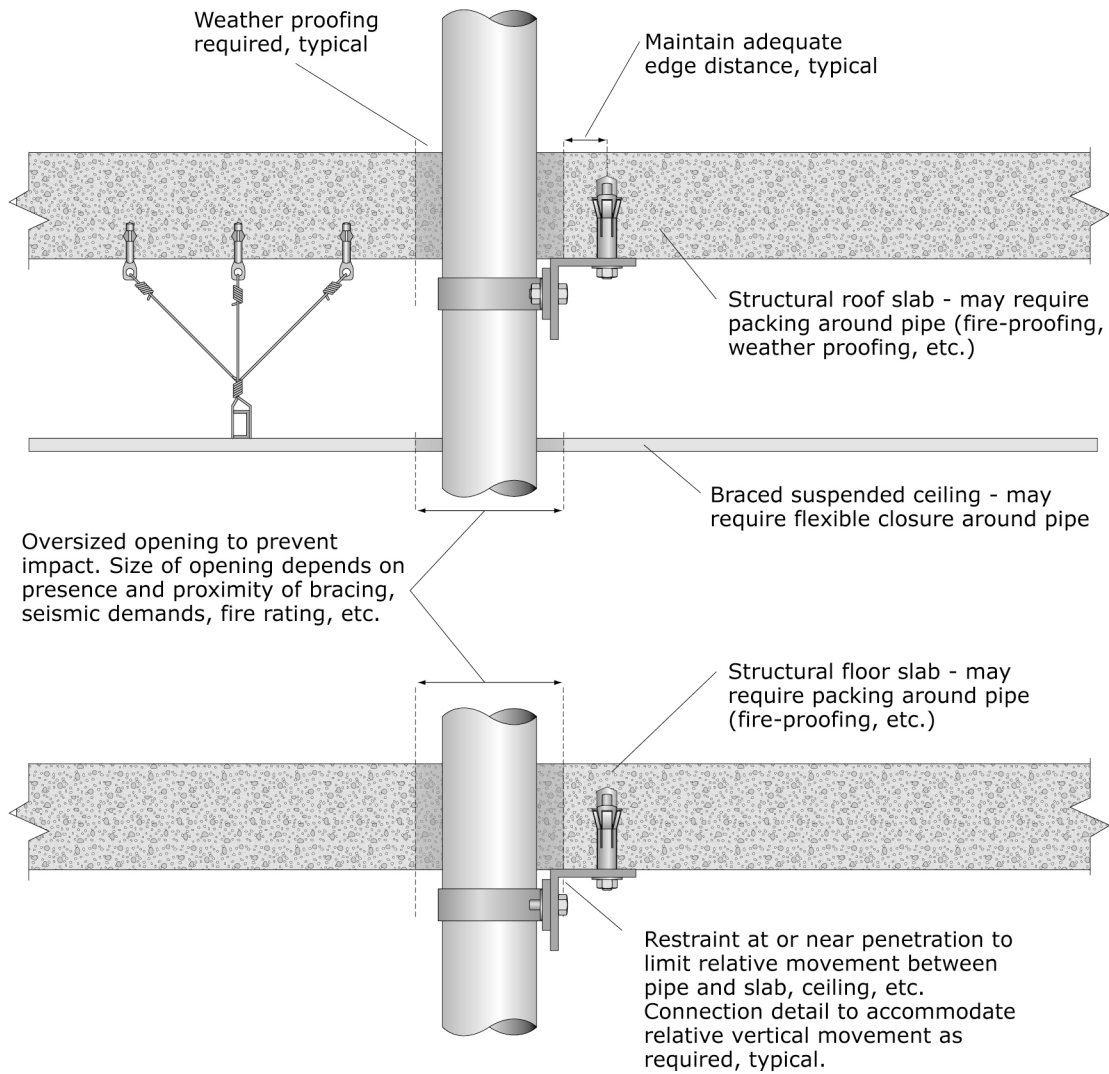
Figure 6.4.3.8-8 Floor or roof penetration (ER).
