## 6.4 Mechanical, Electrical, and Plumbing Components

### 6.4.5 Fluid Piping, not Fire Protection

#### 6.4.5.2 Nonhazardous Materials Piping

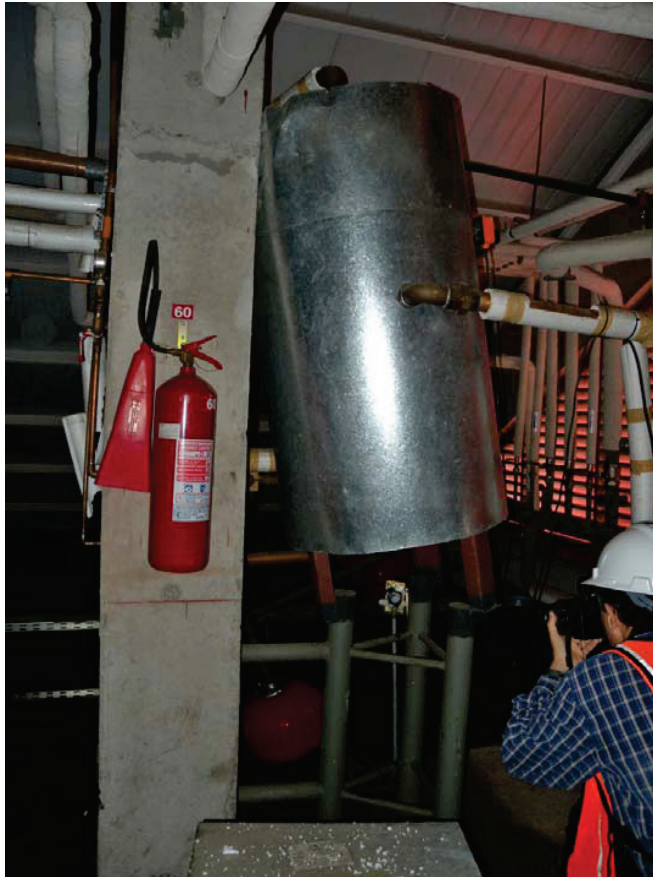
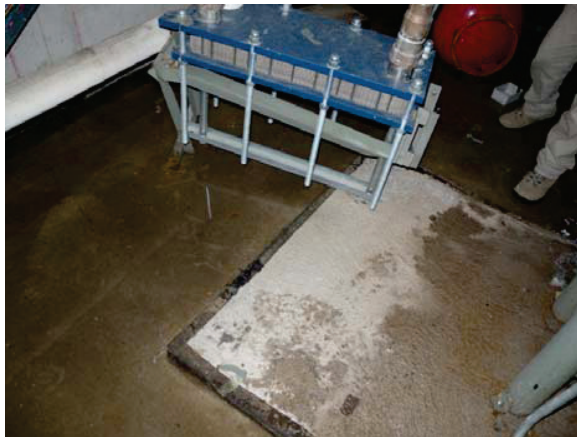
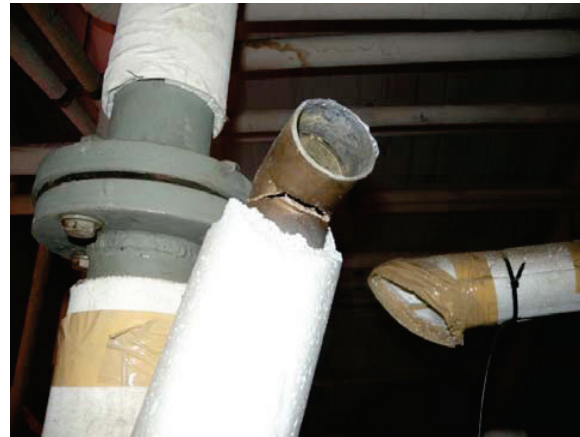
Figure 6.4.5.2-1 Broken copper hot water piping for at the San Carlos Hospital in the 2010 Chile Earthquake. Piping failure caused by movement of inadequately braced boiler shown at left (Photos courtesy of Gilberto Mosqueda, SUNY Buffalo).

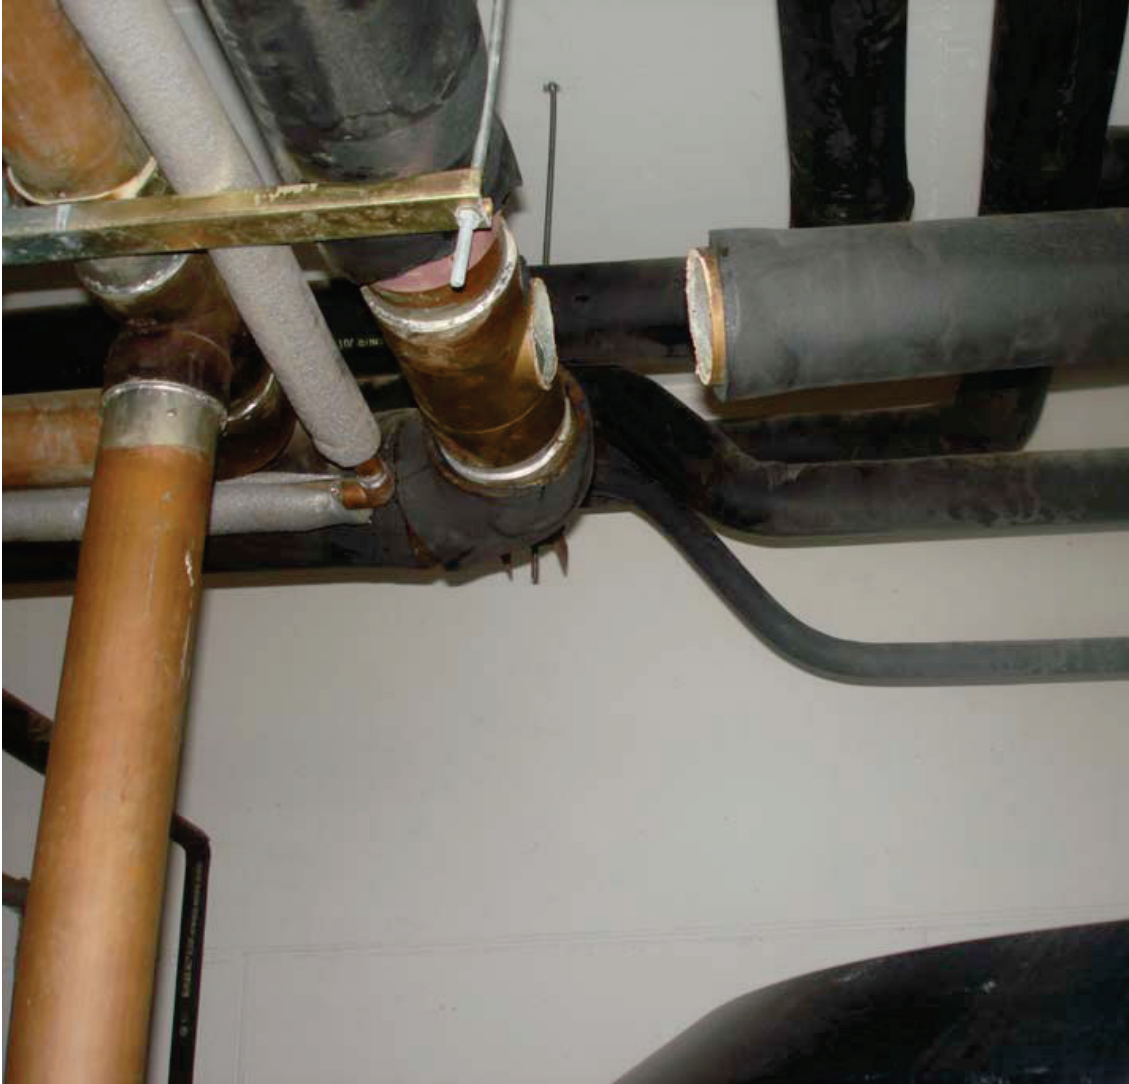
Figure 6.4.5.2-2 Broken copper piping for hot water supply in residential building in the 2010 Chile Earthquake. Trapeze shown not laterally braced but hangers appear to be less than 12" in length and may not have required lateral restraints per ASCE 7-10 (Photo courtesy of Gokhan Pekcan).

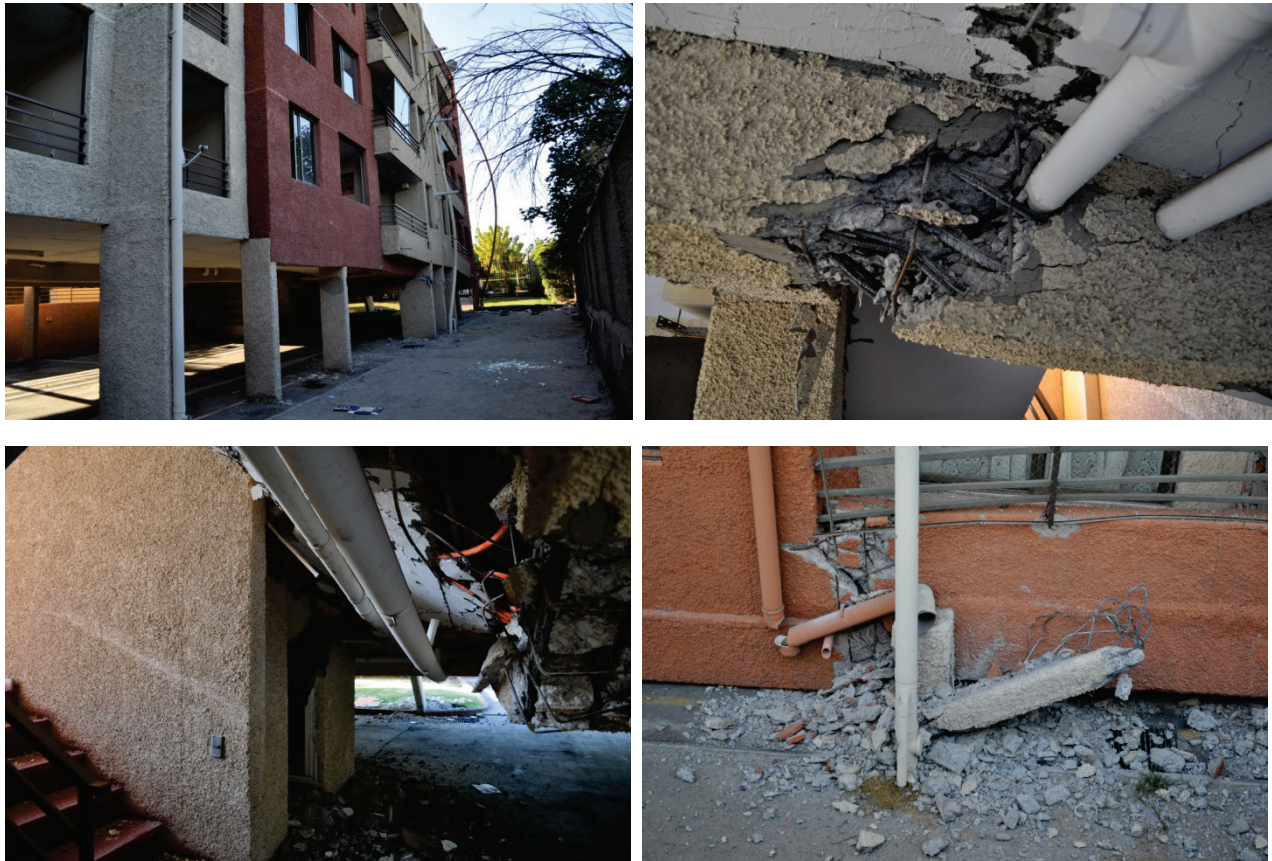
Figure 6.4.5.2-3 Photos displaying resilience of piping systems; this building suffered a partial structural collapse along one side in the 2010 Chile Earthquake. The only broken pipe (shown at lower right) was along the collapsed side; the other piping had broken pipe supports in some locations but the joints remained largely intact, even with these very large deformations (Photos courtesy of Eduardo Fierro, BFP Engineers).

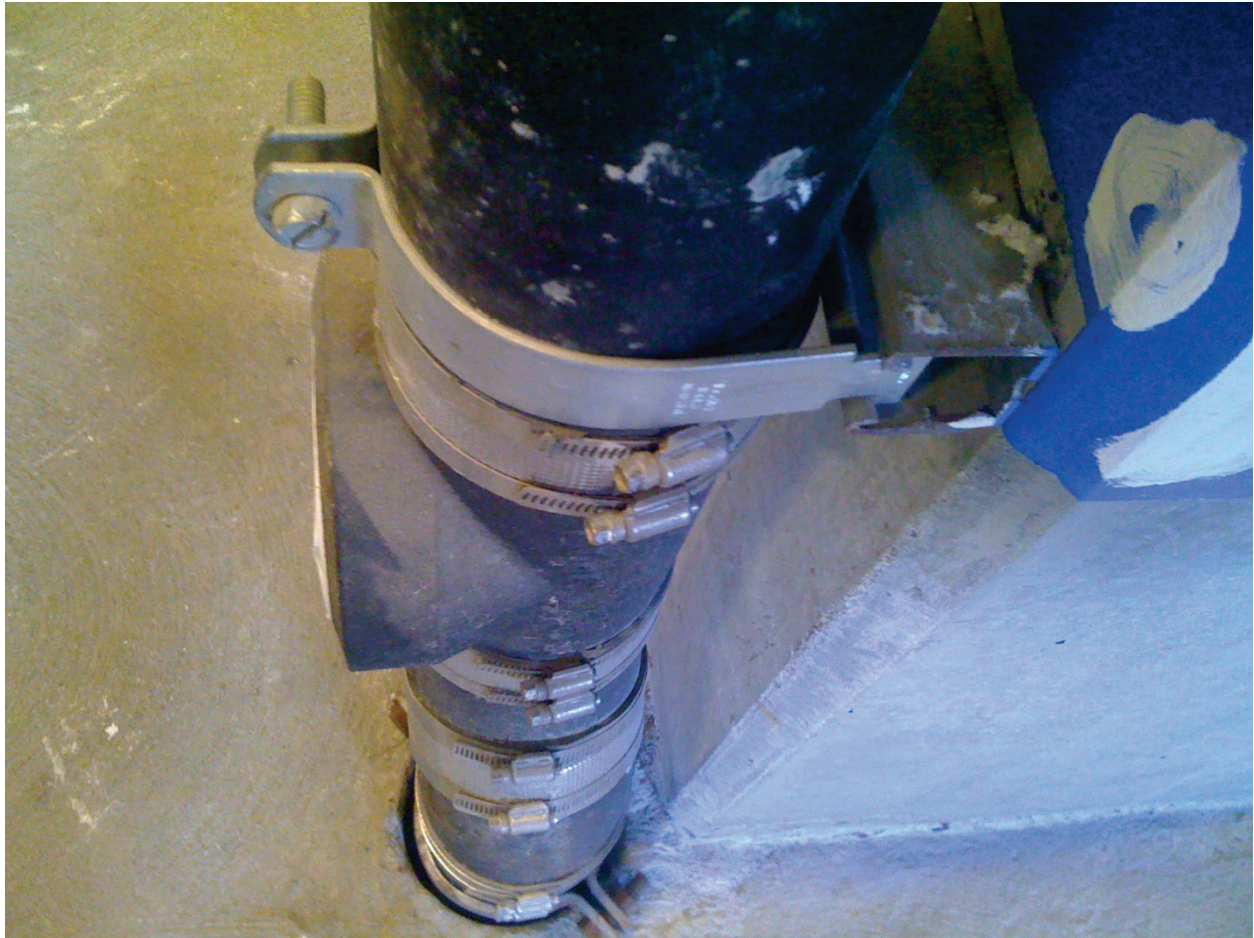
Figure 6.4.5.2-5 Poor example of sanitary sewer pipe support installed in San Francisco Bay Area in 2010; strut clamp has inadequate edge distance to end of strut and could slip off the end (Photo courtesy of Cynthia Perry, BFP Engineers).

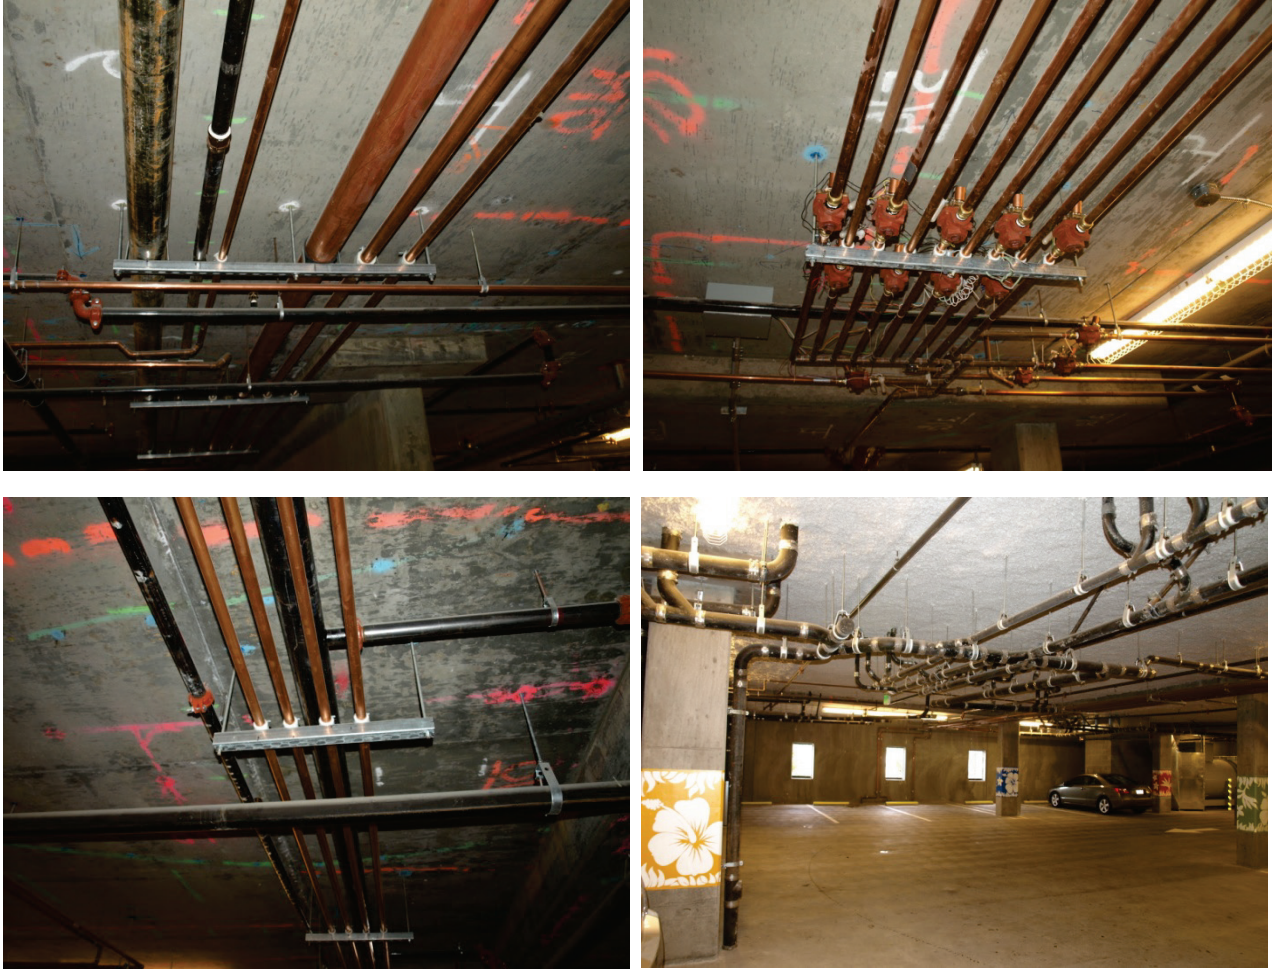
Figure 6.4.5.2-6 Piping installation in garage of mixed commercial/residential building San Francisco Bay Area completed in 2010. Note piping and trapeze supports do not have lateral restraints as all hangers were kept under 12" in length; only the sprinkler lines were laterally restrained. (Photo courtesy of Cynthia Perry, BFP Engineers).
