6.4 Mechanical, Electrical, and Plumbing Components

6.4.10 Elevators and Escalators

6.4.10.2 Traction Elevators

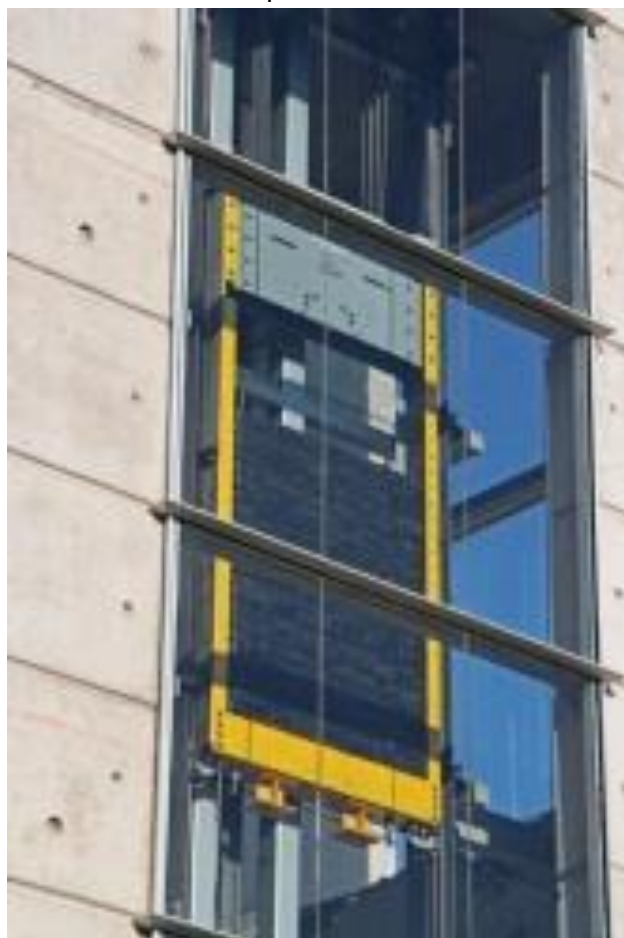
Figure 6.4.10.2-1 Examples of an elevator counterweight (Photo courtesy of Eduardo Miranda, Stanford University).

- The most common cause of damage in elevators is counterweight derailment. Counterweights are the heaviest component in an elevator and typically weigh the same as the cab filled at 50% capacity. Elevators are often programmed to spend more time in the ground floor and therefore when earthquakes occur the counterweight is likely to be located in the upper part of the building where the largest acceleration demands occur. This means that often counterweights are subjected to forces that are larger than those experienced by the cab (car). Counterweight derailment is a very serious type of damage because once it is out of the guide rails the heavy counterweight may violently swing in the hoistway and collide against other components causing the damage to guide rails and rail brackets. In some cases collisions with the cab occur if the elevator is operated with its counterweight derailed. In other cases, severe pounding of a derailed counterweight against the guide rails or the hoistway can cause damage to the frame of the counterweight and individual block which are typically made of cast iron or steel plates may become loose and fall into the shaft or onto the roof of the cab.

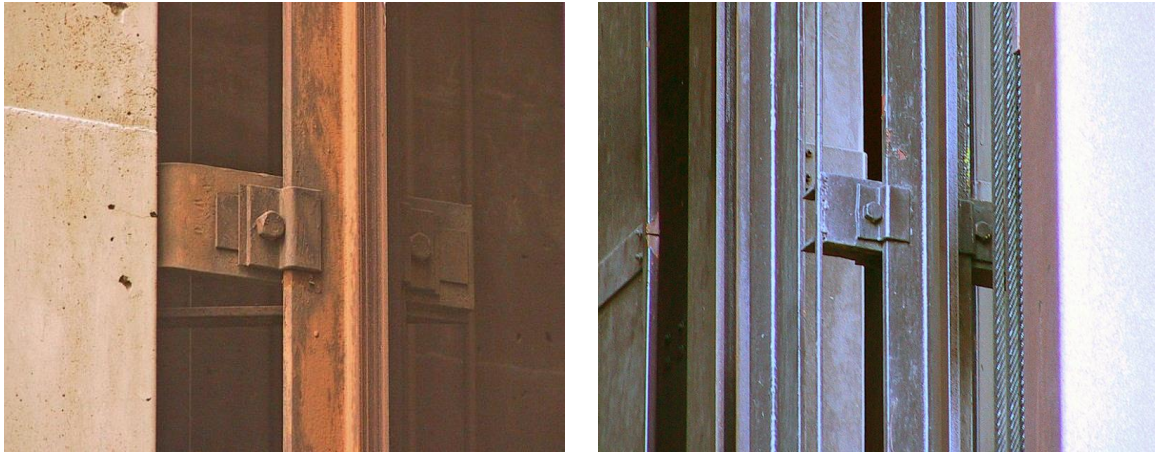
Figure 6.4.10.2-2 Examples of brackets and clips attaching the elevator guide rails to the structure (Photo courtesy of Eduardo Miranda, Stanford University).

- Guide rails are attached to the structure by steel brackets. As shown in Figure 6.4.10.2–1 the rails are attached to the brackets by clamps that hold the flanges of the rail to the bracket. Both brackets and clamps are damaged as a result of the forces acting on the counterweight or car. The most common type of damage consists of bending of the brackets.

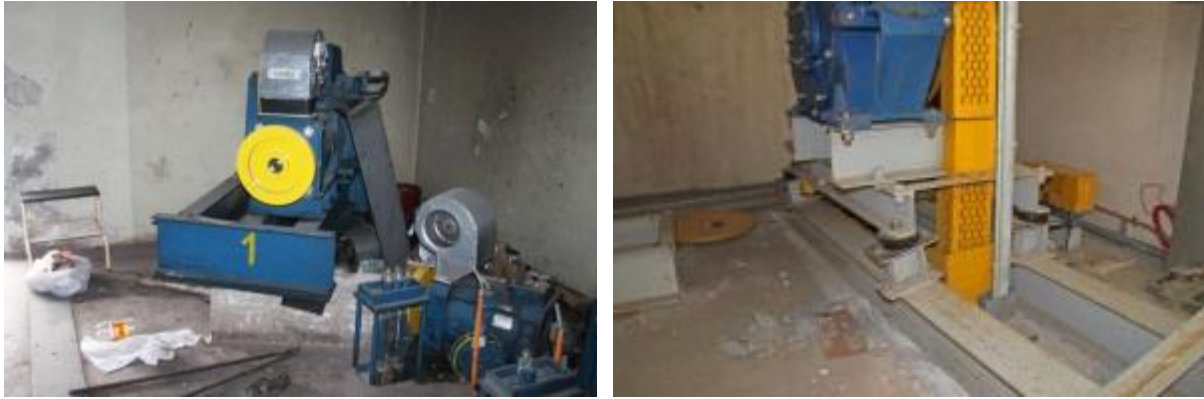
Figure 6.4.10.2-4 Examples of damage to elevator machines produced by inadequate anchorage to the structure (Photos courtesy of Eduardo Miranda, Stanford University).

- At the top of the elevator is a room that houses the elevator machines. The main components housed in the elevator machine room are the electrical motors which are usually directly attached to the shaft. The elevator machines must be properly anchored to the base otherwise a sliding may occur during earthquakes.

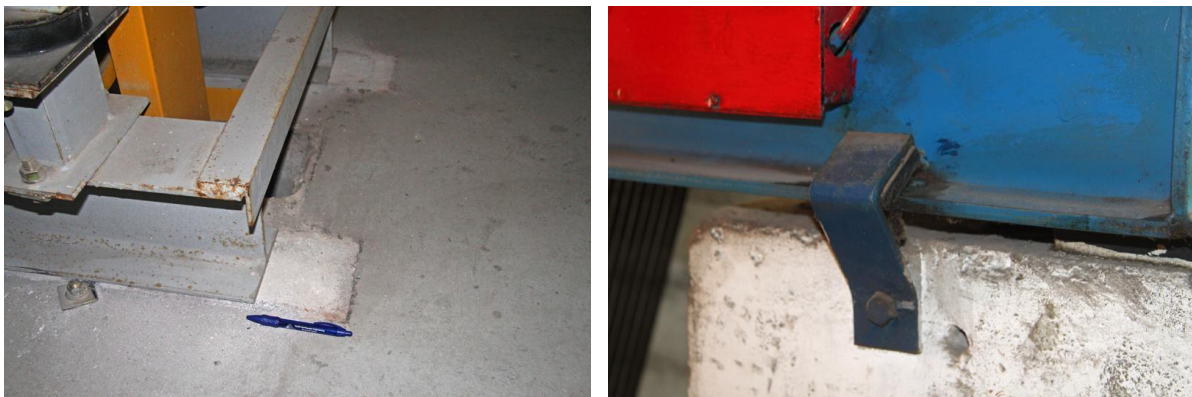
Figure 6.4.10.2-5 Details of bent bracket (left) and large displacement at the base of elevator machines (Photos courtesy of Eduardo Miranda, Stanford University).

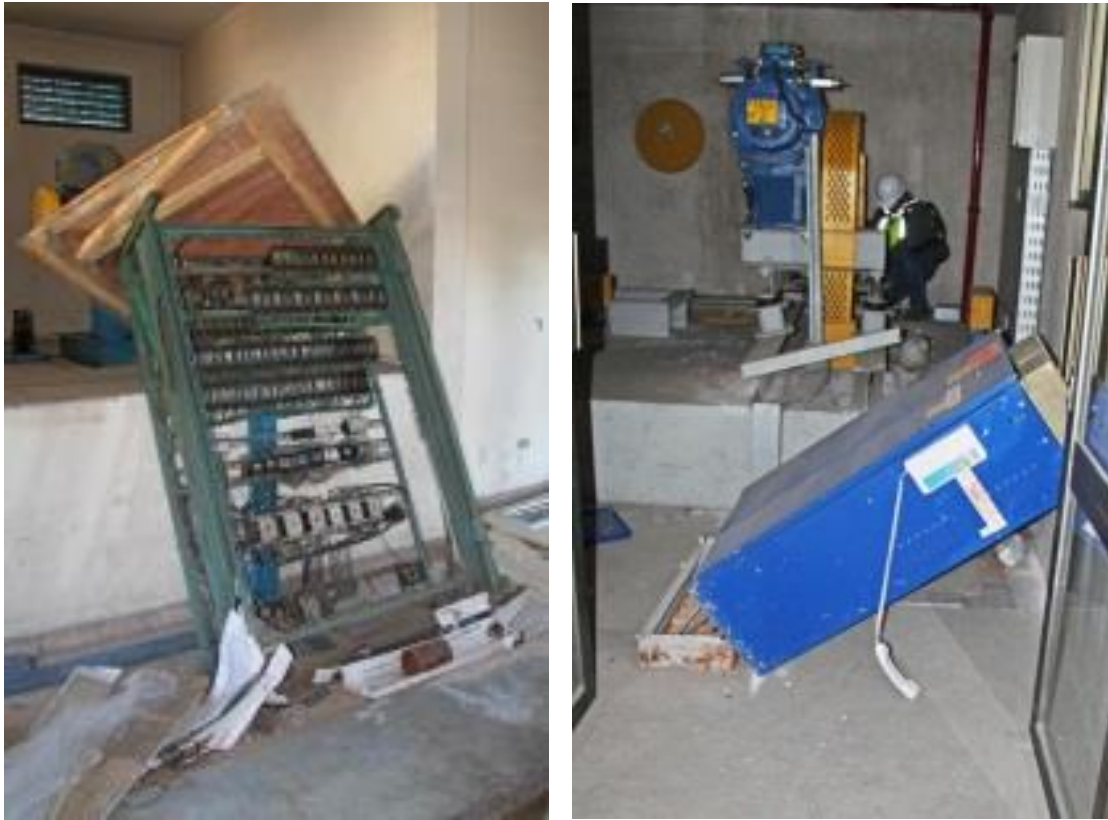
Figure 6.4.10.2-6 Overturned control panels in the 2010 Chile earthquake (Photos courtesy of Eduardo Miranda, Stanford University).

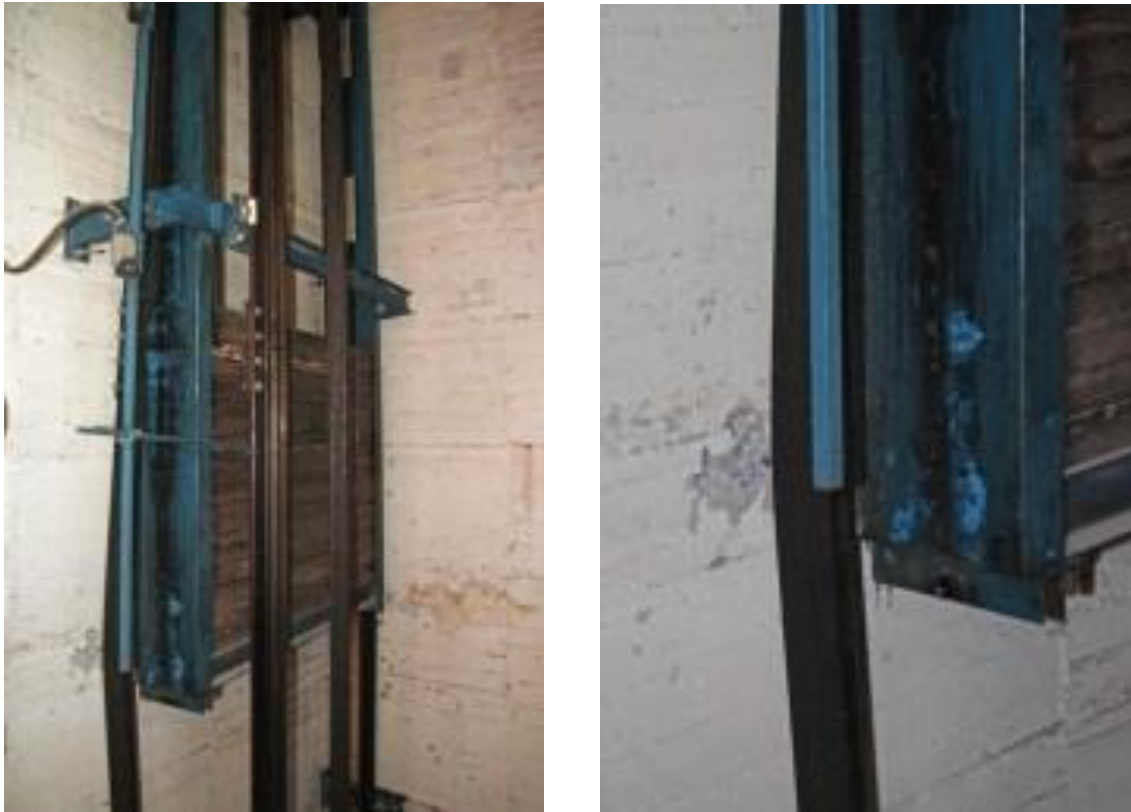
Figure 6.4.10.2-7 Damage to guide rails caused by derailment of the counterweight in a hospital in Chillan during the 2010 Chile earthquake (Photos courtesy of Eduardo Miranda, Stanford University).

- Counterweight and car guide rails often are bent as a result of large inertia forces acting on the counterweight and car that push the guiderails during the earthquake. Damage

typically occurs when the counterweight or car are between floors where the rails are not attached to the structure and therefore are subjected to large bending deformations. Guide rails also get damaged as a result of pounding against the counterweight or the car. Bent rails often need to be replaced, which may require several days.

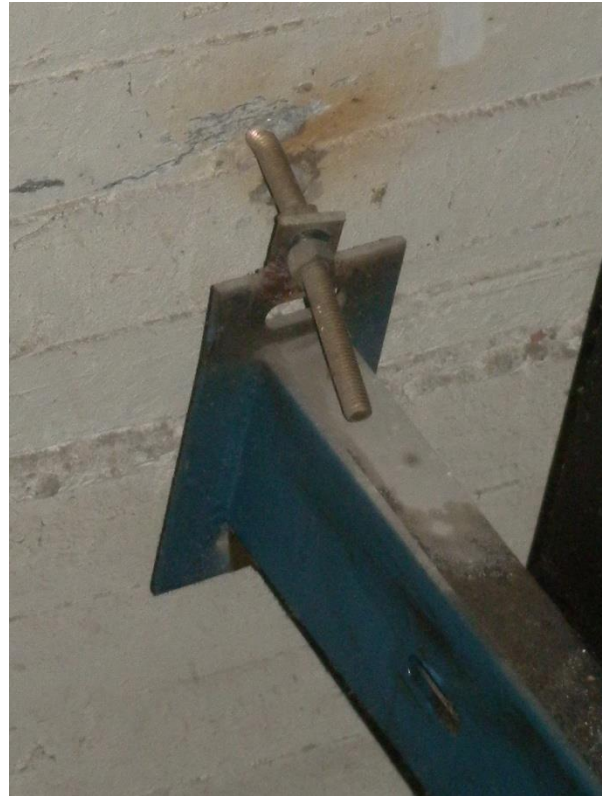
Figure 6.4.10.2-8 Damage to guide rail support brackets in the 2010 Chile Earthquake (Photo courtesy of Gilberto Mosqueda, SUNY Buffalo).

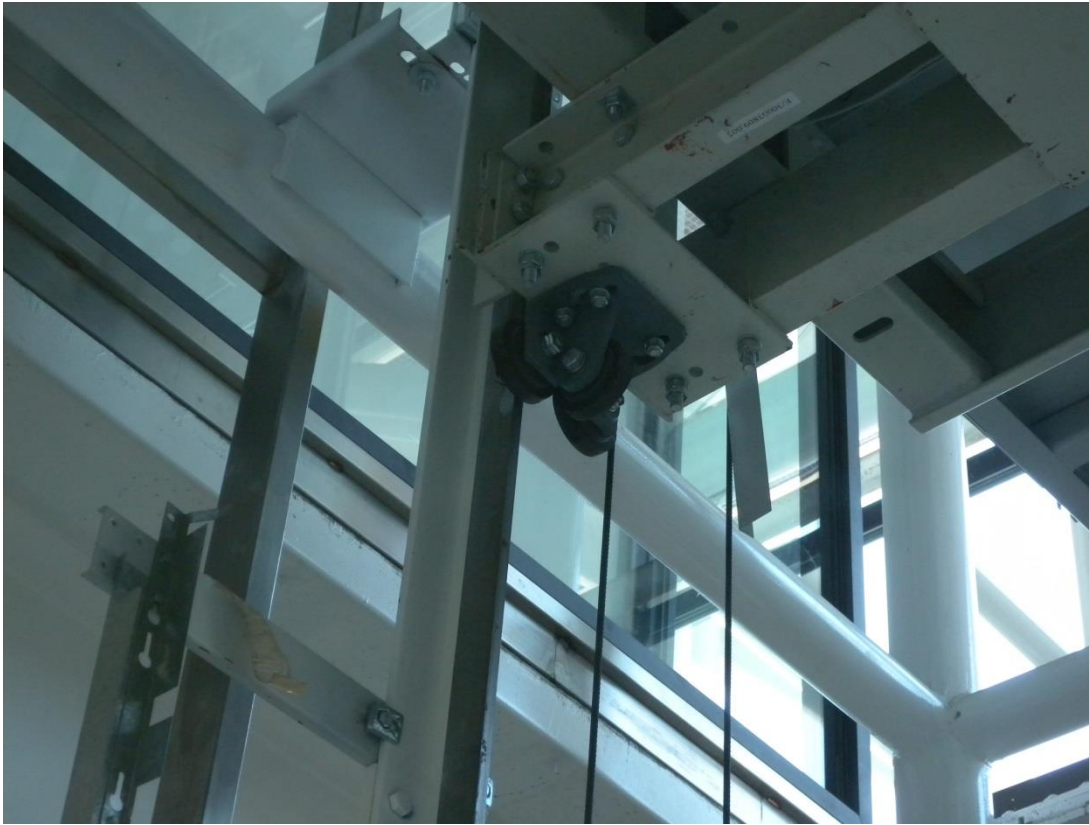
Figure 6.4.10.2-9 Derailed car roller assembly of the guide rail at the Santiago airport in the 2010 Chile Earthquake (Photo courtesy of Gilberto Mosqueda, SUNY Buffalo). The three rollers are supposed to travel along three sides of the stem of the T-shaped steel guide rail.

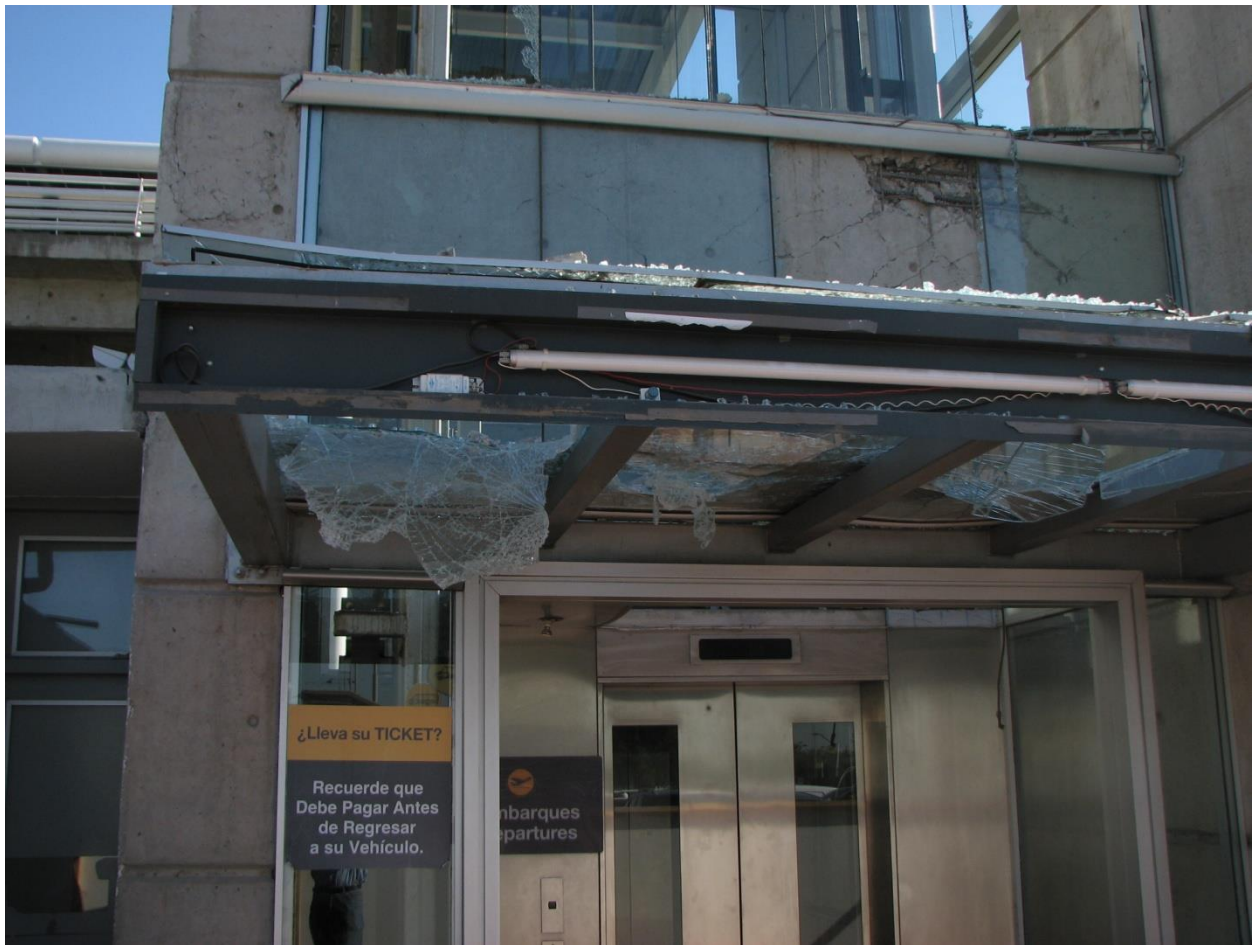
Figure 6.4.10.2-10 Glazing failures caused additional hazards at Santiago airport elevator in the 2010 Chile Earthquake (Photo courtesy of Antonio Iruretagoyena, Rubén Borsochek & Associates).

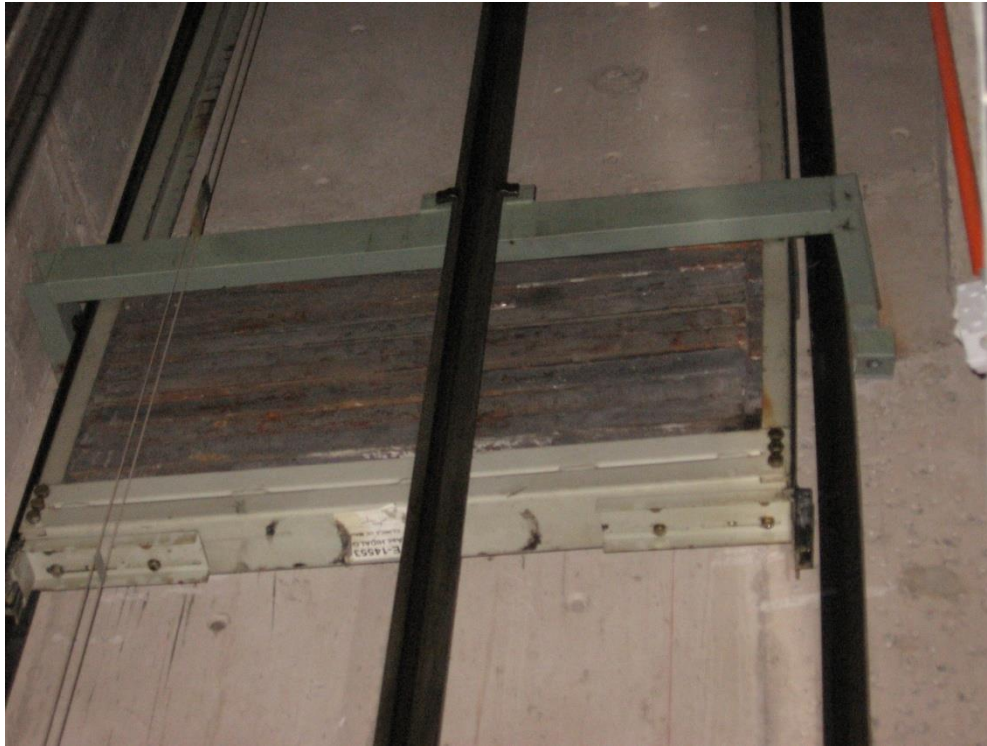
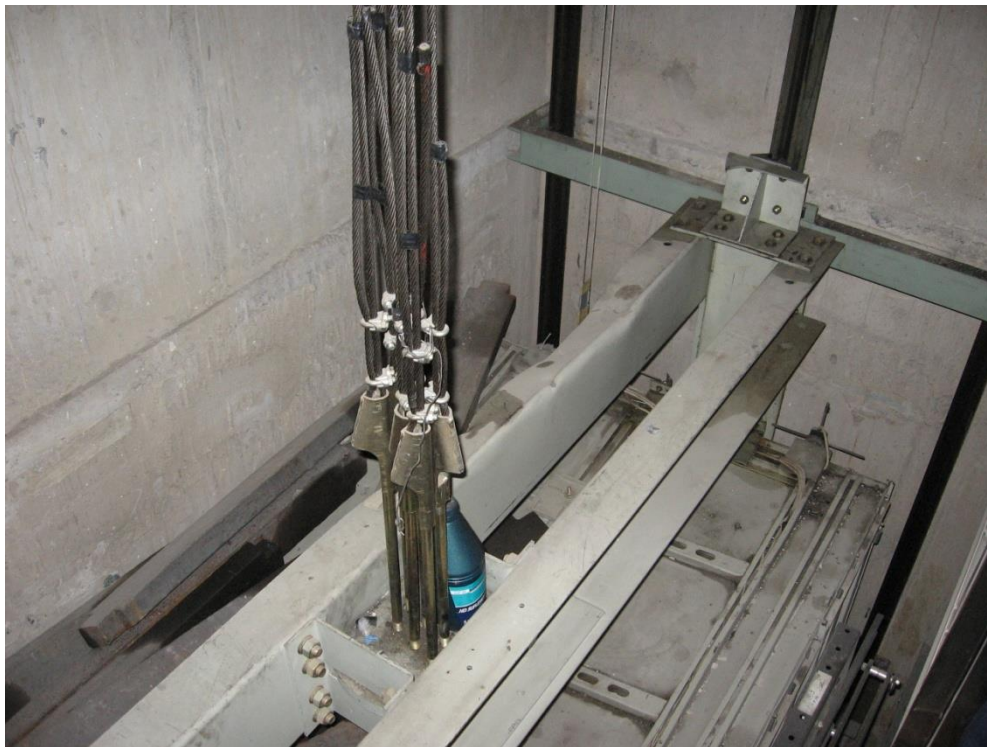
Figure 6.4.10.2-11 Unrestrained movement of the counterweights damaged the counterweight assembly and bent the counterweight guide rails; over half the subweights dropped onto the top of the cab and damaged the cab framing in the 2010

Chile Earthquake (Photo courtesy of Rodrigo Retamales, Rubén Borsochek & Associates).

- Following the 2010 Chile Earthquake, it was reported that 50%–80% of hospital elevators were damaged. In a number of locations, patients had to be carried down many flights of stairs, often cluttered with fallen debris, in order to evacuate them to safety. The most common damage was due to unrestrained movement of the counterweights, resulting in damage to the guide rails. Movement of unrestrained mechanical equipment was another problem. One security camera at a military hospital in Santiago, Chile captured a sequence through the open door of an empty elevator cab where the counterweights derailed and then the subweights came crashing down on top of the cab. (Source: Bill Holmes, March 2010).

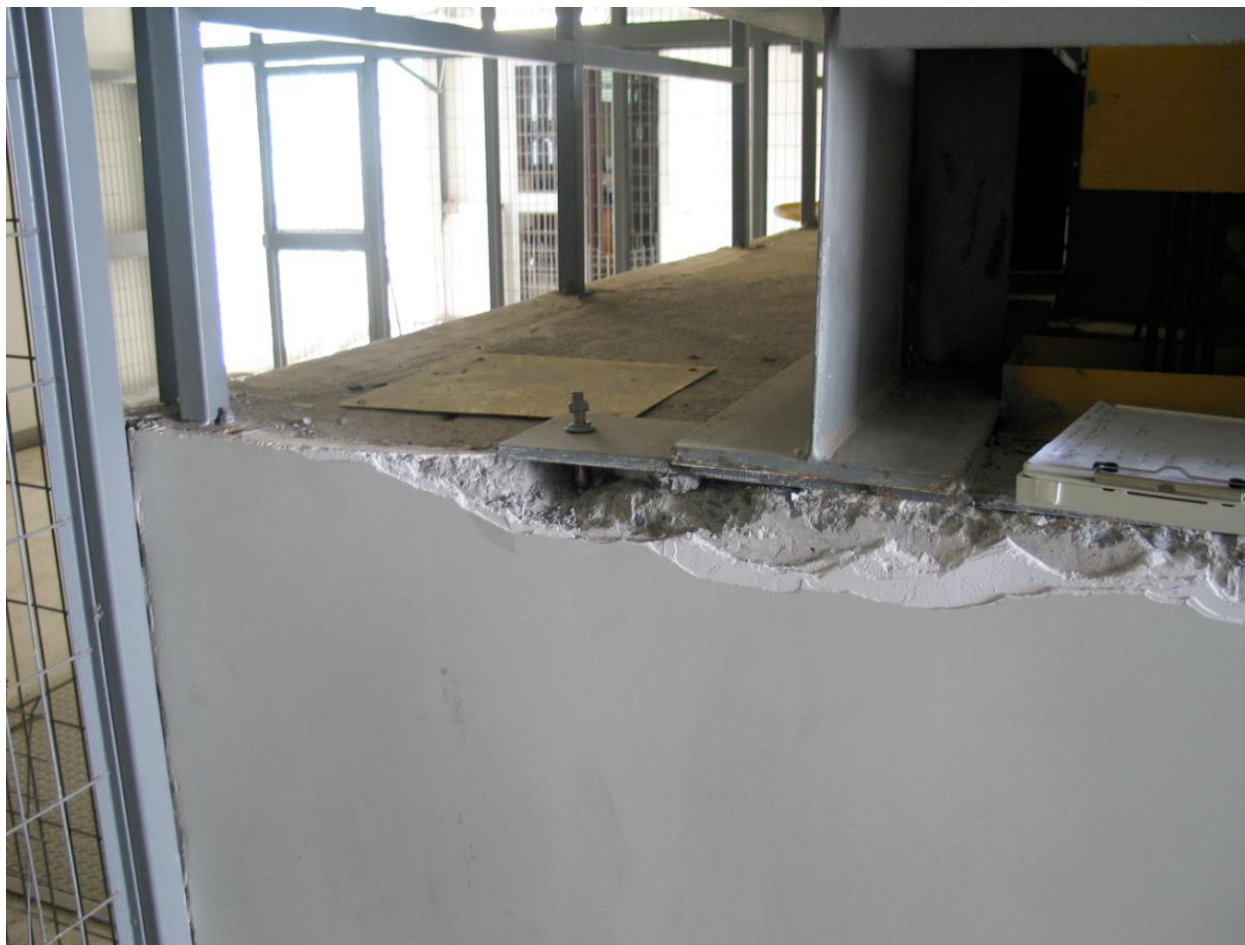
Figure 6.4.10.2-12 Anchor bolt failure of the elevator generator set due to inadequate edge distance for the bolts at the Los Angeles Regional Public Hospital in the 2010 Chile Earthquake (Photo courtesy of Bill Holmes, Rutherford & Chekene).

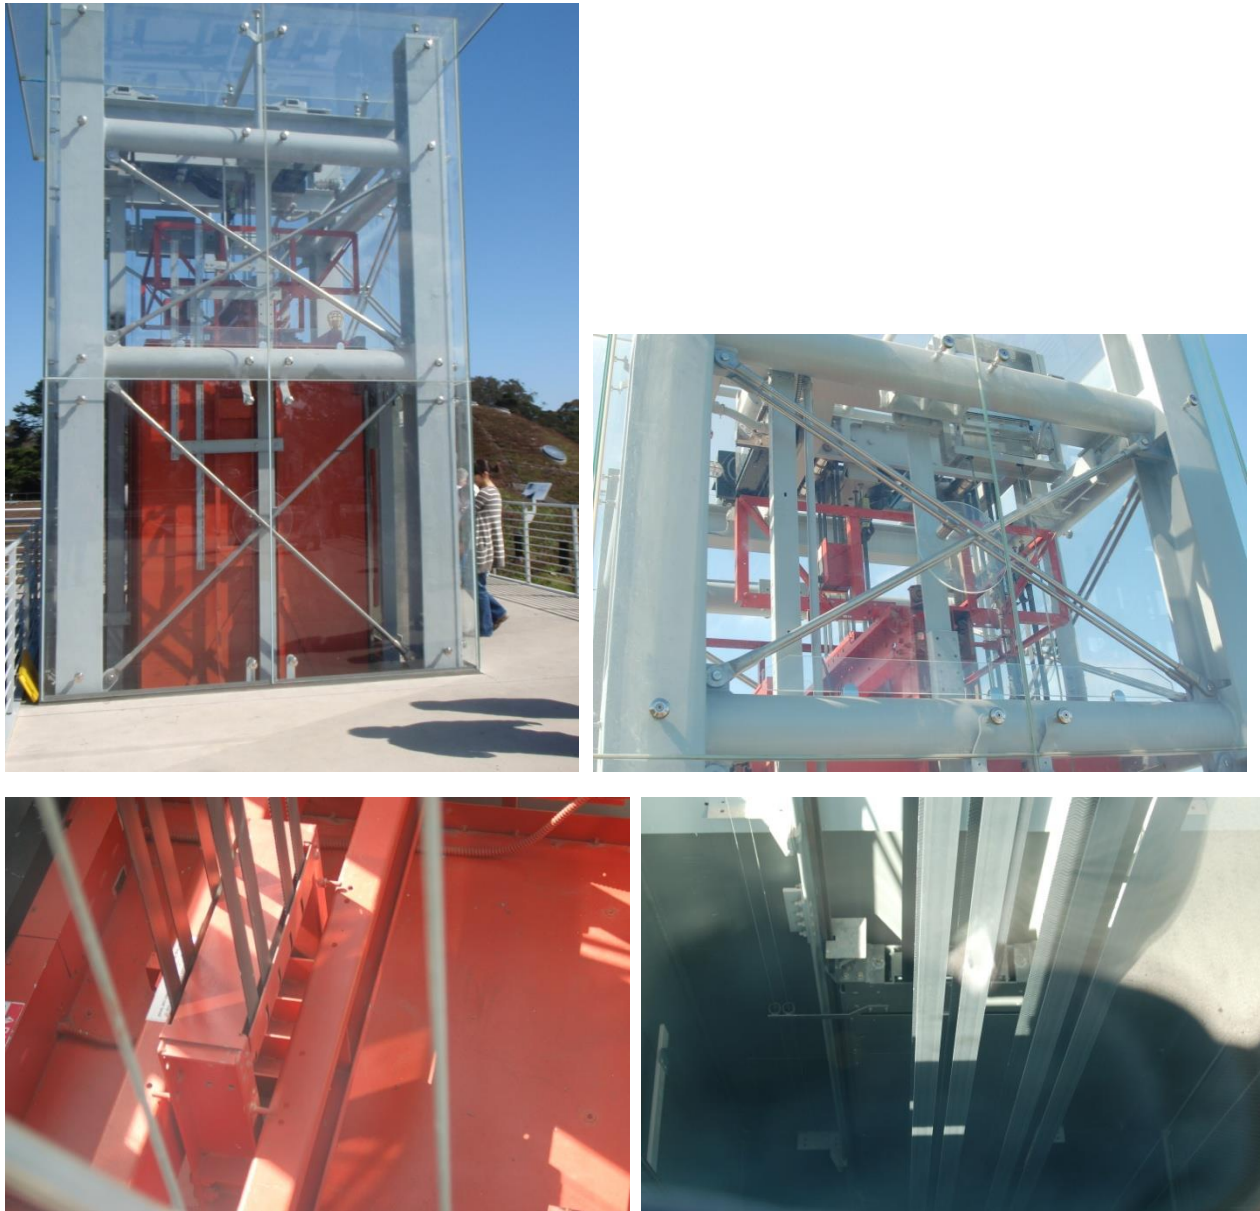
Figure 6.4.10.2-13 Small “machine-roomless” traction elevator with flat belts at the Academy of Sciences, San Francisco, California (Photos courtesy of Eduardo Fierro, BFP Engineers). Clockwise: Overview of elevator at roof; view of guide rails and sheaves; top of cab showing belts; view down shaft at belts, counterweight, guide rails and guide rail brackets.
