6.5 Furniture, Fixtures, Equipment and Contents

6.5.3 Computer and Communication Equipment

6.5.3.1 Computer Access Floors and Equipment

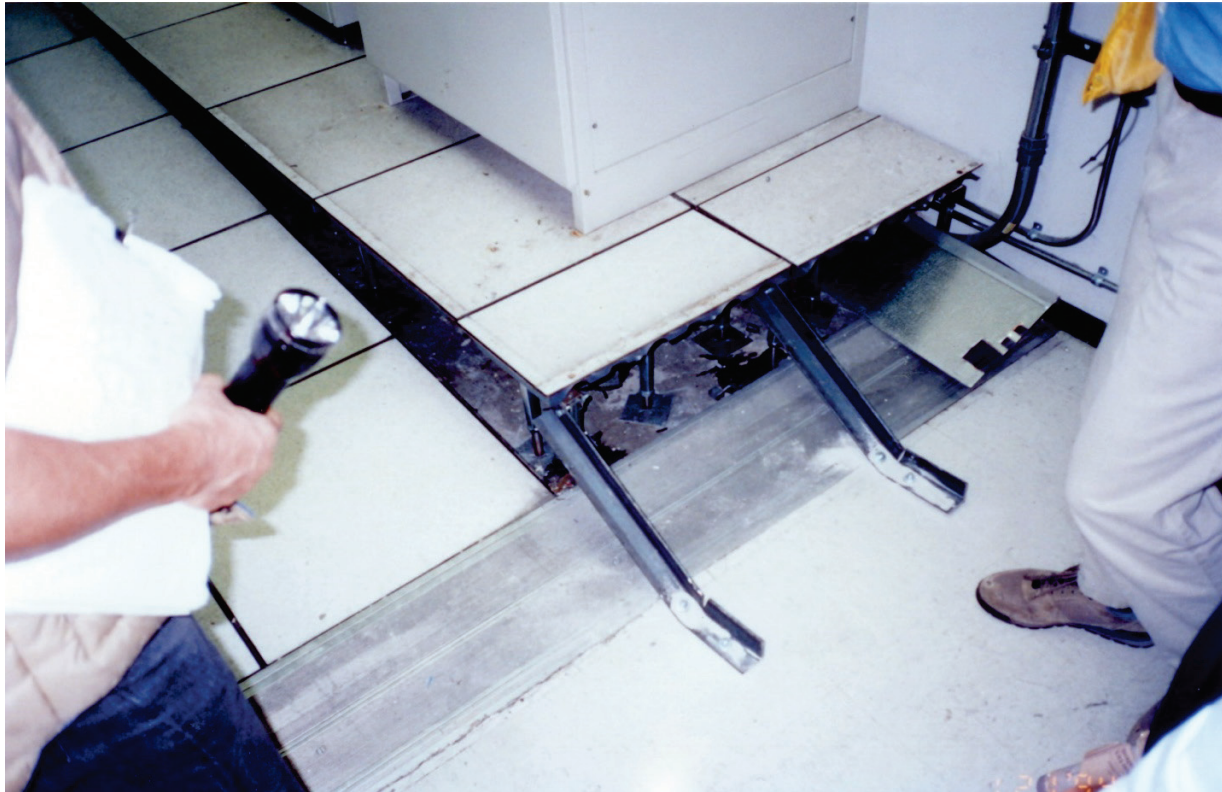
Figure 6.5.3.1-1 Temporary bracing for access floor collapsed in the 1994 magnitude-6.7 Northridge Earthquake (Photo courtesy of Wiss, Janney, Elstner Associates).

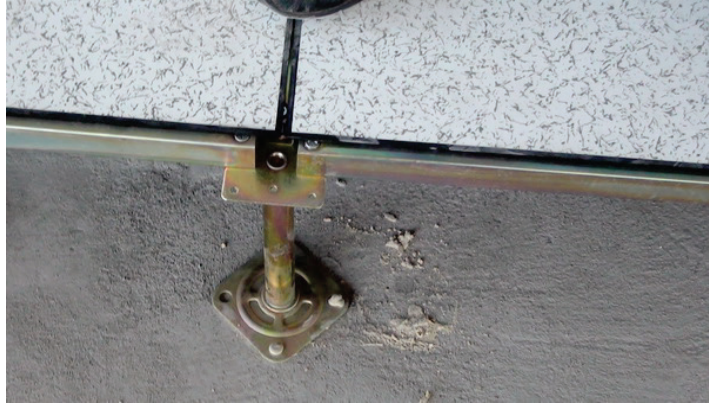
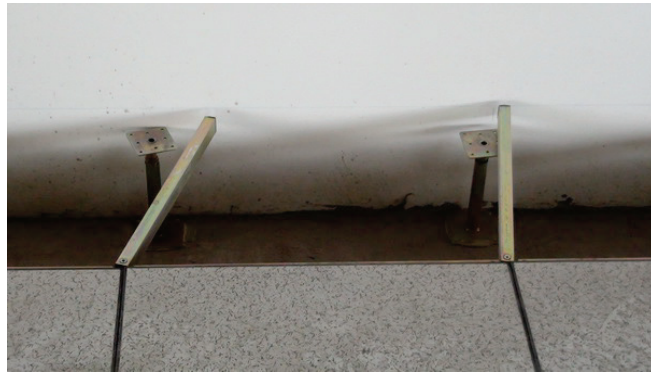
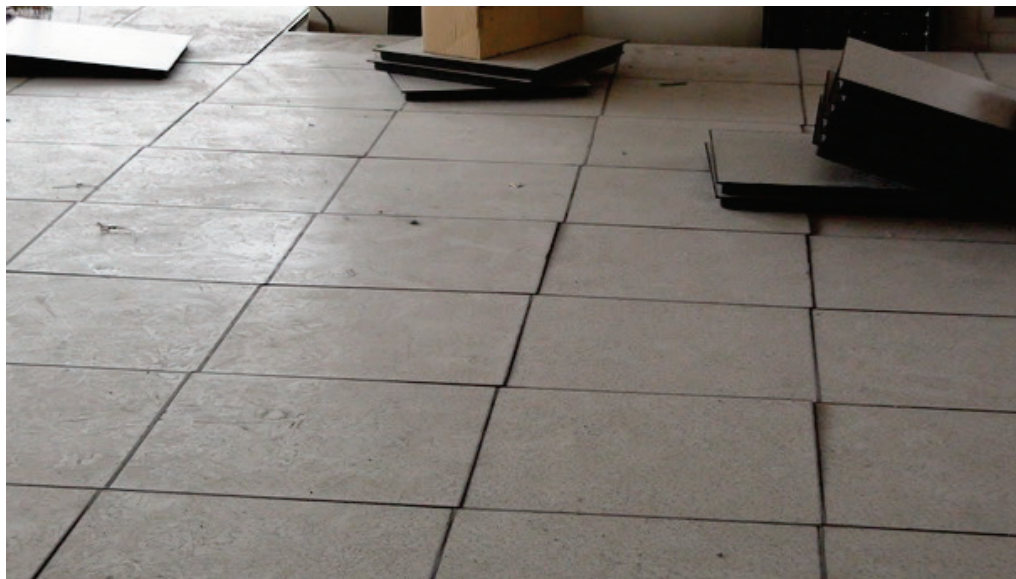
Figure 6.5.3.1-2 Damage to access floor with short anchored pedestals in the 2010 magnitude-6.7 Chile Earthquake; floor did not have lateral bracing. Note many tiles misaligned (Photos courtesy of Antonio Iruretagoyena, Rubén Boroschek & Associates).

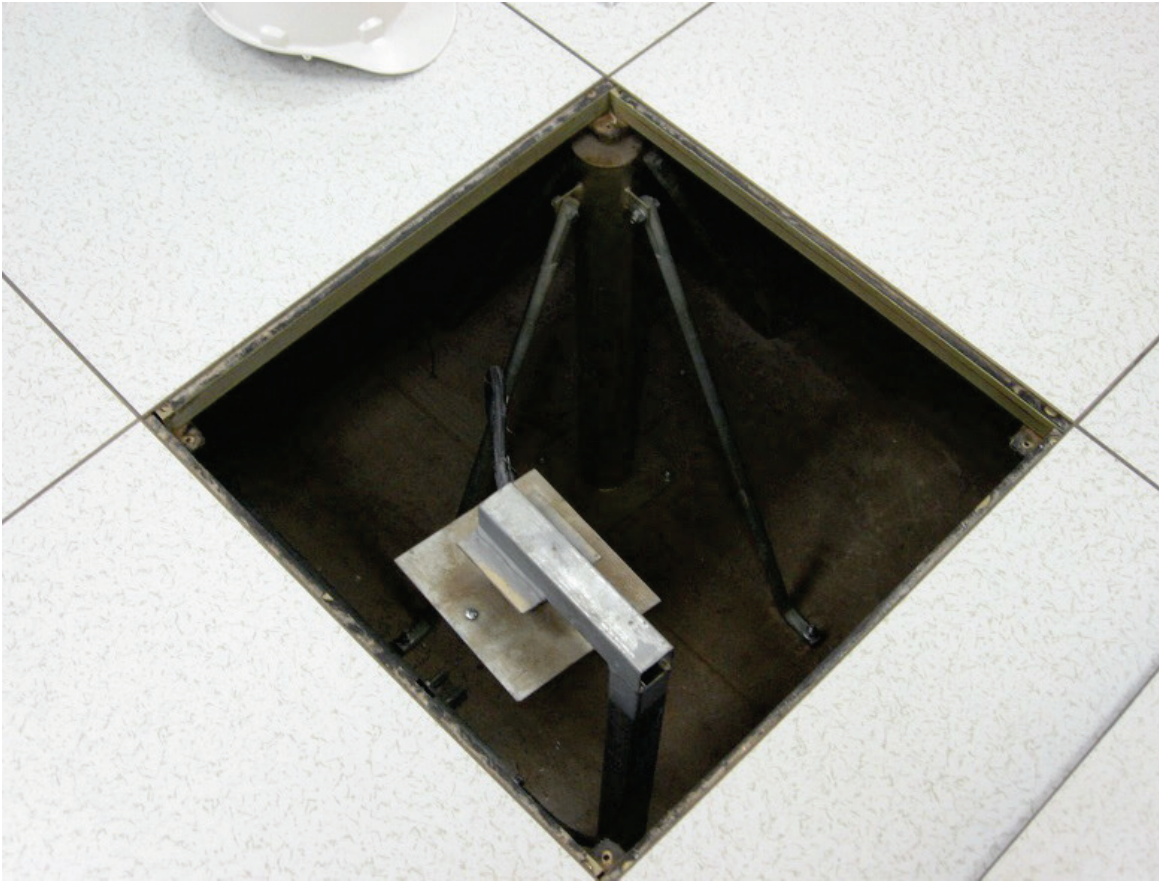
Figure 6.5.3.1-3 Undamaged access floor with braced pedestals in the 2010 Chile Earthquake (Photo courtesy of Rodrigo Retamales, Rubén Boroschek & Associates).

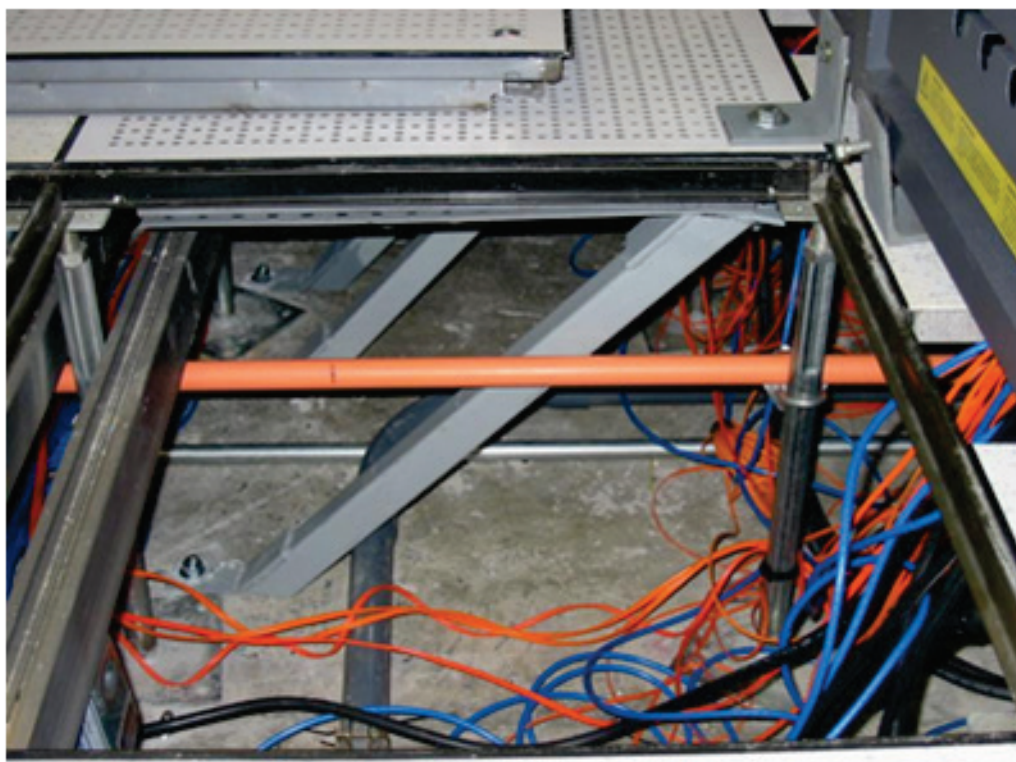
Figure 6.5.3.1-4 Raised floor braced with strut (Photo courtesy of Maryann Phipps, Estructure).

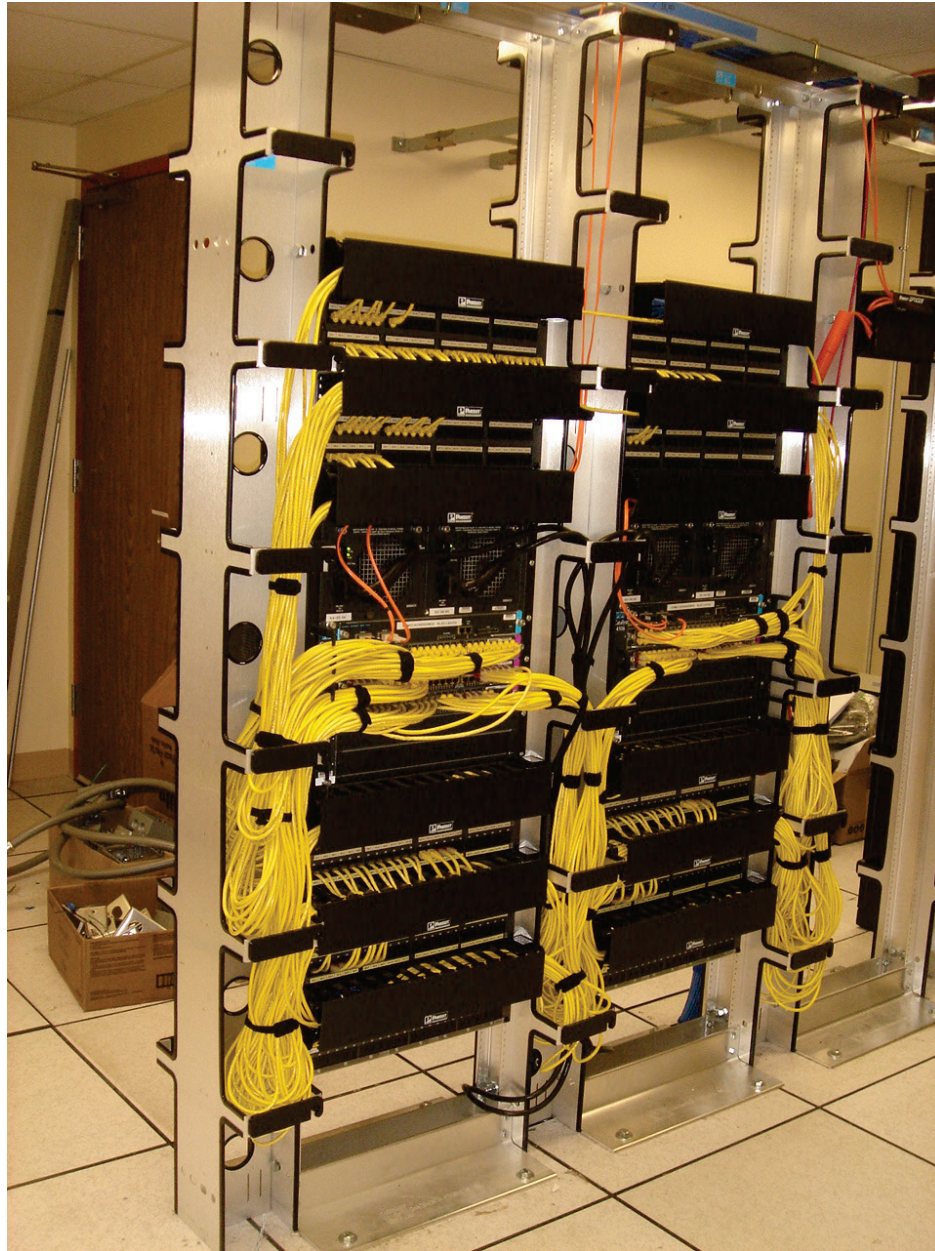
Figure 6.5.3.1-5 Data rack bolted through access floor to supplemental strut bracing below (Photo courtesy of Maryann Phipps, Estructure).

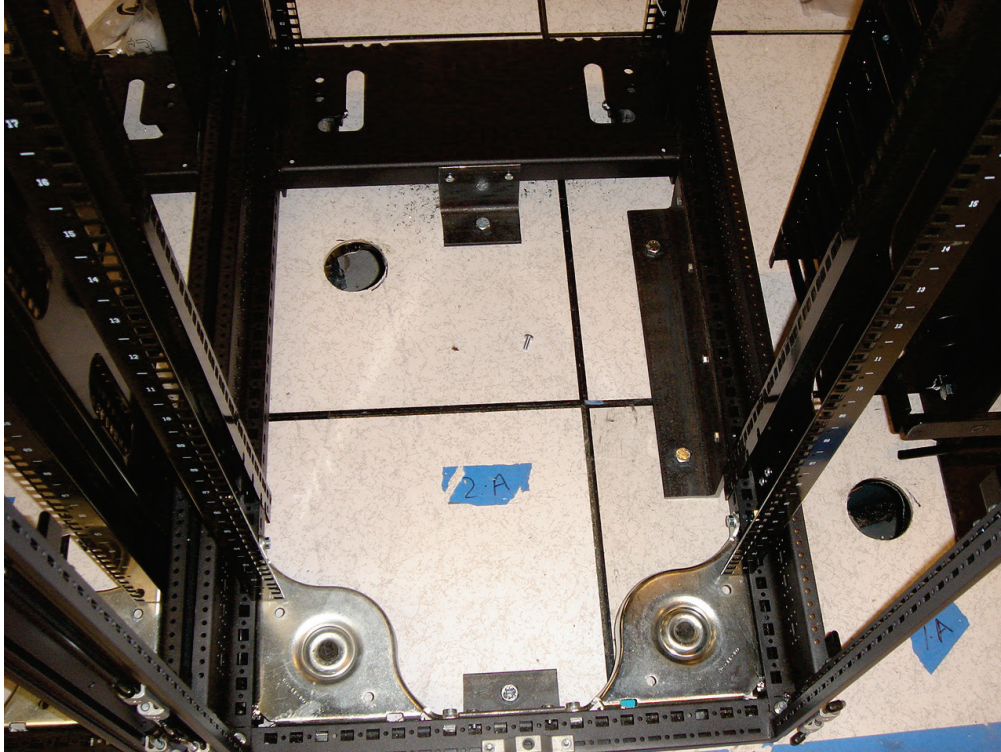
Figure 6.5.3.1-6 Base of data cabinet with supplemental angles bolted to strut bracing below floor (Photo courtesy of Maryann Phipps, Estructure).

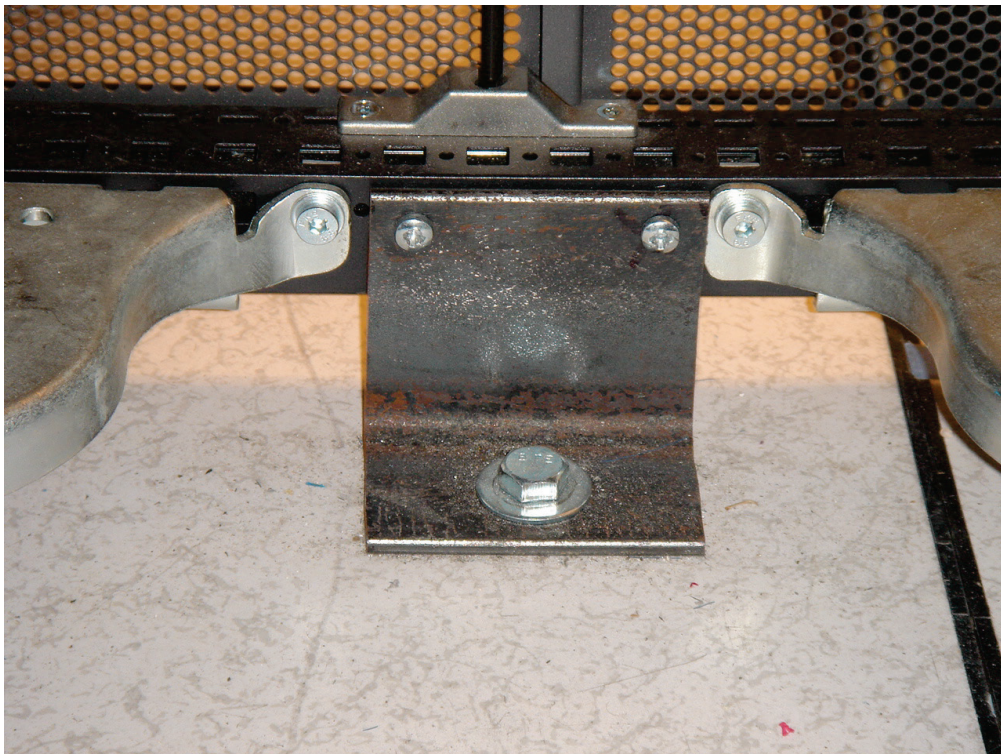
Figure 6.5.3.1-7 Close-up of supplemental angles connecting data cabinet to strut bracing below floor (Photo courtesy of Maryann Phipps, Estructure).

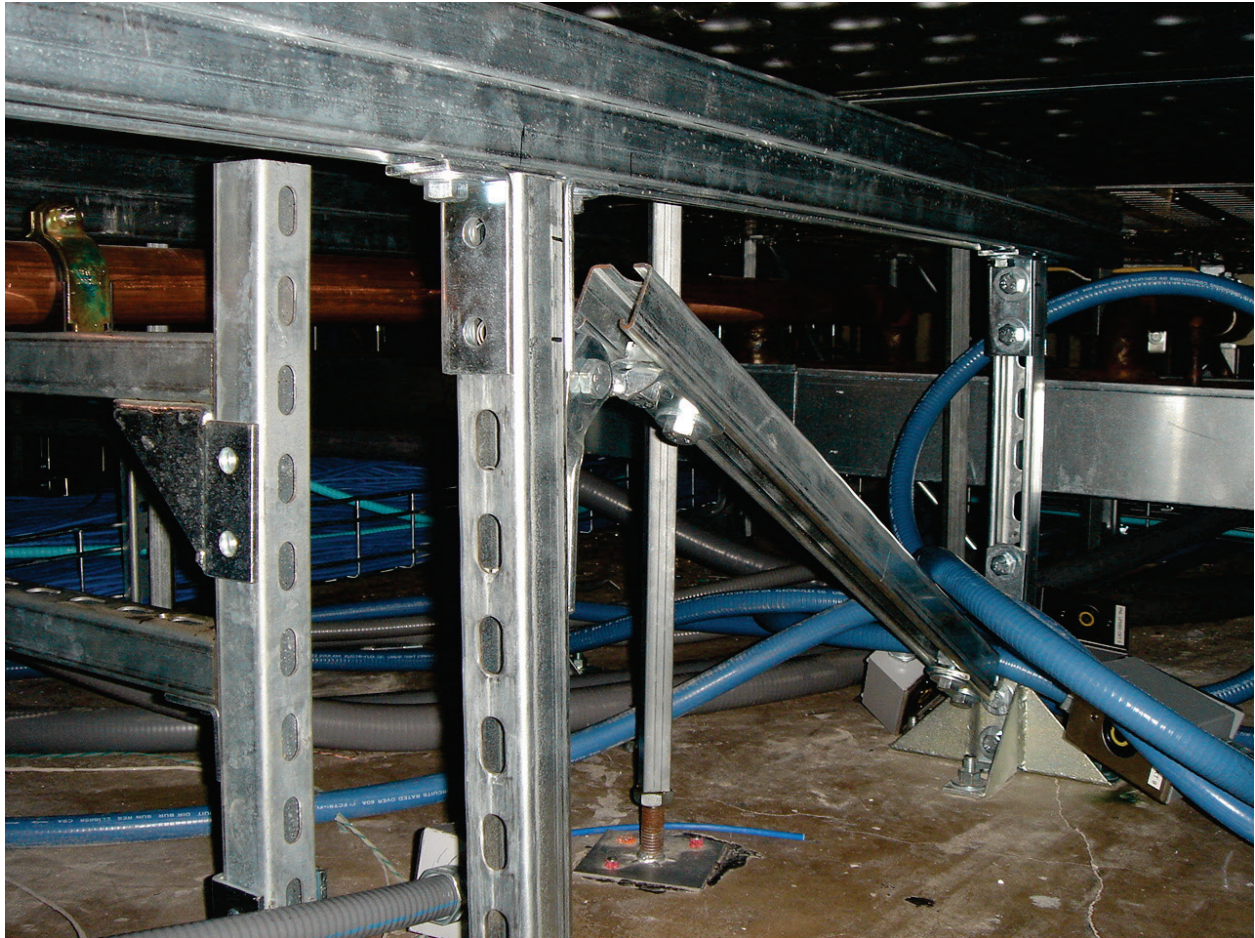
Figure 6.5.3.1-8 Strut framing added to brace data cabinet located on access floor. Bolts from angles above are connected to strut framing below (Photo courtesy of Maryann Phipps, Estructure).

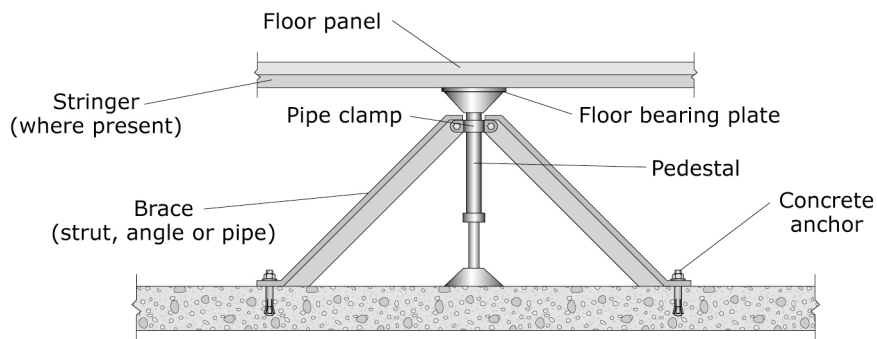
Cantilevered Access Floor Pedestal

Braced Access Floor Pedestal

(use for tall floors or where pedestals are not strong enough to resist seismic forces)

Note: For new floors in areas of high seismicity, purchase and install systems that meet the applicable code provisions for "special access floors."

Figure 6.5.3.1-9 Equipment mounted on access floor (ER).

- Access floor base pedestals should be anchored to the floor slab; taller pedestals may also need diagonal bracing. In zones of low or moderate seismicity, or where the floor height is less than 12 inches high, it may be feasible to adhere the pedestals to the floor slab rather than anchoring them. Check the internet for vendors who supply access floors with a seismic capacity rating.

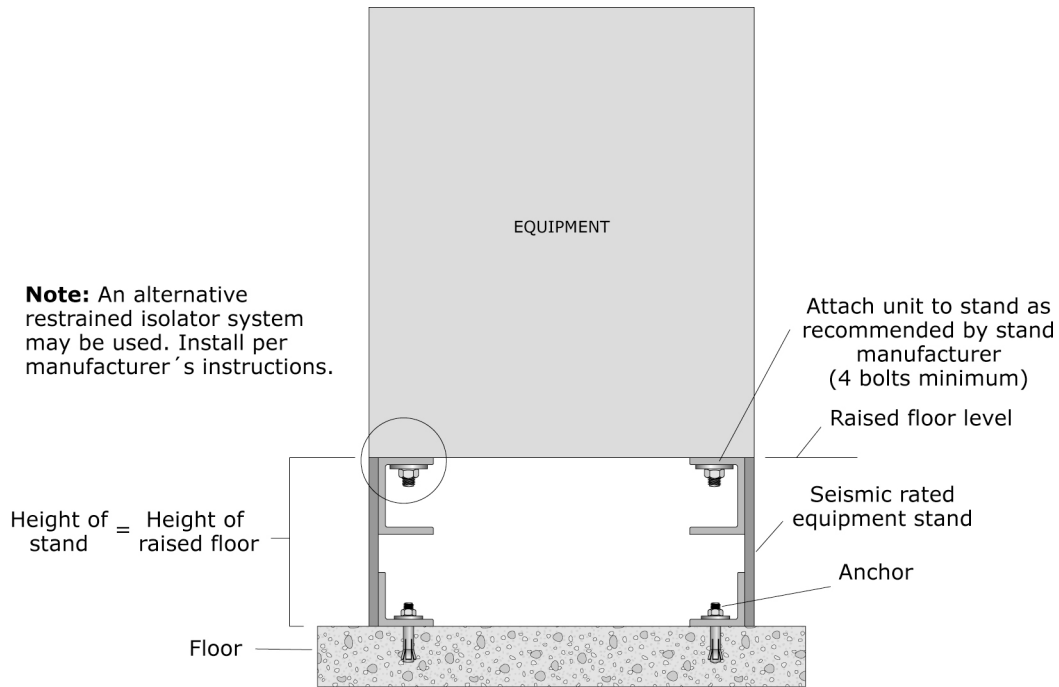
Equipment installed on an independent steel platform within a raised floor

Figure 6.5.3.1-10 Equipment mounted on access floor - independent base (ER).

- Equipment placed on access floors should be tethered; heavy equipment should be anchored to structural slab below. Anchorage may be accomplished through installation of an independent frame beneath the equipment. Alternatively, the equipment may be anchored to properly designed access floor framing, or supplemental bracing components.

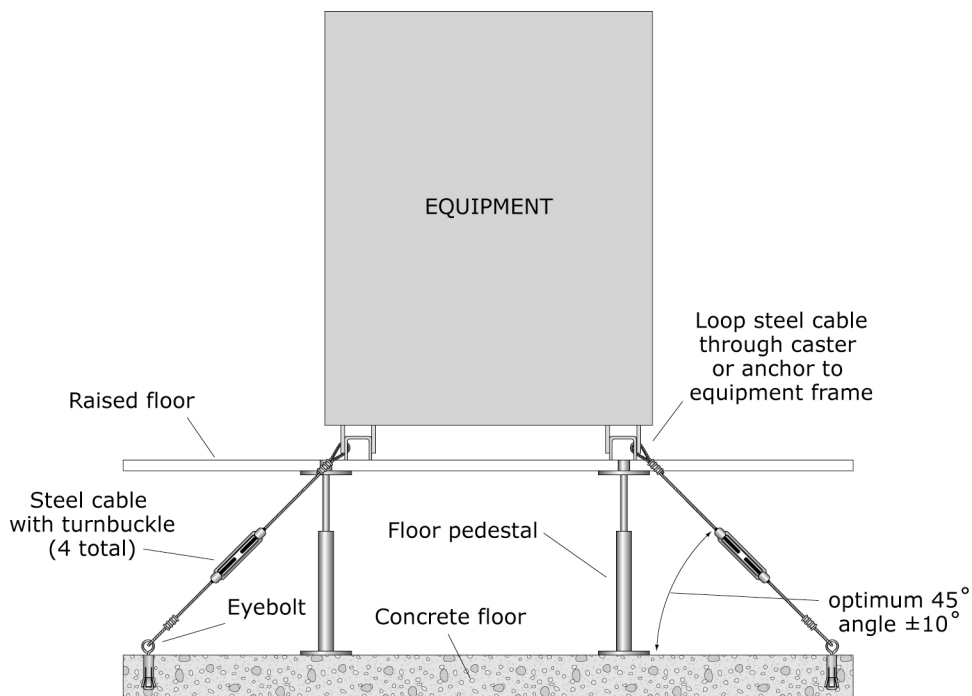
Equipment restrained with cables beneath a raised floor

Figure 6.5.3.1-11 Equipment mounted on access floor – cable braced (ER).

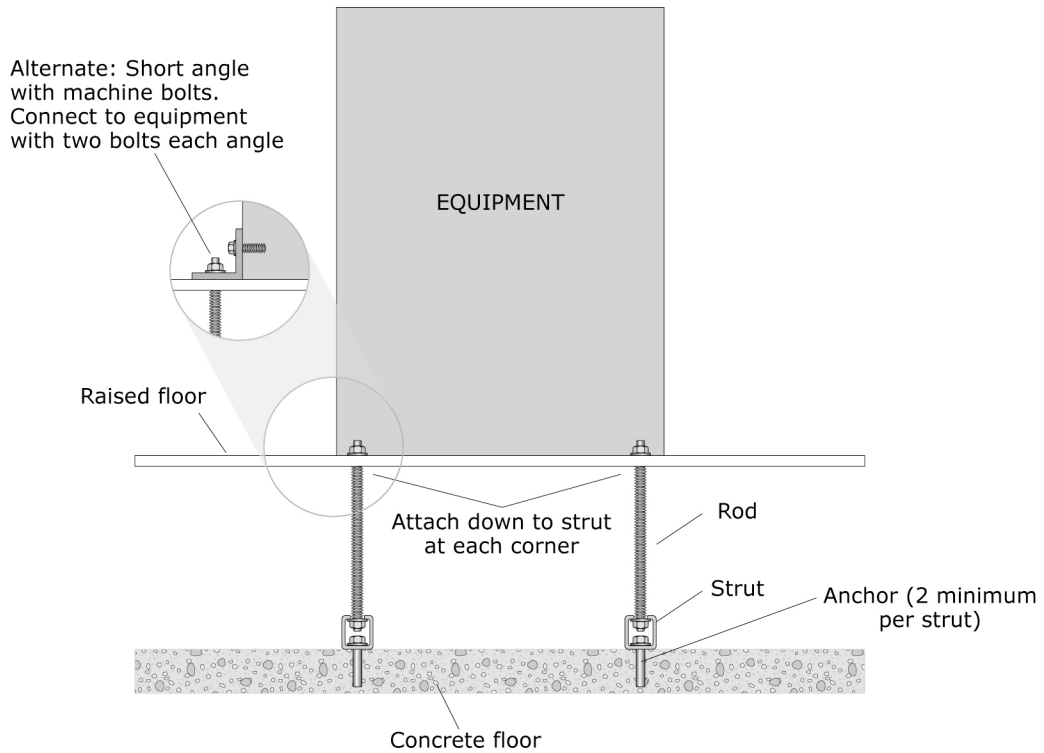
Equipment anchored with vertical rods beneath a raised floor

Figure 6.5.3.1-12 Equipment mounted on access floor – tiedown rods (ER).
