6.5 Furniture, Fixtures, Equipment and Contents

6.5.6 Miscellaneous Contents

6.5.6.3 Fragile Artwork

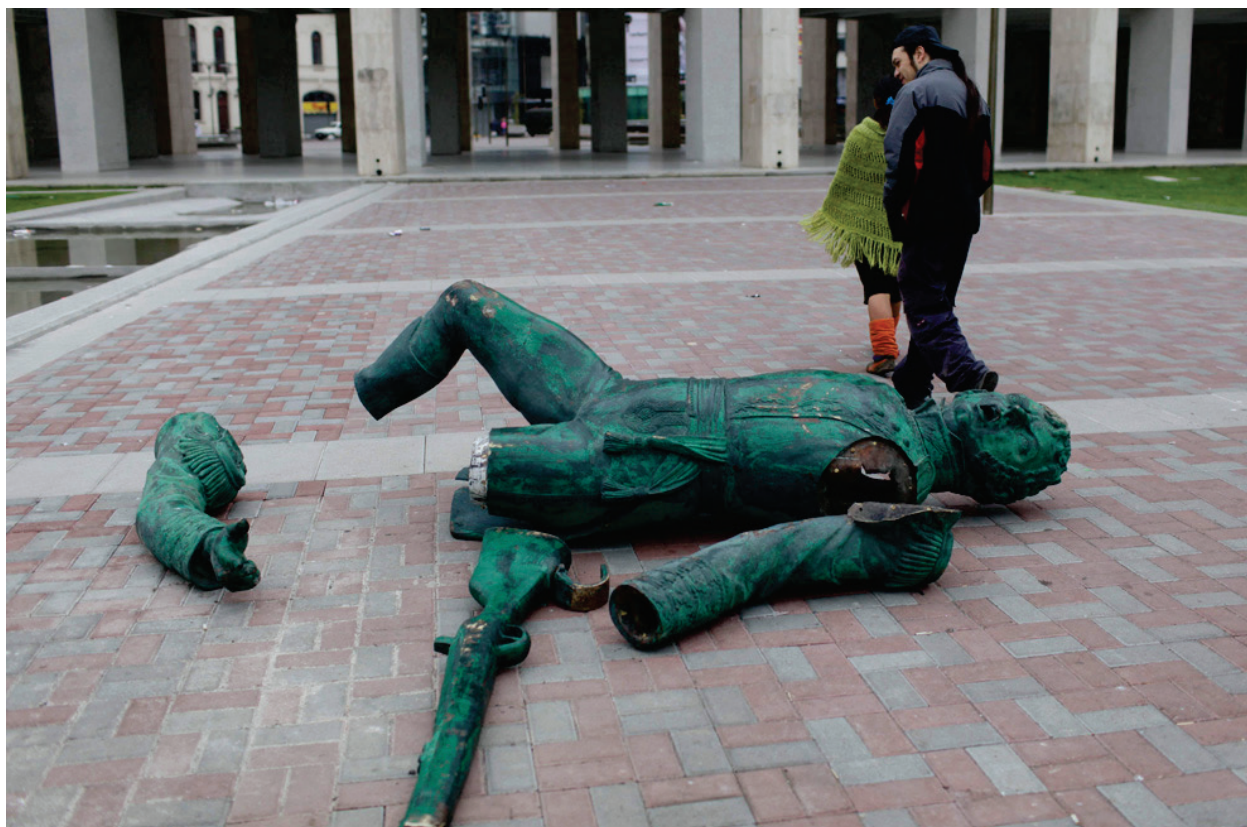
Figure 6.5.6.3-1 Fallen sculpture that collapsed in the 2010 Chile Earthquake (Photo by Natach Pisarenko, AP Photo).

- Loose items on shelves or hanging items may slide, bang, overturn or fall. Paintings or other wall hangings may fall. Sculptures may slide or fall due to shaking.

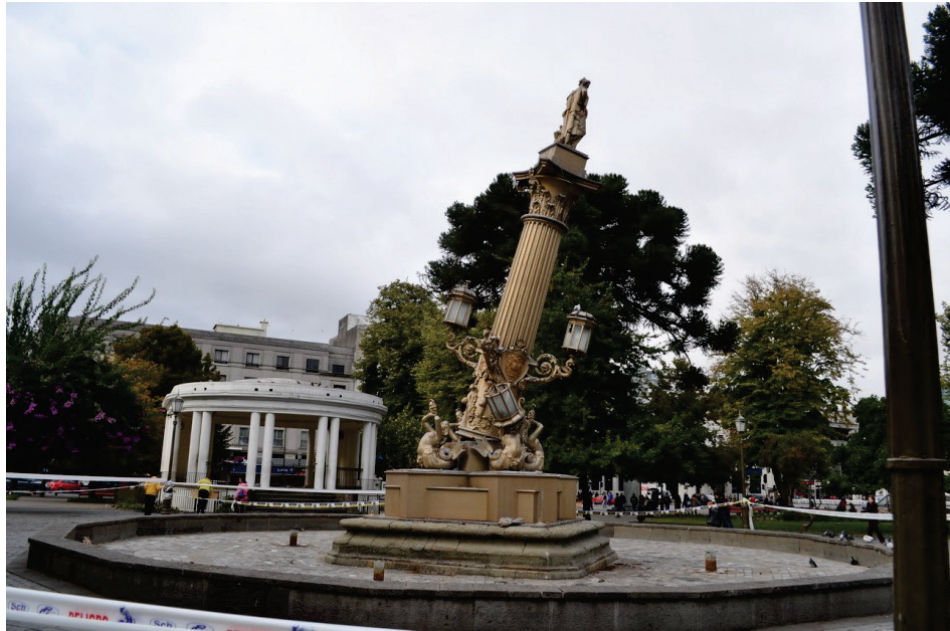
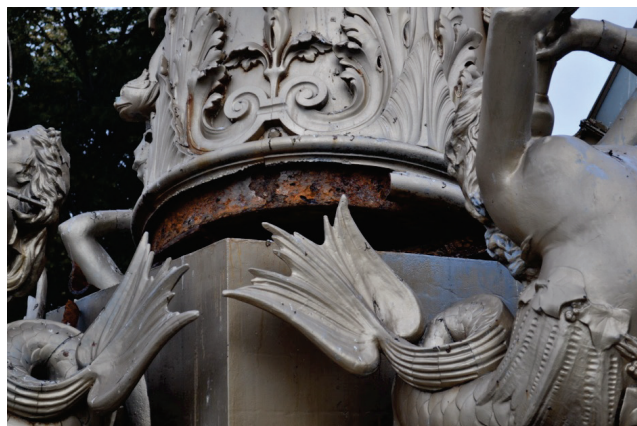
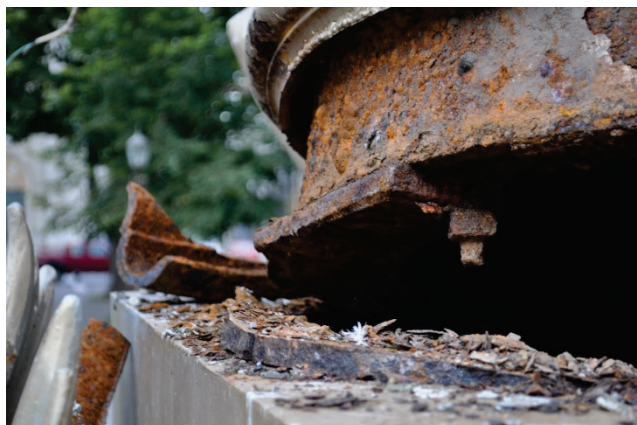
Figure 6.5.6.3-2 Leaning fountain after the 2010 Chile Earthquake; corrosion was a factor (Photos courtesy of Eduardo Fierro, BFP Engineers).

- Items hanging on walls should be secured with a positive attachment such as an eyebolt with closed wire loops. Ceramics, glassware, and decorative items on shelves should be individually restrained or provide edge restraint for the shelves. Items hanging from the ceiling should be anchored to structural framing; heavy items should not be located where they can swing and impact a window, wall, or other object. Provide positive restraint for statuary and large vases. Items displayed outdoors must be protected from corrosion and weathering; mounting and connection hardware should be corrosion resistant.

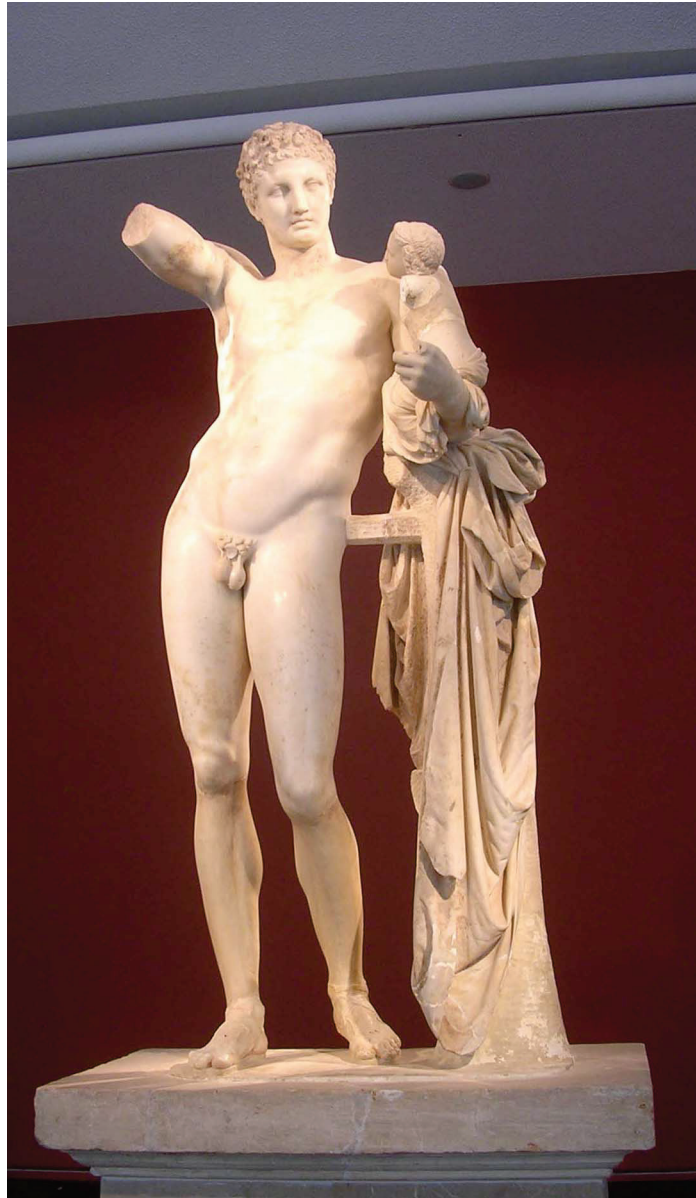
Figure 6.5.6.3-3a Seven foot tall marble statue located in the Archaeological Museum of Olympia, Greece (Photo courtesy of University at Buffalo).

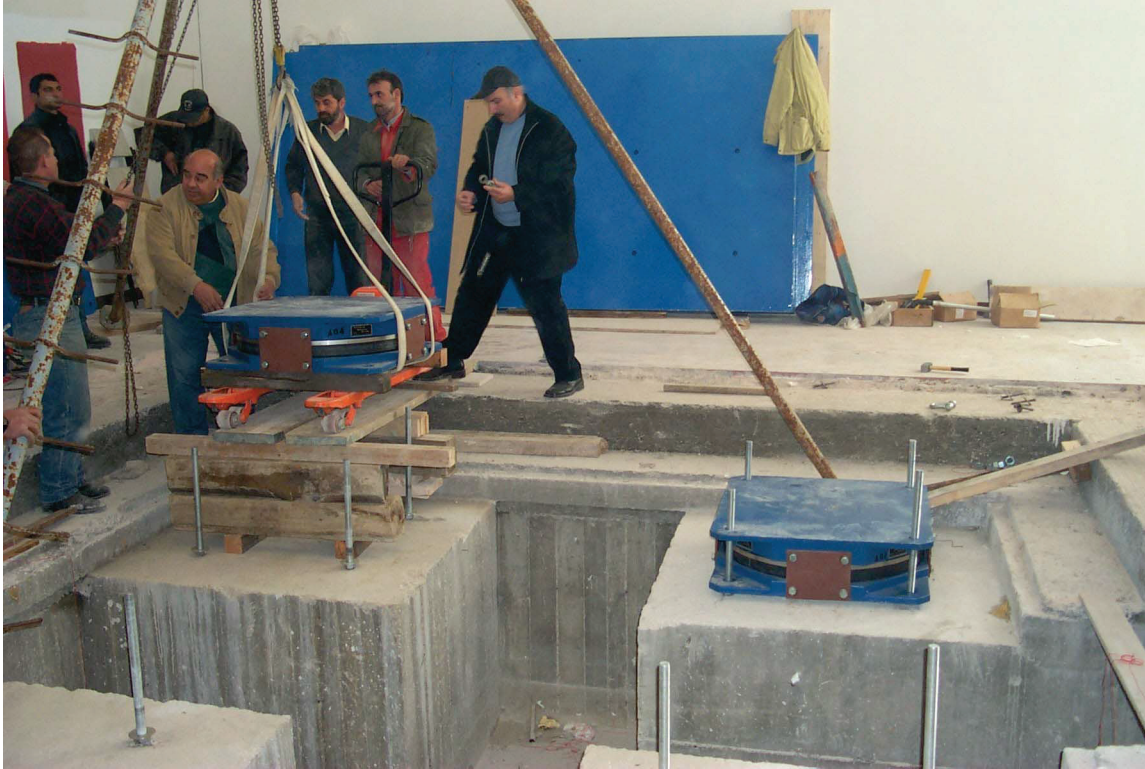
Figure 6.5.6.3-3b Installation of base isolation devices to support reinforced concrete slab for statue (Photo courtesy of University at Buffalo).

- Many proprietary safety straps, mats, small enclosures, base isolation platforms and other devices are available to protect fragile or expensive art, collectibles and other artifacts. Check the internet for available devices.

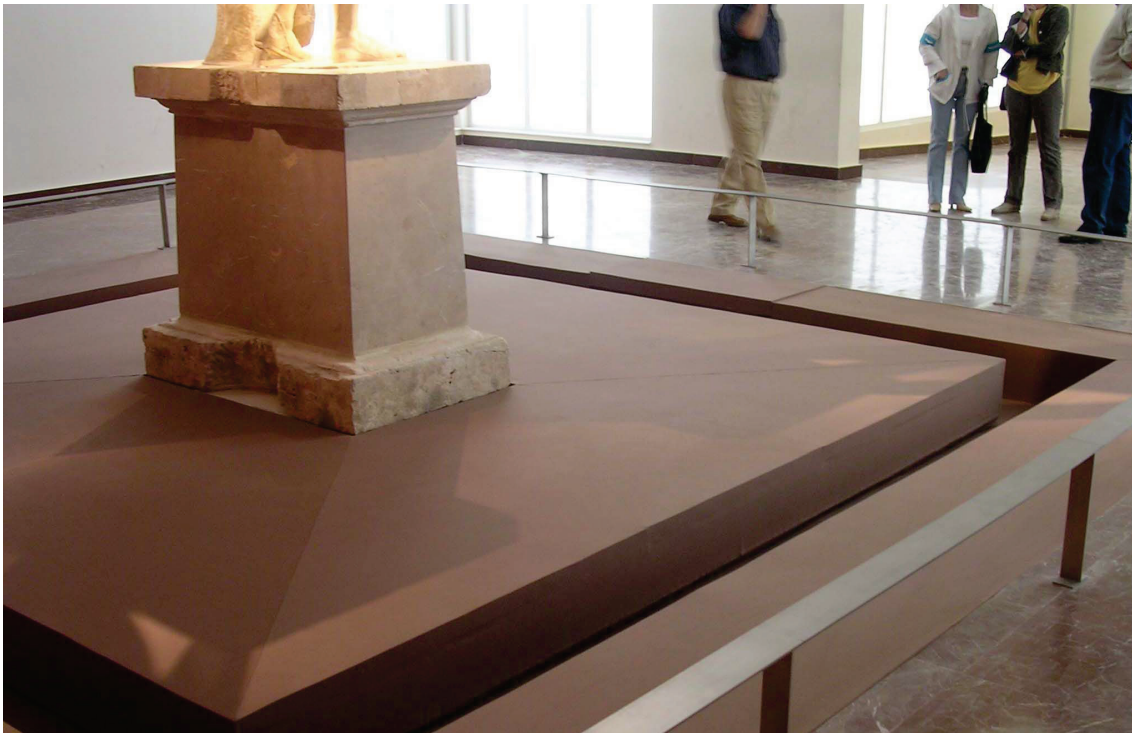
Figure 6.5.6.3-3c Completed installation of statue on platform with base isolation (Photo courtesy of University at Buffalo, SUNY).

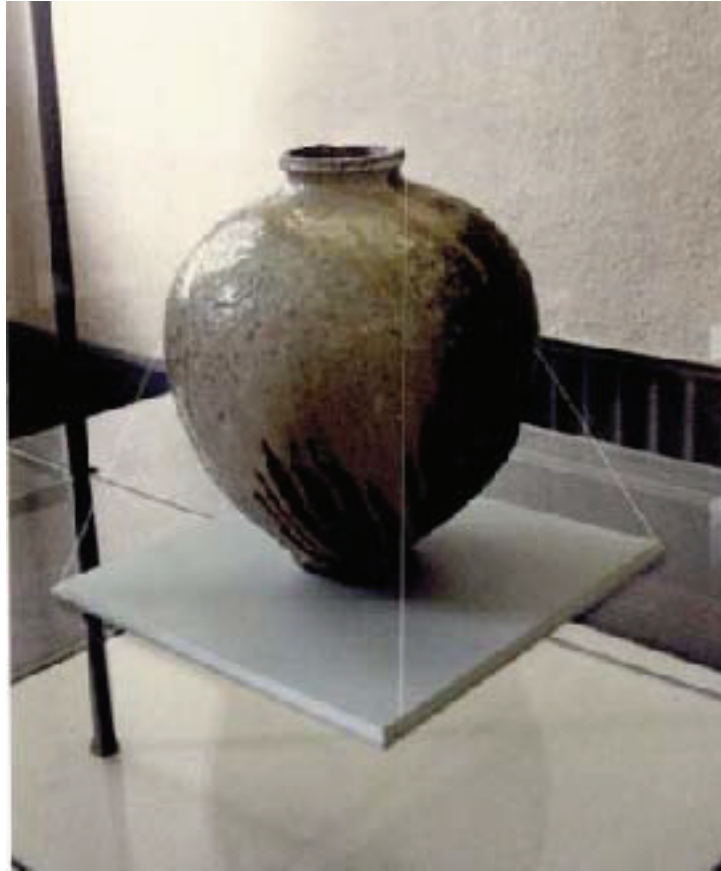
Figure 6.5.6.3-4 Seismic restraint of an object with artistic and historical value with nylon filament (fishing line) in the Tokyo Museum in Ueno Park (Photo courtesy of Robert Reitherman, CUREE).

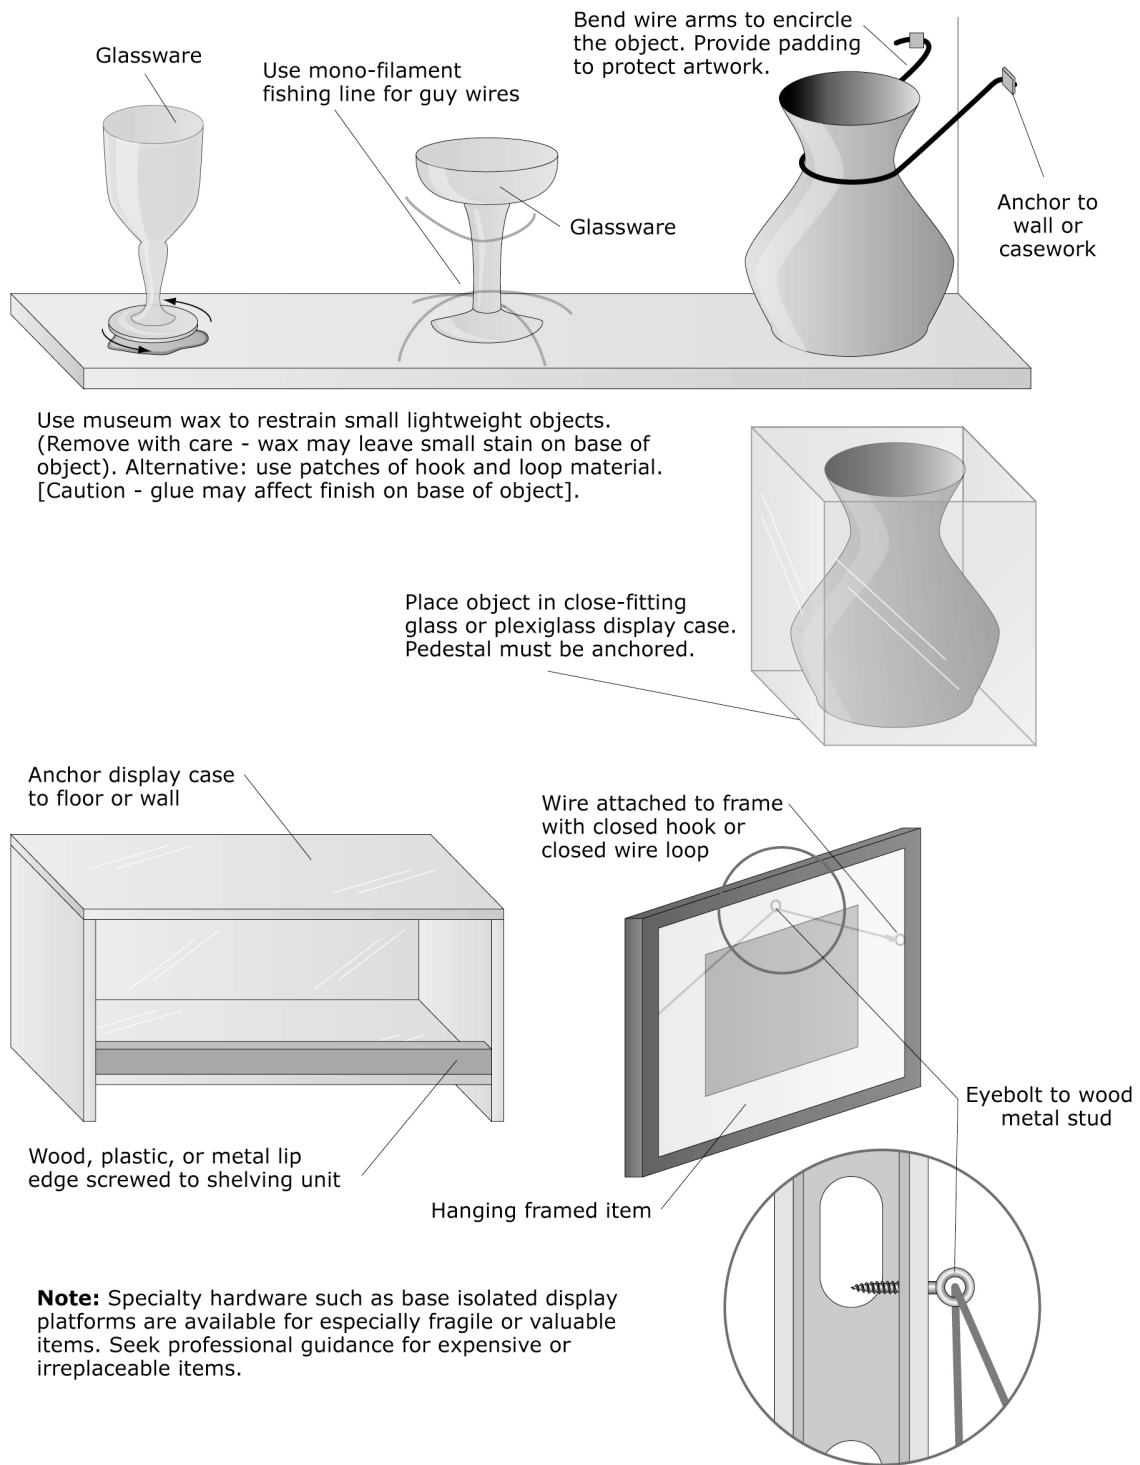
Figure 6.5.6.3-5 Fragile artwork restraints (NE).
