## 6.3 Architectural Components

### 6.3.2 Interior Partitions

#### 6.3.2.2 Interior Partition Walls, Light

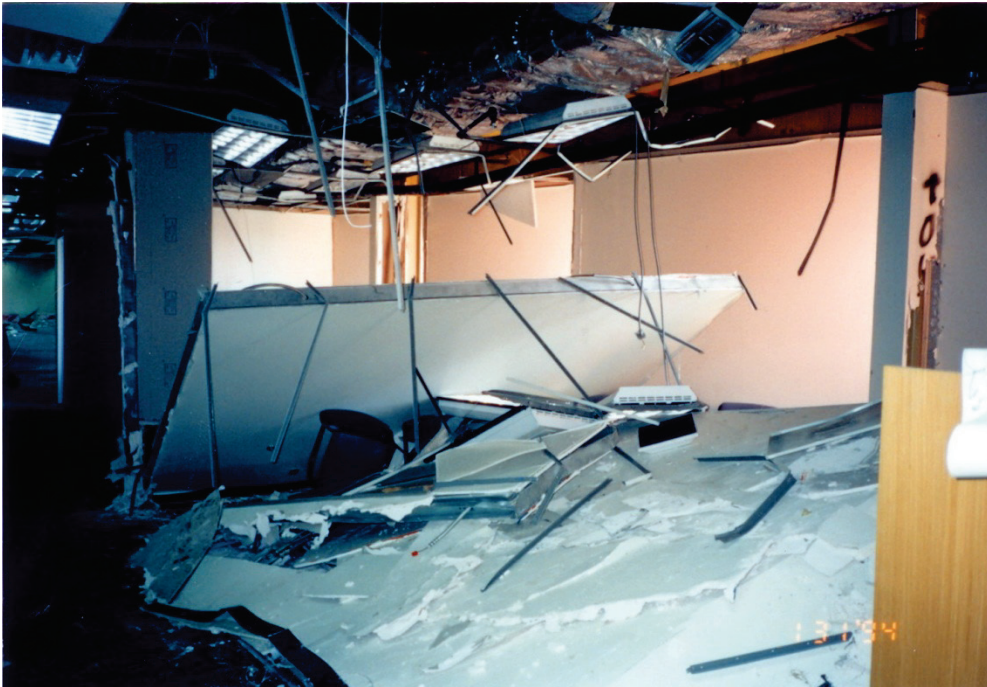
Figure 6.3.2.2-1 Out-of-plane failure of inadequately braced partial height metal stud partitions in the 1994 Northridge Earthquake (Photo courtesy of Wiss, Janney, Elstner Associates).

- Out-of-plane (perpendicular to the wall) damage is due to inertial loading on the wall from the floor accelerations (shaking). This loading is proportional to partition weight, so partitions with heavy finishes or hung book or storage shelves are more susceptible. Typically, damage from this loading occurs at the top connection of the partition to the structure or ceiling and may include local connection damage or complete failure leading to overturning of the partition. Such partition failures may create falling hazards, block corridors, and endanger occupants attempting to exit from damaged buildings.

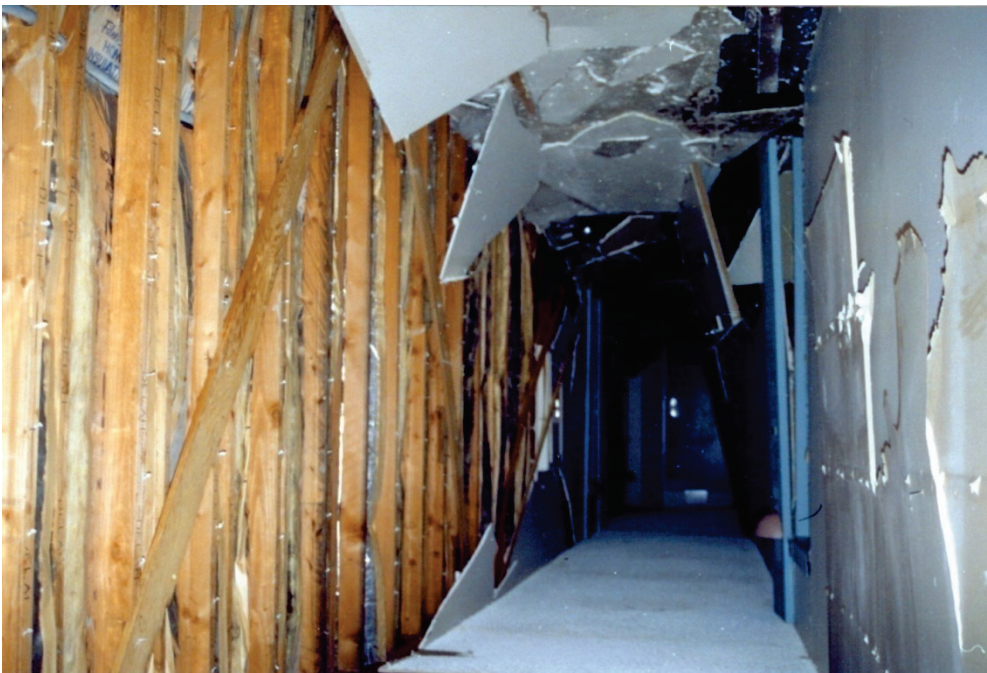
Figure 6.3.2.2-2 In-plane damage to wood stud wall spanning floor-to-floor caused by differential movement between the two floors in the 1994 Northridge Earthquake (Photo courtesy of Wiss, Janney, Elstner Associates).

- In-plane (parallel with the wall) damage can occur to light partitions as a result of deformations of the structure (drift). Full-height partitions in flexible structures may be damaged in this way unless they are isolated from the building deformations. Typical damage consists of cracked or spalled finishes, deformed partition framing, and failed connections. Damage to ceilings may occur at partial height partitions, due to the in-plane stiffness of the partition and the flexibility of the ceiling suspension and bracing.

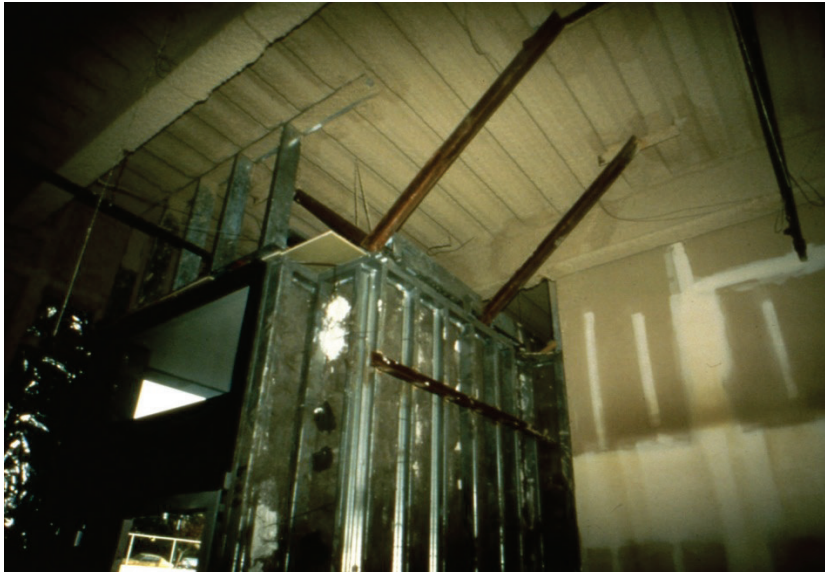
Figure 6.3.2.2-4 Bracing of partial height stud partition (Photo courtesy of Degenkolb Engineers).

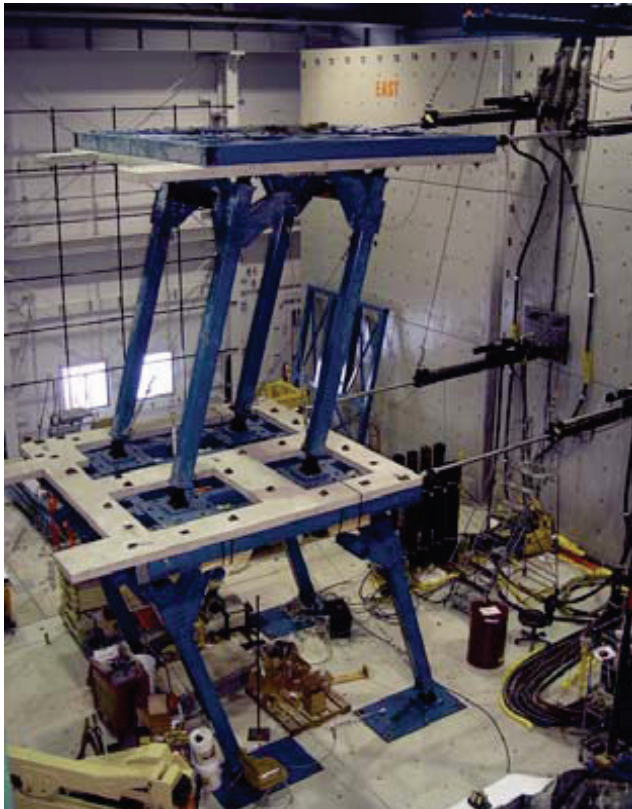
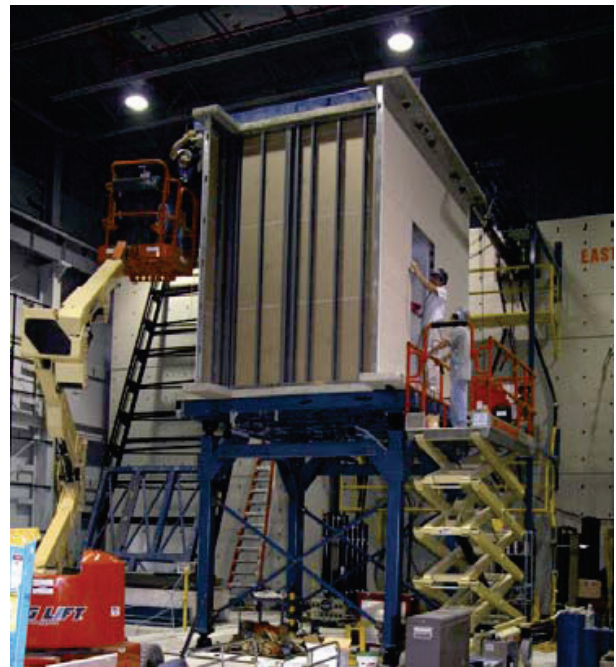
Figure 6.3.2.2-5 Two-story nonstructural component simulator at the University of Buffalo, SUNY shown at left. Preparation for dynamic testing of stud partitions for the NEES Nonstructural Project shown at right. Tests such as these improve understanding of the seismic behavior of nonstructural components (Photos courtesy of University of Buffalo, SUNY).
