6.3 Architectural Components

6.3.2 Interior Partitions

6.3.2.3 Glazed Partitions

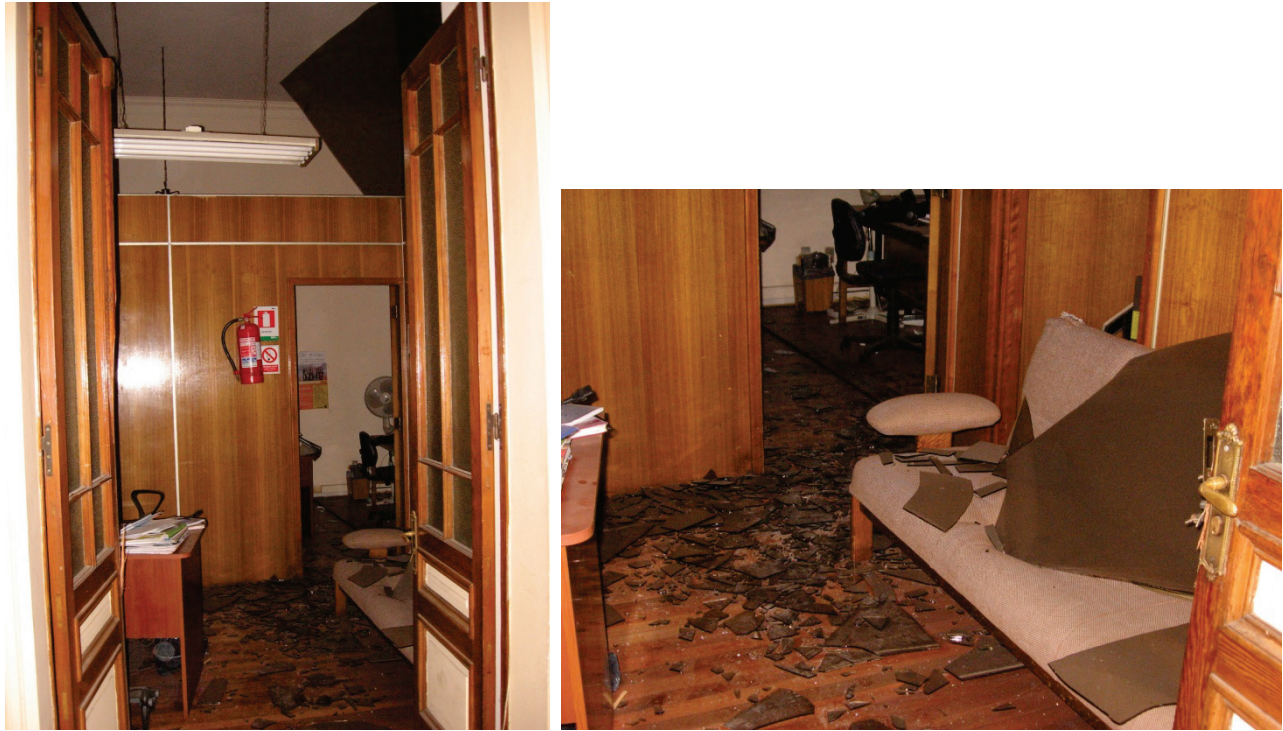
Figure 6.3.2.3-1 Glass shards fallen from the top of partial height office partitions in the reception area during the magnitude-8.8 2010 Chile Earthquake (Photo courtesy of Rodrigo Retamales, Rubén Boroscchek & Associates).

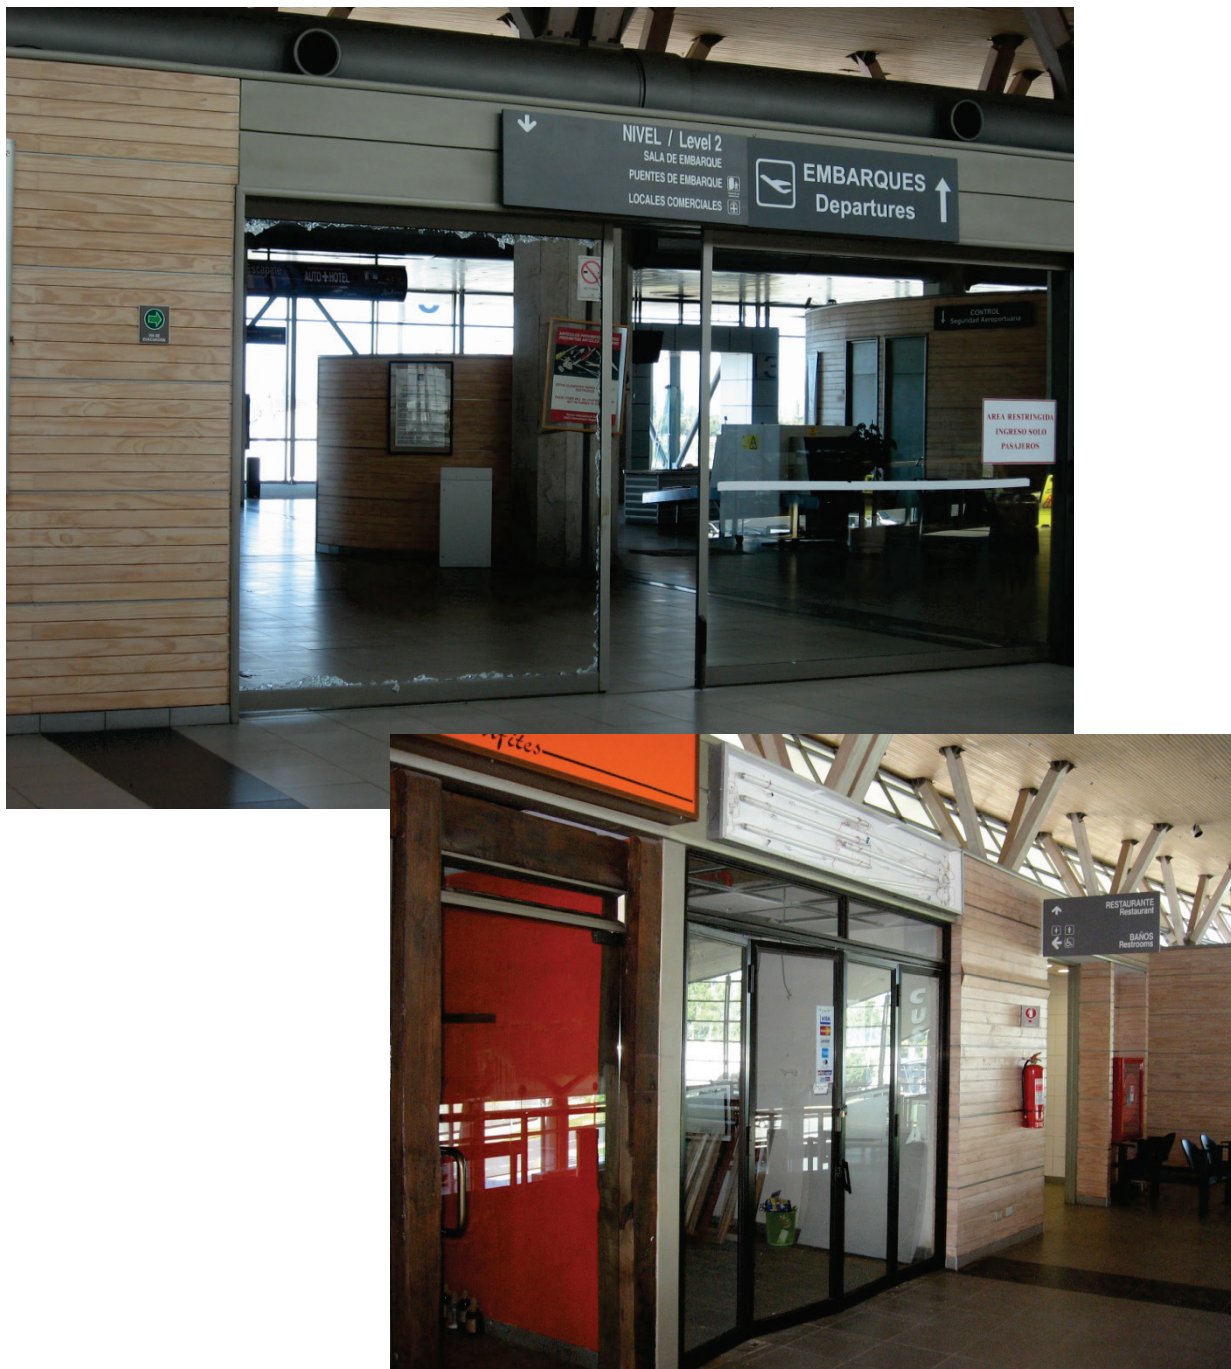
Figure 6.3.2.3-2 Damage to glazed doors at the Concepción airport in the 2010 Chile Earthquake. In the top photo the glazing in the sliding glass door shattered; in the lower photo the glass is intact but the door frames are misaligned (Photos courtesy of Rodrigo Retamales, Rubén Boroschek & Associates).

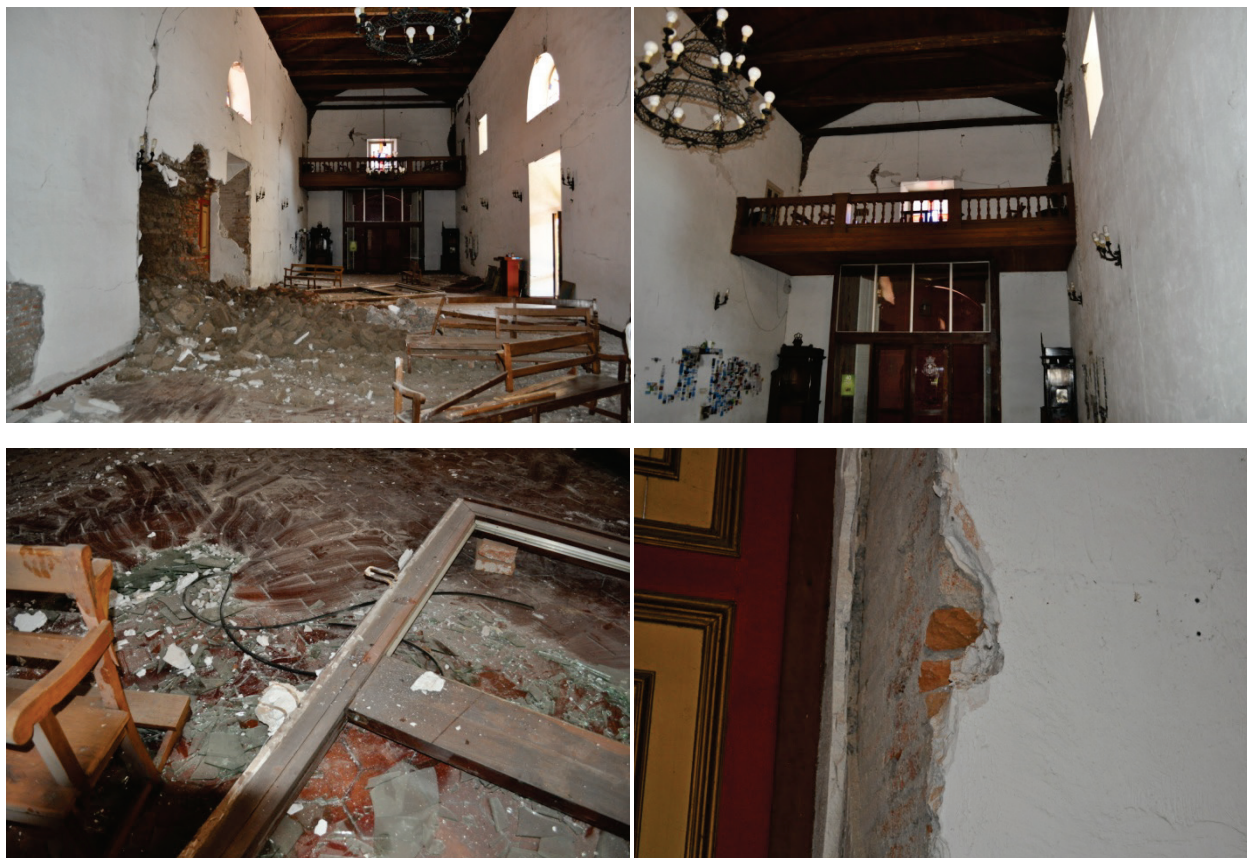
Figure 6.3.2.3-3 Failed wood framed glazing assembly in the 2010 Chile earthquake (Photo courtesy of Eduardo Fierro, BFP Engineers). The wood framing was held in place by metal or rebar brackets embedded in the masonry wall. The adobe wall on the left of the door collapsed and the brackets on the right side pulled out of the brick masonry wall (lower right). The glazing assembly at the rear entrance of the chapel was anchored overhead to the wood balcony framing and was undamaged.

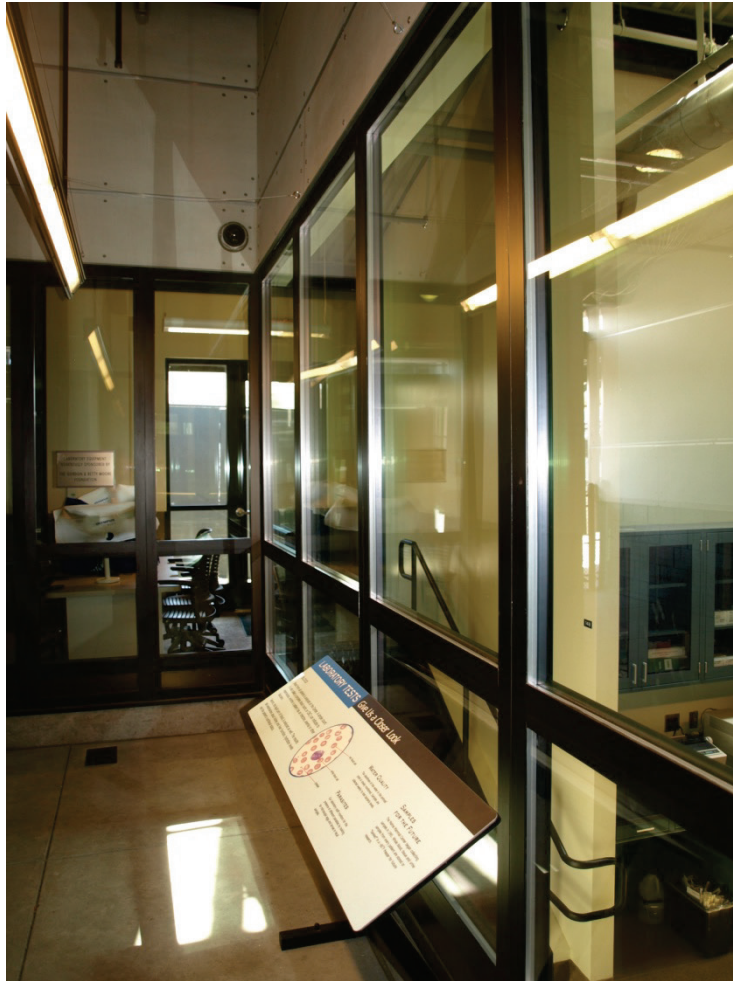
Figure 6.3.2.3-4 Glazed partition supported at base with slip track at top; partition above glazing suspended and braced from above. Glazing subdivided into relatively small panels with ample clearance at mullions (Photo courtesy of Cynthia Perry, BFP Engineers).

have an adequate lintel so the weight does not bear on the glazing or mullions. A deep leg slip track could be installed either at the top of the mullion or at the structure above, depending on the structural framing configuration. Note that because glazed partitions must meet the seismic drift limits for glass components, glazed partitions may require additional or different bracing than a similar partition without glazing. Also note that where the partition is properly detailed to be isolated from the seismic inter-story drift of the surrounding structure, the glass-to-frame clearance required around each pane of glazing is reduced. Special care should be given when detailing glass on intersecting planes such as corners and reentrant corners as these locations are particularly vulnerable to damage.

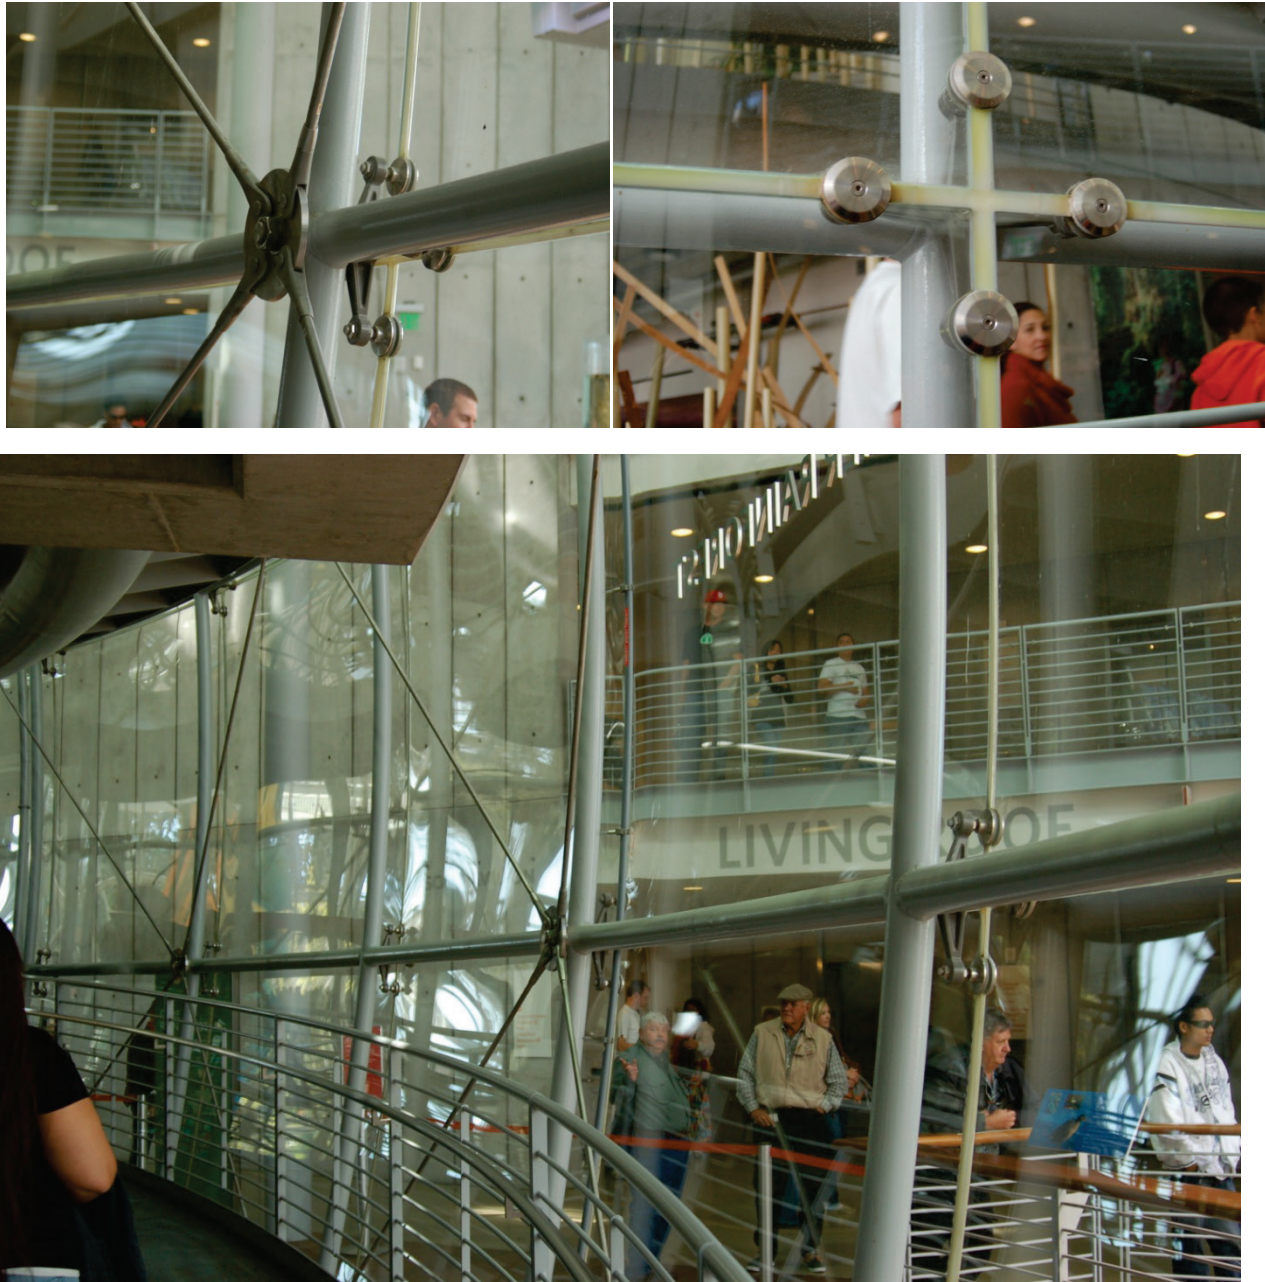
Figure 6.3.2.3-5 Specialized glazing details for glass dome using specialty hardware, such as large sealant joints required to accommodate thermal movement and seismic deformations at the California Academy of Sciences, San Francisco, California (Photos courtesy of Cynthia Perry, BFP Engineers).

- All glass assemblies have become common for enclosing lobby areas or atria in large commercial buildings. These typically are suspended from specially designed steel framing and may include details such as glass fins and steel connecting hardware. These assemblies are typically left free to slip at the bottom and must be specially detailed at edges and corners to avoid impact with adjacent panes.
