## 6.3 Architectural Components

### 6.3.4 Ceilings

#### 6.3.4.2 Ceilings applied Directly to Structure

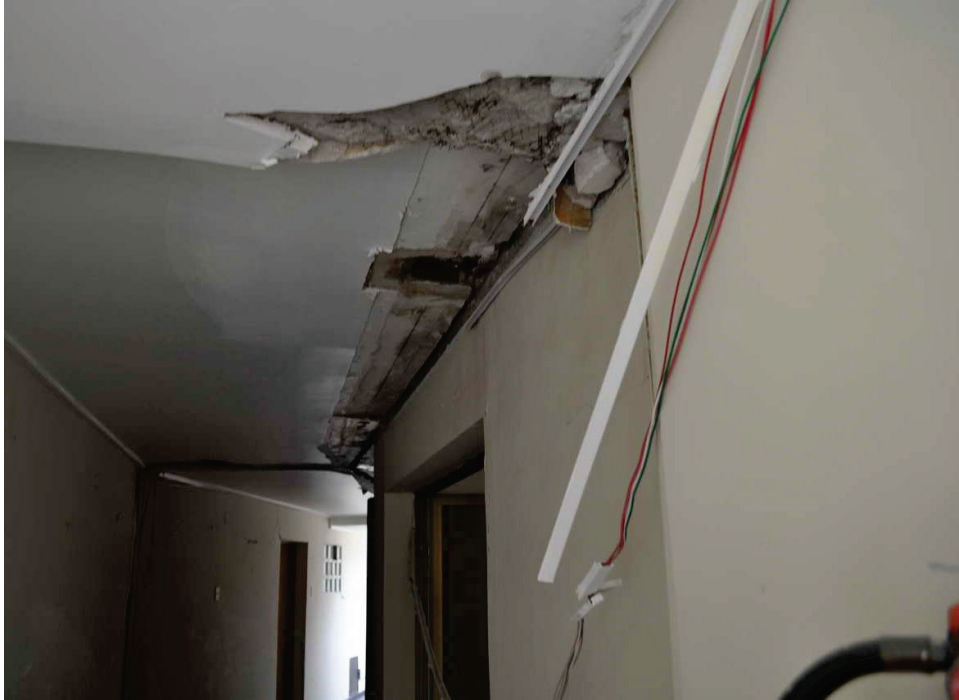
Figure 6.3.4.2-1 Damage to metal lath and plaster ceiling applied to the underside of the concrete slab in 10-story residential building in the 2010 magnitude-8.8 Chile Earthquake (Photo courtesy of Eduardo Fierro, BFP Engineers). The damage occurred due to pounding at the interface between two wings of the structure.

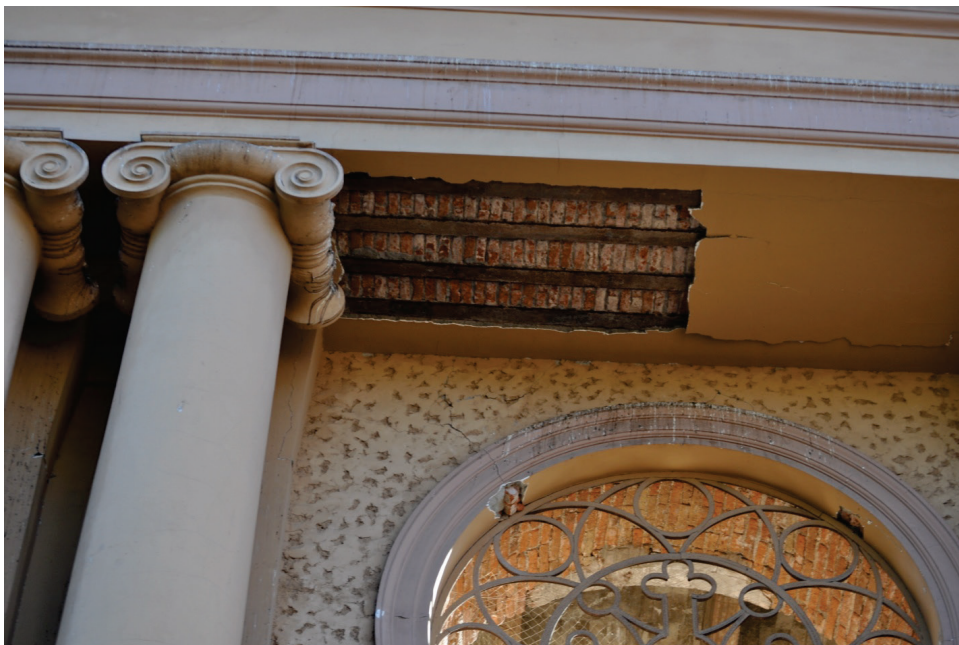
Figure 6.3.4.2-2 Damage to stucco soffit of historic church in the 2010 Chile Earthquake (Photo courtesy of Eduardo Fierro, BFP Engineers). Stucco applied directly to the underside of the slab above without furring; portion at left has fallen, portion at right delaminated.

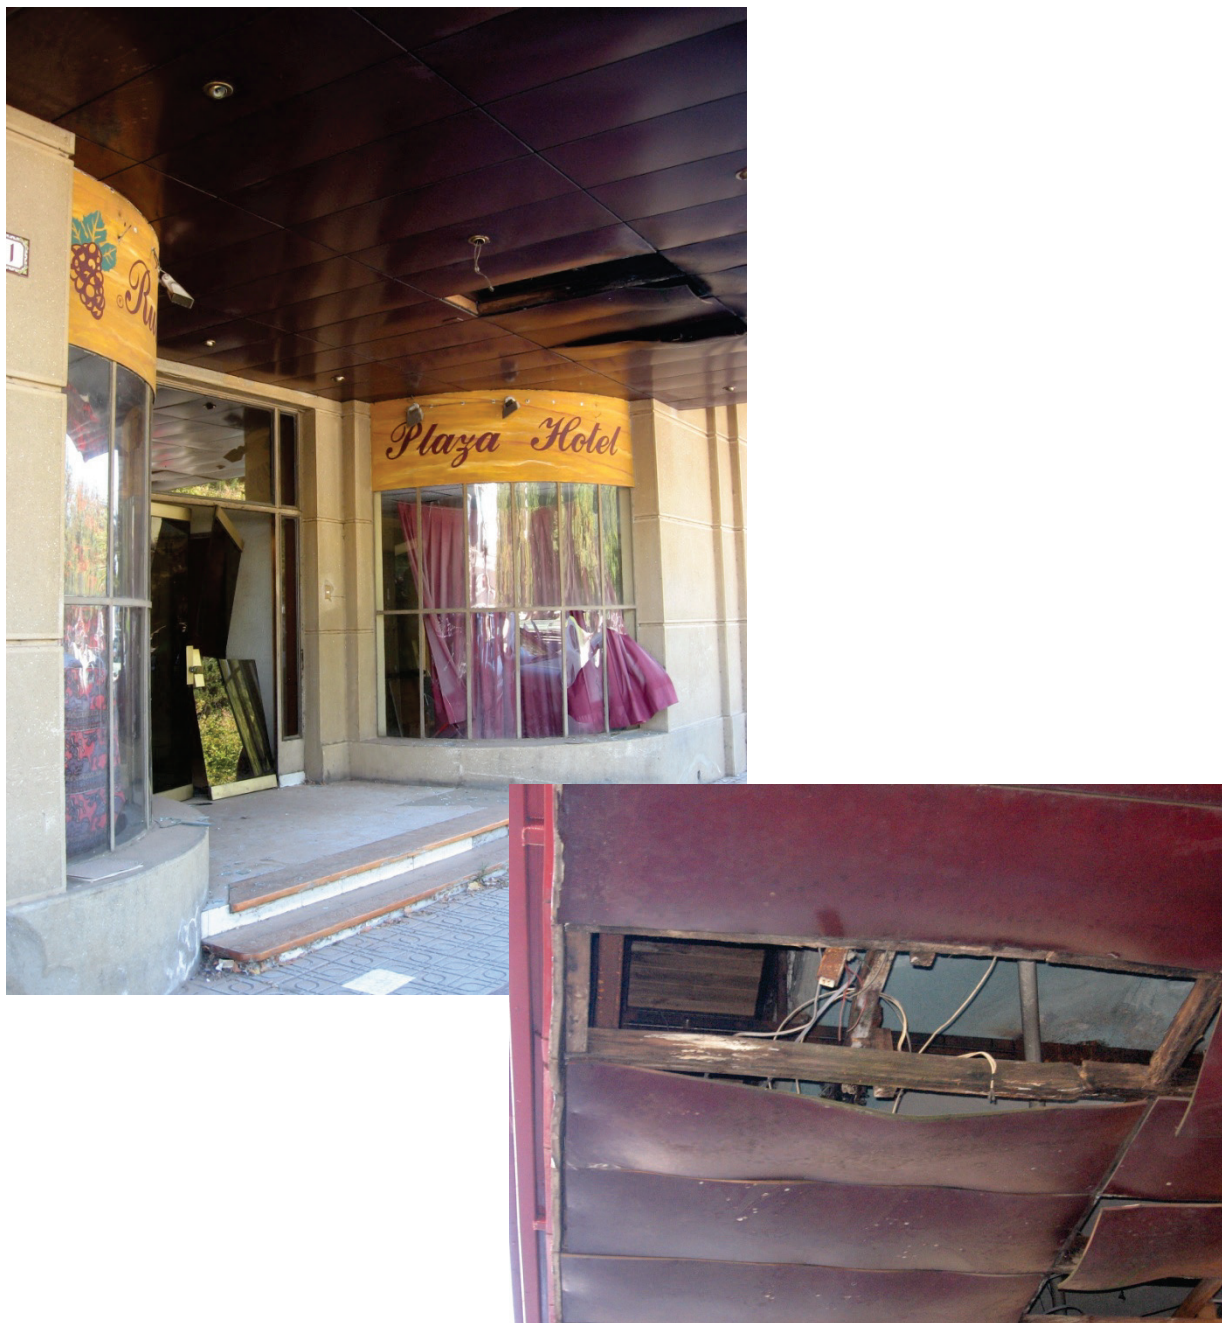
Figure 6.3.4.2-3 Damage to soffit paneling and wood framing at hotel in the 2010 Chile Earthquake; panels and wood framing show signs of prior water damage and deterioration. Note also damage to storefront glazing and glass doors (Photos courtesy of Rodrigo Retamales, Rubén Boroschek & Associates).

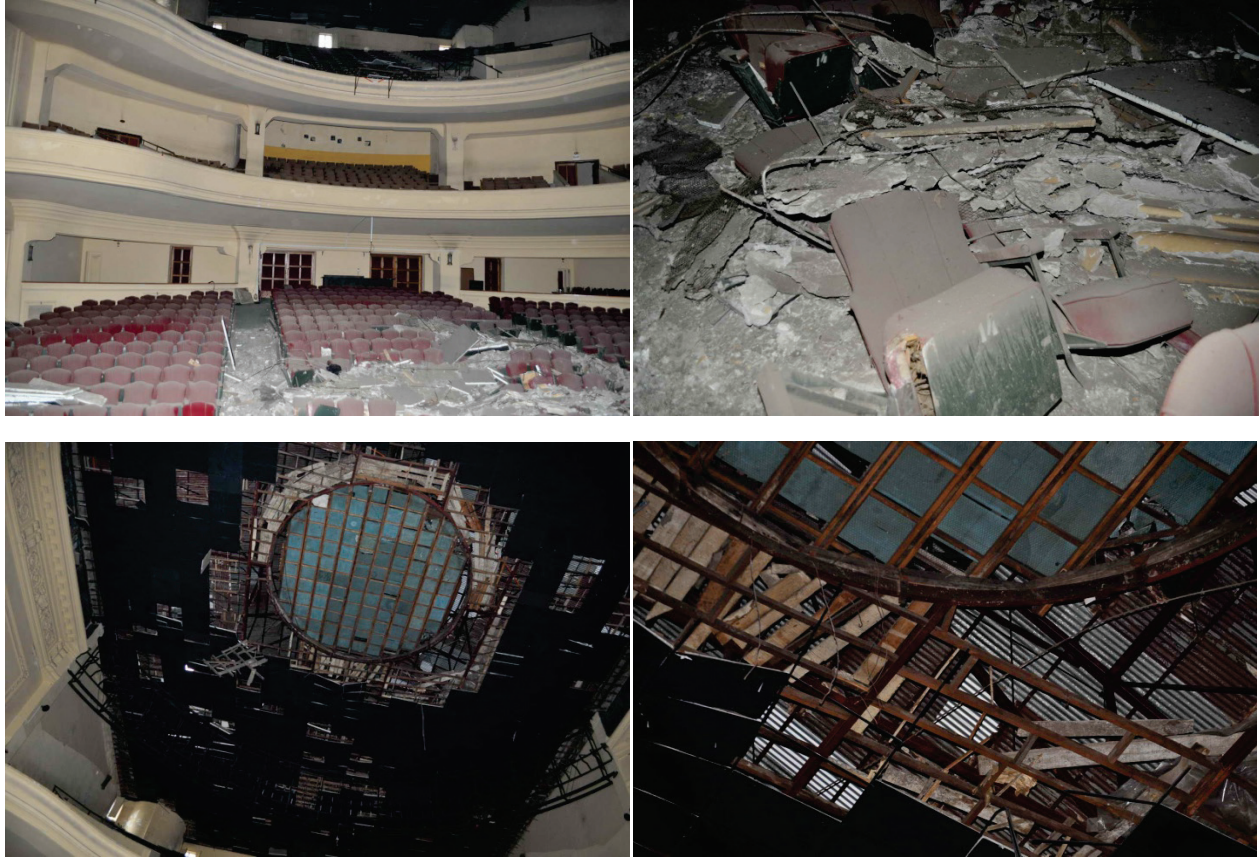
Figure 6.3.4.2-4 Damage to theater ceiling where foam panels and grid came down over orchestra seating and in upper balcony at the Municipal Theater Valparaiso in the 2010 Chile Earthquake (Photo courtesy of Eduardo Fierro, BFP Engineers). A circular section of metal lath and plaster collapsed completely. It appears the metal lath may have only been attached around the perimeter to wood furring added in the plane of the steel framing; circular area of wired glass is in a plane above the level of the wood furring. Black panels are lightweight foam supported by a grid attached directly to the wood furring.

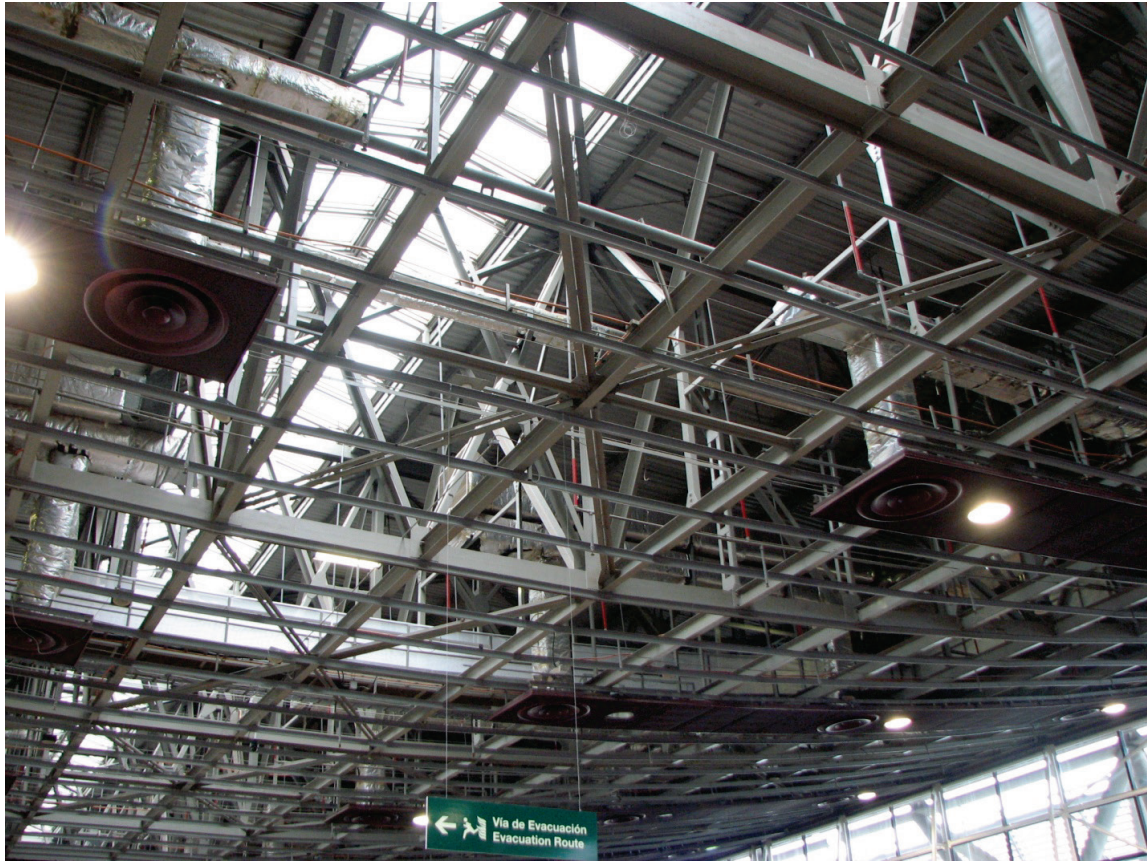
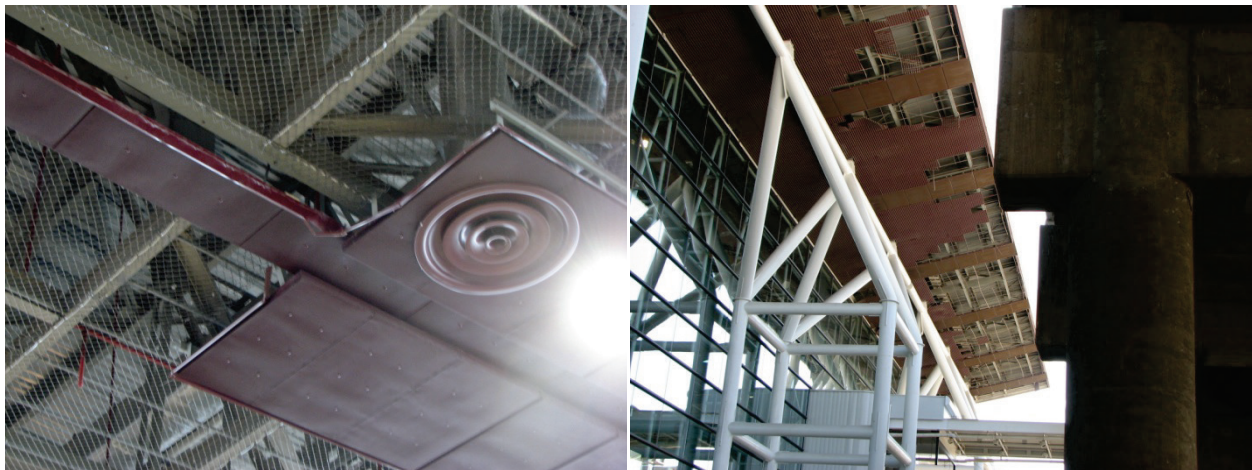
Figure 6.3.4.2-5 Extensive failure of ceiling in the main terminal of the Santiago airport in the 2010 Chile Earthquake. Metal panels with lights and diffusers hung from furring on short metal tabs; these remained in place but detail at lower left shows they also sustained some damage. Furring channels still in place throughout ceiling but majority of lightweight ceiling panels and much of the cross furring came down as shown at lower right photo of exterior soffit with same system (Photos courtesy of Antonio Iruretagoyena, Rubén Boroscchek & Associates).

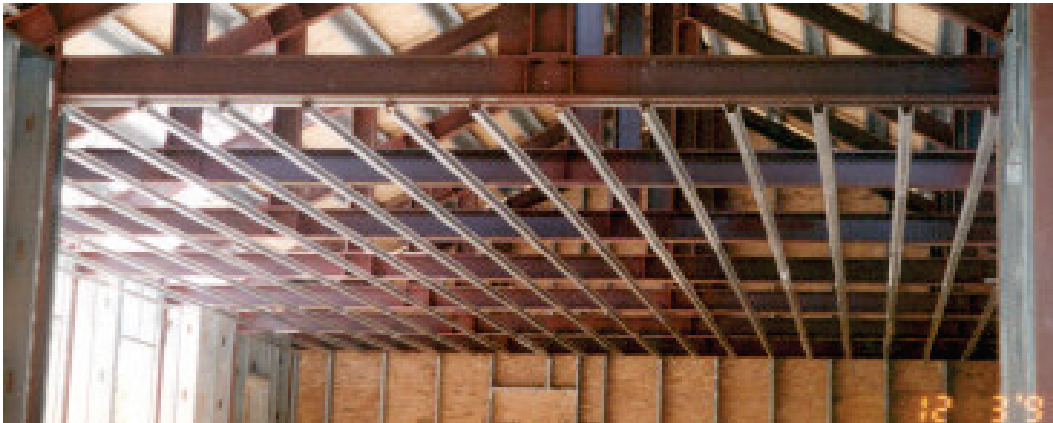
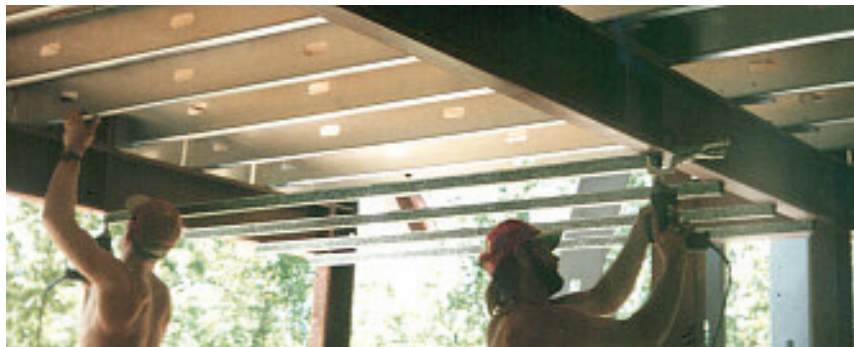
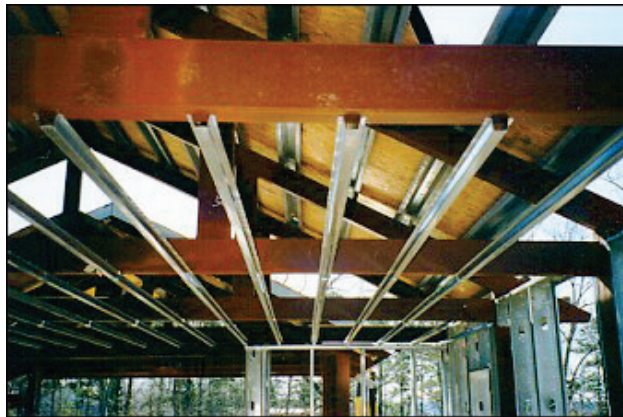
Figure 6.3.4.2-6

Mitigation examples with 1-1/2" hat channels at 16" on centers screwed in place with #12 self drilling screws and furring strips ready to receive gypsum board (Photo courtesy of Excalibur Steel). No special seismic details are required for this type of ceiling where the gypsum board is well secured directly to furring strips.

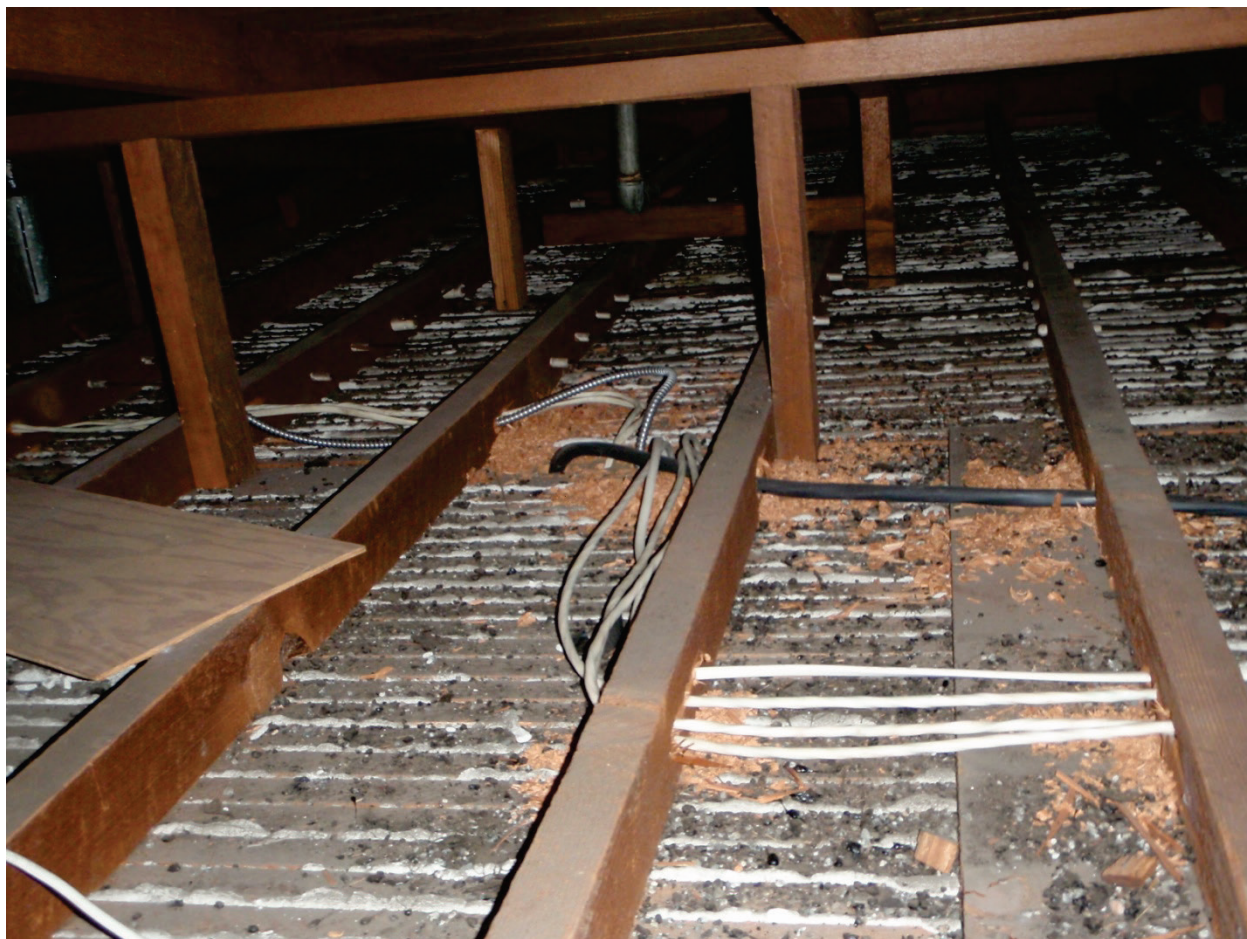
Figure 6.3.4.2-7 View of typical wood lath and plaster ceiling from the 1920's from above (Photo courtesy of Cynthia Perry, BFP Engineers). The wood lath is well nailed to the underside of the ceiling joists. This type of ceiling typically remains intact during an earthquake but may require crack repair and painting. Where the plaster has delaminated from the lath due to age or water leakage, wood strips could be installed from below as in Figure 6.3.4.2-8.

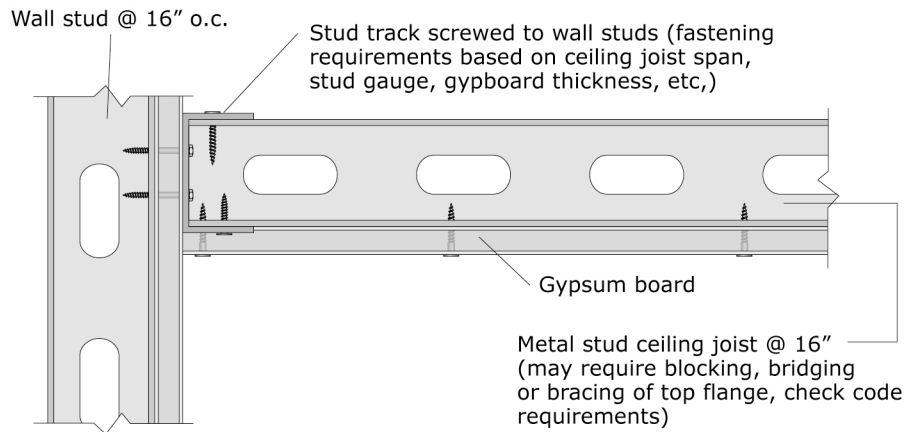
**a) Gypsum board attached directly to ceiling joists**

Note: Commonly used details shown; no special seismic details are required as long as furring and gypboard secured. Check for certified assemblies (UL listed, FM approved, etc.) if fire or sound rating required.

Figure 6.3.4.2-8 Gypsum board ceiling applied directly to structure (NE).

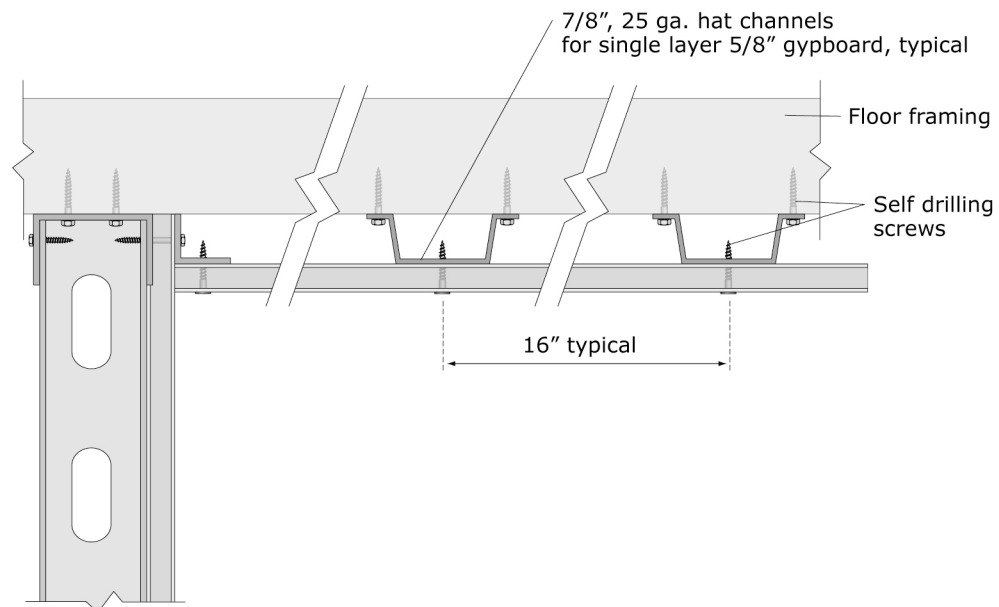
**b) Gypsum board attached directly to furring strips (hat channel or similar)**

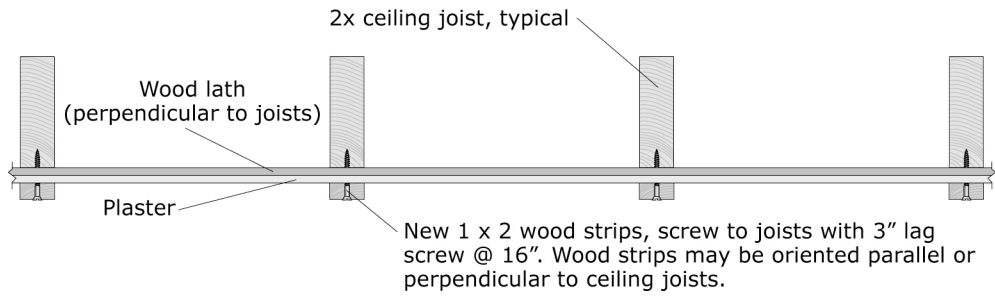
Figure 6.3.4.2-9 Retrofit detail for existing lath and plaster (NE).

- Vintage lath and plaster ceilings still exist in many older structures. These ceilings should be in good condition with the lath securely fastened to the structure and the plaster secured to the lath. The most reliable way to upgrade these ceilings would be to remove and replace with a code compliant ceiling system. Where it is important to match other vintage finishes, screw attached metal lath with a new plaster finish can be used. As an alternative to replacement, screwing 1x2 wood strips at 16 in centers into the joists from below may serve as a safety net (See Figure 6.3.4.2-9). Some ornate theatre ceilings have been encapsulated from below with netting to reduce the falling hazard; such netting and all its attachments must be designed to contain any falling debris.
