6.3 Architectural Components

6.3.7 Chimneys and Stacks

6.3.7.1 Unreinforced Masonry Chimney

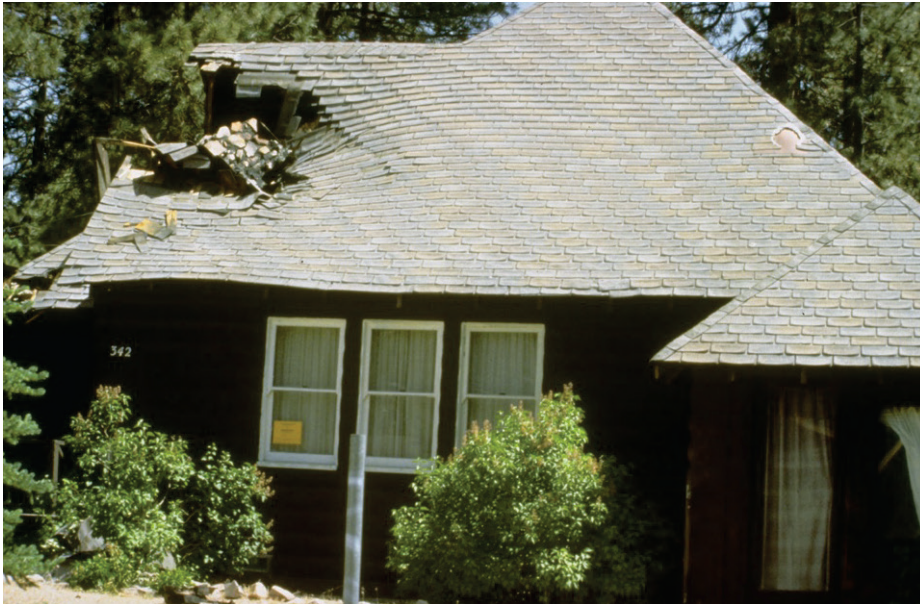
Figure 6.3.7.1-1 Chimney collapsed and fell through the roof; approximately 2,600 chimneys were destroyed in the 1992 Big Bear City, California earthquake (NGDC, 2009).

- Unreinforced masonry chimneys may crack, spall, separate from the structure, or collapse. They may fall through the roof structure and injure occupants or fall to the ground.
- Chimneys may suffer damage even at relatively low levels of ground shaking.

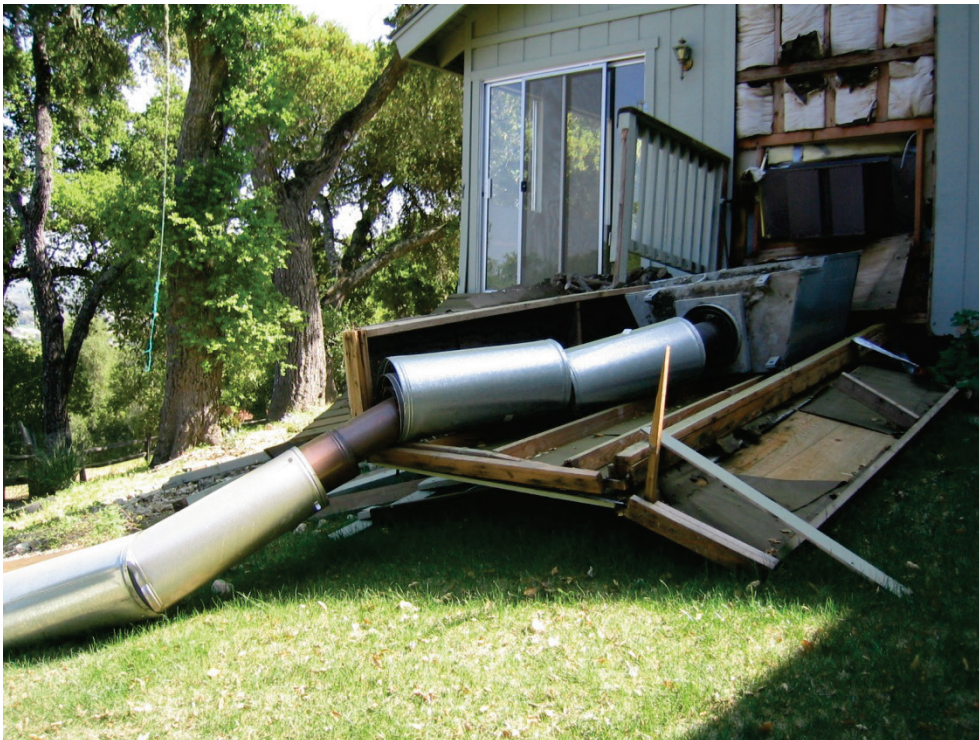
Figure 6.3.7.1-2 Residential metal flue in wood frame chimney that failed in the 2003 magnitude-6.5 San Simeon earthquake. The house fell off its cripple wall, pushing over the chimney (Photo courtesy of Michael Mahoney).

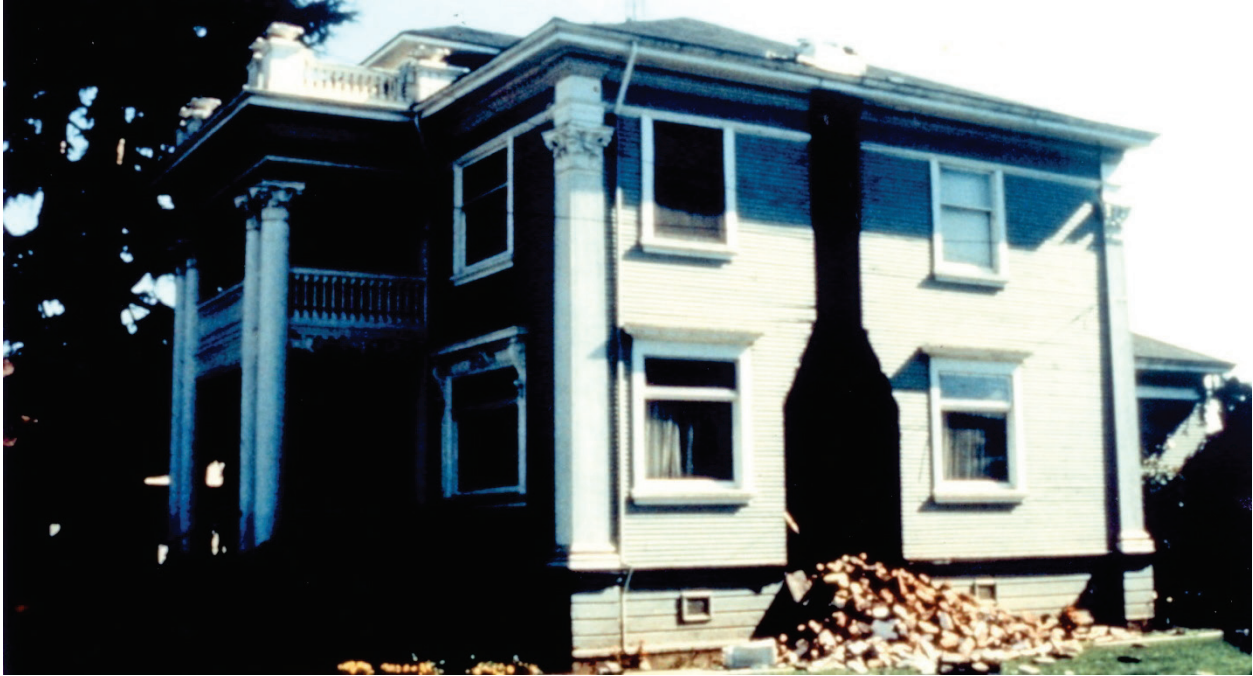
Figure 6.3.7.1-3 Chimney collapse (Photo courtesy of Earthquake Engineering Research Institute).

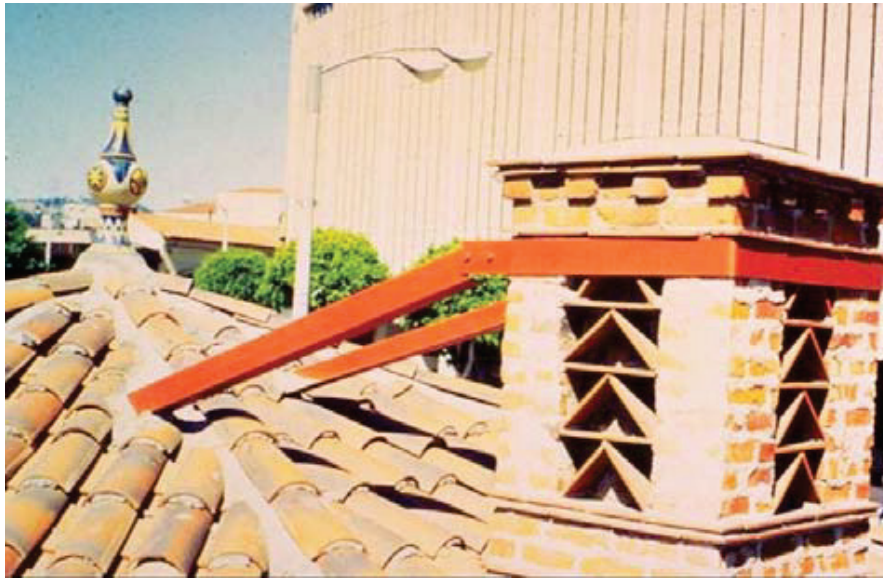
Figure 6.3.7.1-4 Braced chimney (FEMA, 2004).

- If the chimney is not being used, reducing its height to not more than 1 to 2 feet above the roofline will limit the potential for damage.
- Chimney and roof configurations vary widely. If a URM chimney is to be braced in place, an engineered design is needed to account for specific as-built construction details.
